Rear Door Symptom: Squeaking Noise from the Rear Door when Opening or Closing (SY 100/24)

Model Line: **Panamera (YAA / YAB)**

Model Year: **2024**

Concerns: **(Lower) seal for rear door**

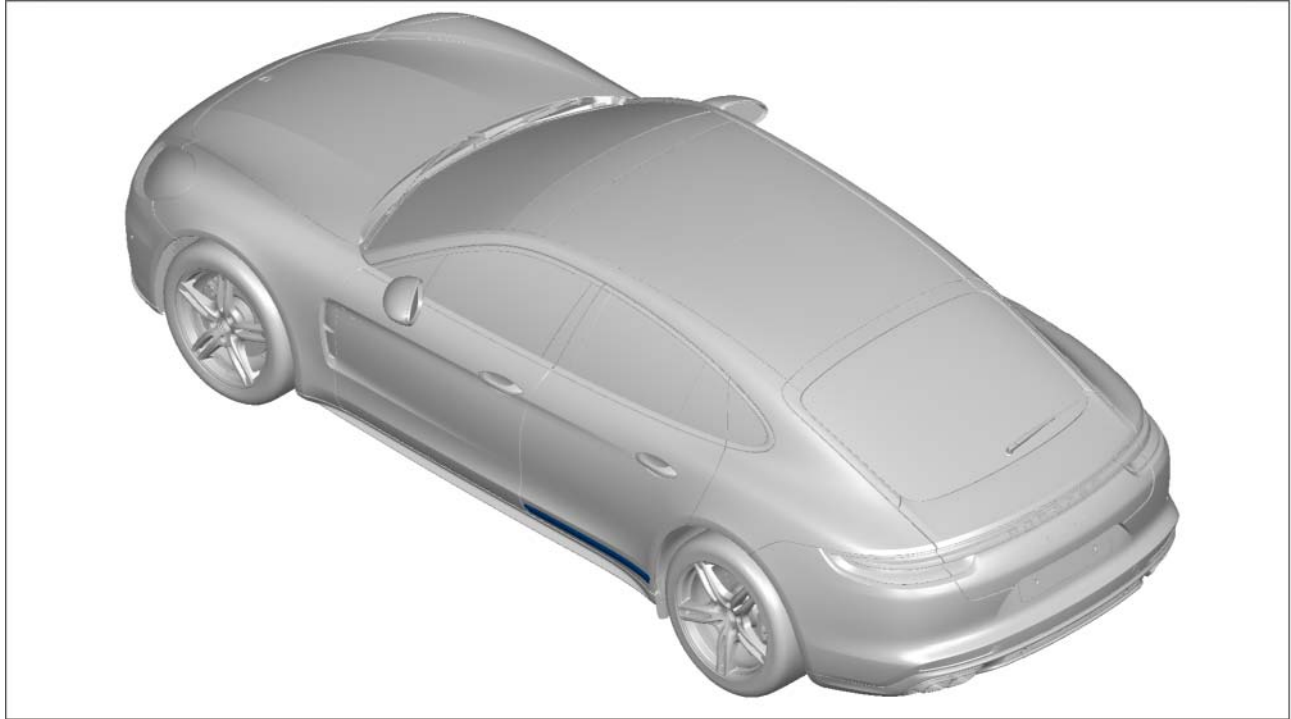
Installation position of seal for rear door (bottom)

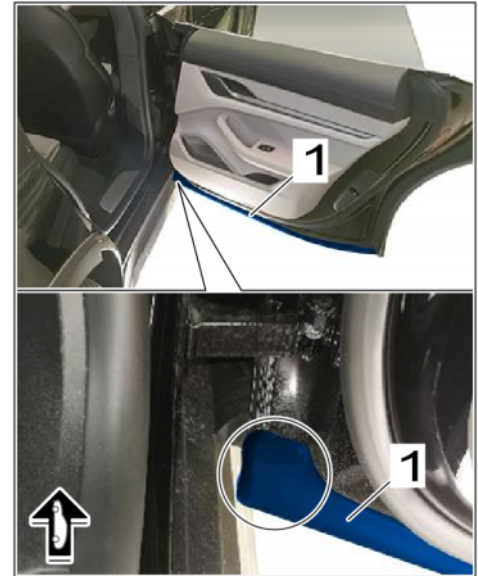
Rework area for rear seal (shown on right side of vehicle)

- 3 Clean the front area ⇒ *Rework area for rear seal (shown on right side of vehicle) -Circle-* of the seal on the rear door (bottom) ⇒ *Rework area for rear seal (shown on right side of vehicle) -1-* of dirt and adhering particles all the way around, including the front thinner lip area of the seal ⇒ *Coating area (shown with thin lip bent backwards) -2-*, with a cloth.

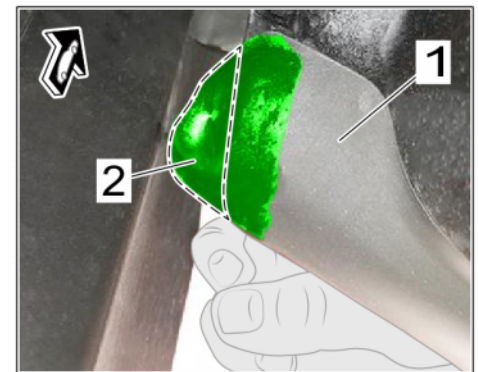
Coating area (shown with thin lip bent backwards)

- 4 ⇒ *Coating area (shown with thin lip bent backwards) -1-* Apply "Carbaflo XTR 5F" to the front part of the cleaned seal on the rear door (bottom) ⇒ *Coating area (shown with thin lip bent backwards) -green-* in the area marked all the way ⇒ *Coating area (shown with thin lip bent backwards) -2-* around, including the front thinner lip area.

If necessary, fold the front lip area of the seal ⇒ *Coating area (shown with thin lip bent backwards) -2-* backwards.

The "Carbaflo XTR 5F" is applied using the foam pad, which is attached to the front end of the tube under the cap.
