Surround Camera Intermittent Operation

Models	Model Year	Model Type	VIN Range	Vehicle-Specific Equipment
Cayenne	As of 2019 up to 2023	9YA, 9YB	N/A	KA6

Condition

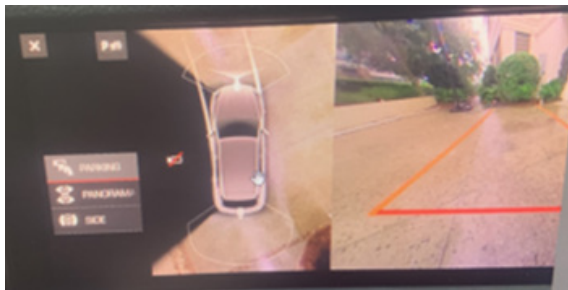
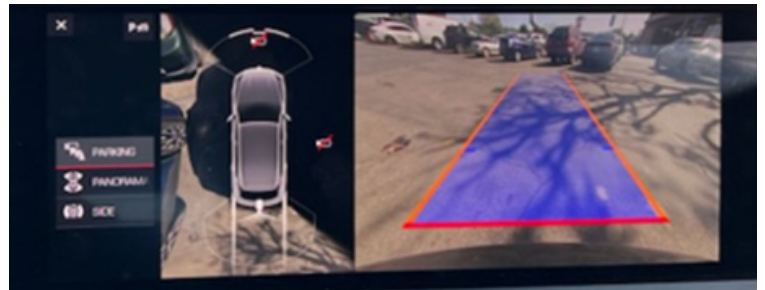
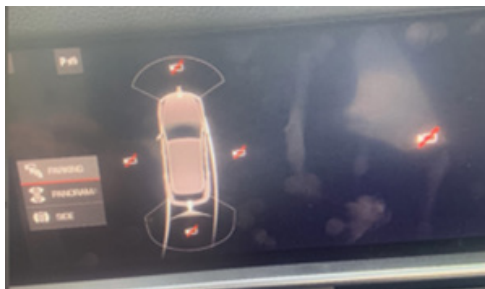
Customer complains of intermittent operation for one or multiple surround view cameras while appearing blank with a crossed-out camera icon for each failed camera.
