**WPS1 - Checking Pressure Sensors and Replacing them if Necessary (Workshop Campaign)**

Model Year: **As of 2020 up to 2023**

Vehicle Type: **Cayenne Turbo S E-Hybrid (9YA / 9YB)**

Concerns: **Air conditioning system pressure sensors**

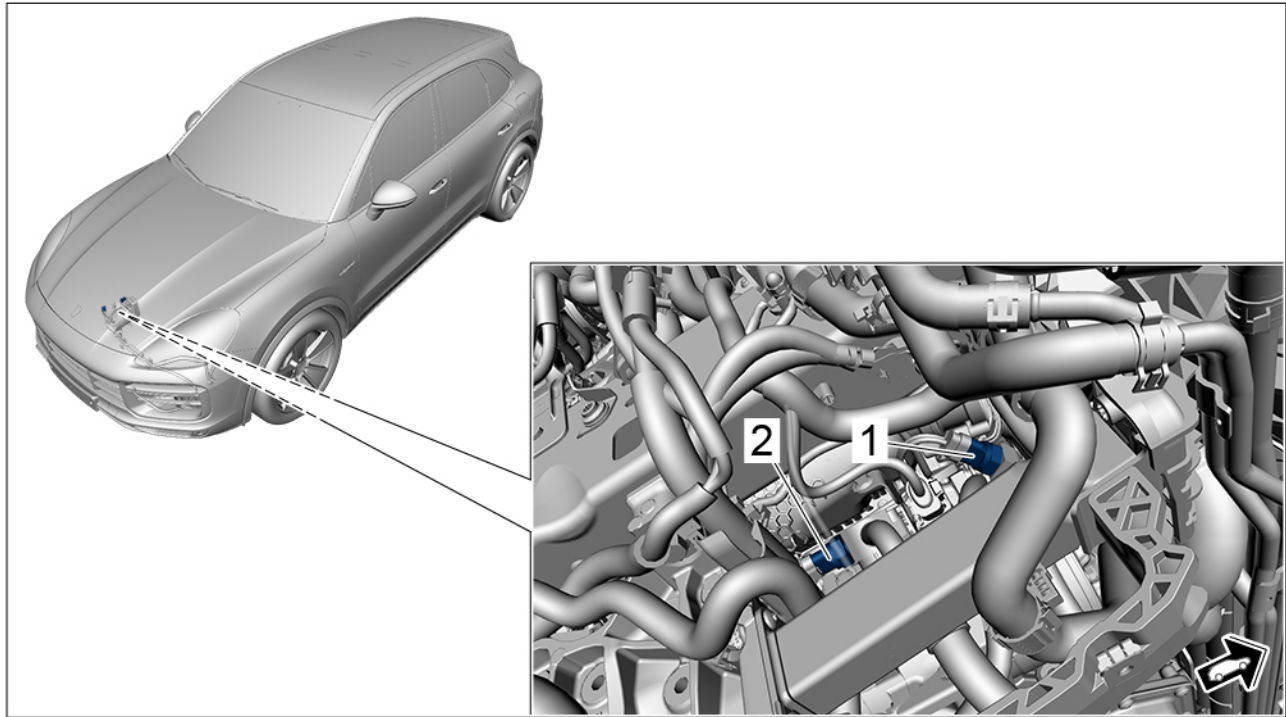
*Installation position of pressure sensors*

Cause: **Due to a manufacturing error at the supplier, pressure sensors for the refrigerant circuit that do not meet the required specifications were installed in the affected vehicles.**

The failure of one or both pressure sensors in the refrigerant circuit therefore cannot be ruled out over the lifetime of the vehicle. As a result, there is a possibility that the air conditioning and battery cooling system are not functioning properly.

- 1 – Pressure sensor (PT1) on high-pressure side (**check and replace if necessary**)
- 2 – Pressure sensor (PT2) on low-pressure side (**check and replace if necessary**)

Action: Check pressure sensors and replace them if necessary.

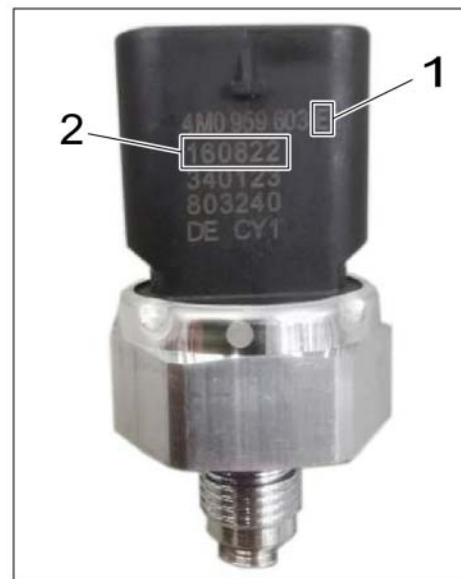
*New type of pressure sensor*

All pressure sensors with spare part number 4M0.959.603.**C** are **not OK** and must be **replaced**.

Pressure sensors with spare part number 4M0.959.603.**E** must also be checked from the applied production date.

- **up to** \_41921 are **not OK** and must be replaced.
- **from** \_42921 are **OK** and do **not** need to be replaced.

- 1 – Spare part index
- 2 – Production date from \_42921 (S / D / CW / YY · Shift / Weekday / Calendar Week / Year). Shown in the image: 1st place not relevant / weekday **6** / calendar week **08** / year**2022**

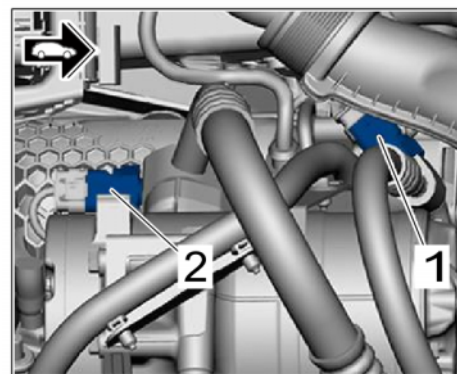
*Checking pressure sensor PT1 and pressure sensor PT2*

- 1 Check whether **pressure sensor PT1** ⇒ *Checking pressure sensor PT1 and pressure sensor PT2 -1-* and **pressure sensor PT2** correspond to ⇒ *Checking pressure sensor PT1 and pressure sensor PT2 -2-* the new component status.

Assessment		Action
(X)	Pressure sensor with spare part number 4M0.959.603.C	Pressure sensors with spare part index <b>C</b> are <b>not OK</b> and must be replaced. Replace the relevant pressure sensors. ⇒ Continue with Step 2 ⇒ [Scope 6 to Scope 8]
(X)	Pressure sensor with spare part number 4M0.959.603.E and production date <b>up to_41921</b>	Pressure sensor is <b>not OK</b> due to production date (up to _41921) and must be replaced. Replace the relevant pressure sensors. ⇒ Continue with Step 2 ⇒ [Scope 6 to Scope 8]
(✓)	Pressure sensor with spare part number 4M0.959.603.E and production date <b>from _42921</b>	Pressure sensor is <b>OK</b> due to spare part index E <b>and</b> production date (from _42921) and does <b>not</b> have to be replaced. <b>End of action.</b> Continue with ⇒ <i>Technical Information '213919 follow-up actions'</i> [Scope 2]

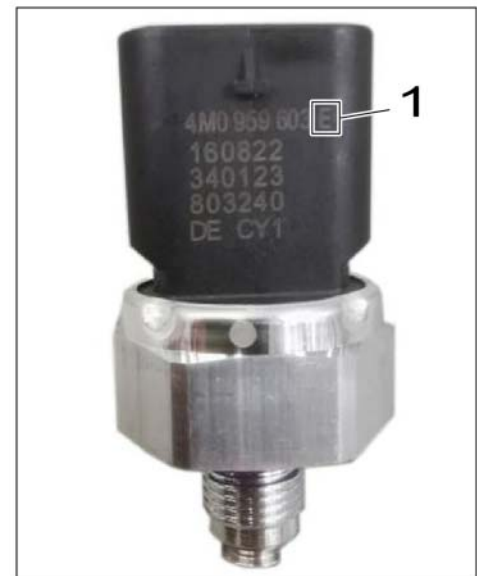
*Spare part index for pressure sensor*

When replacing pressure sensors, it is essential to ensure that the pressure sensors have the same spare part index. If one of the pressure sensors has a different index, the corresponding pressure sensor must also be replaced. The index is visible on the pressure sensor.

- 1 – Spare part index for pressure sensor
- 2 Replace pressure sensors **with old component status**.  
For procedure, see:  
⇒ *Workshop Manual '878319 Removing and installing pressure sensor (PT1 and PT2)'*
