01-19-05TT - Engine Crank, No Start or No -J623- Engine-Motor Control Module Communication, with DTC U0100 Stored in ECM

Release date: 7/11/2024

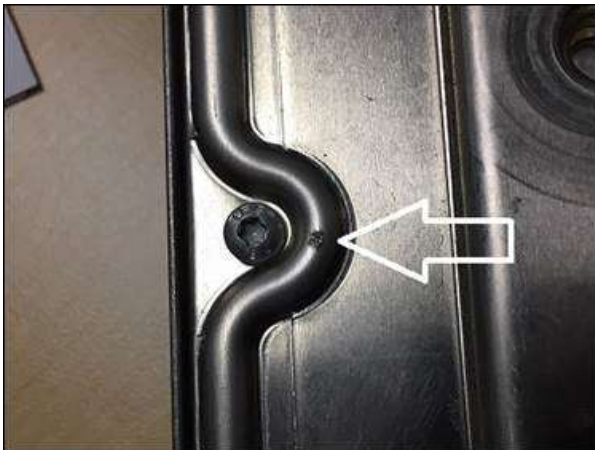
Figure 1

When disconnecting the Battery during service, the -J623- (ECM) may become internally shorted as a result of the Positive Battery Terminal grounding out on the ECM case. DTC U0100 may set, as well as an engine crank with no start condition.

When disconnecting or replacing a Battery, the Repair Manual procedure outlined in Elsa must be followed in its entirety. See Repair Manual Group 27. The Battery Ground Cable must always be disconnected prior to the Battery Positive Cable. Failure to do so may result in internal ECM damage.
