94-22-01 - Taillight Cluster Condensation

Release date: 7/15/2024

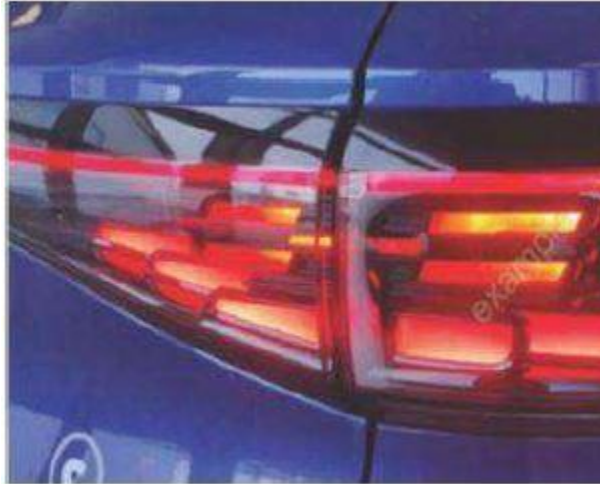
Figure 1:

1. Example of taillight with slight condensation, no drips or water droplets.

1. Taillights: the condensation should systematically dry out after a change of the climate conditions.

This condition is normal, no replacement necessary.

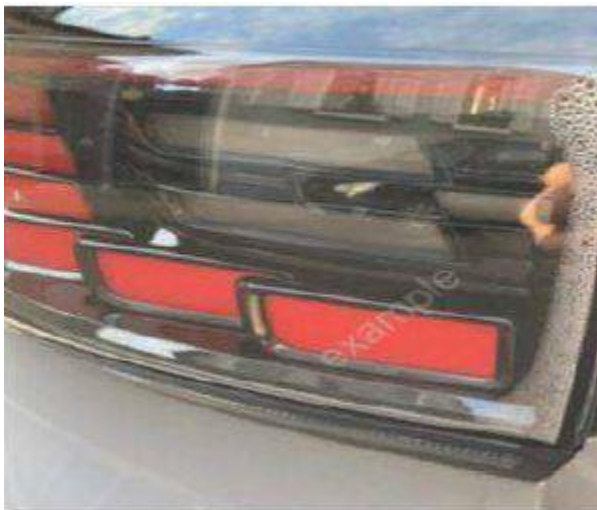
Figure 3:

2. Examples of taillight condensation, with droplets or water dripping.

2. In case of an obvious water ingress check the taillight cluster for optical faults (seal fit, taillight housing cracks).
