# TEAM TIP

Communication #: T-24-07-01

Model Year(s): 2020–2024

## SUBJECT: ALTERNATOR CONNECTOR

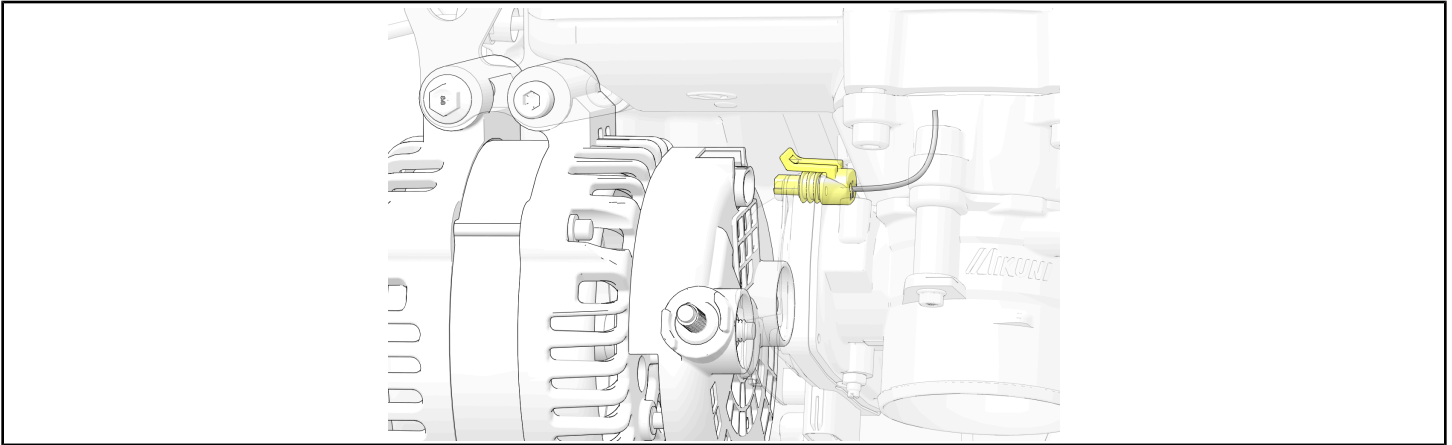
The connector is found on the upper right-hand side of the alternator. Follow the steps on the next page to properly disconnect the alternator connector.

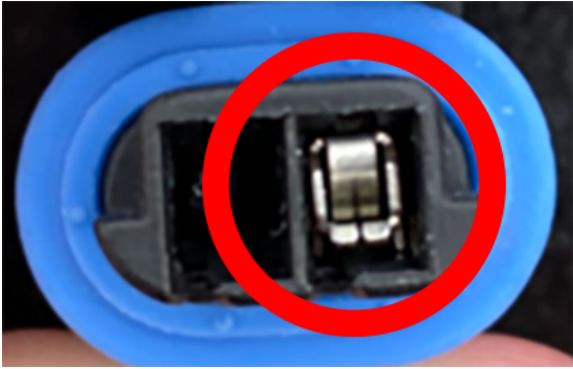
GOOD	BAD
<p>Terminal is centered in the connector and the contact tab makes contact across the entire terminal.</p>

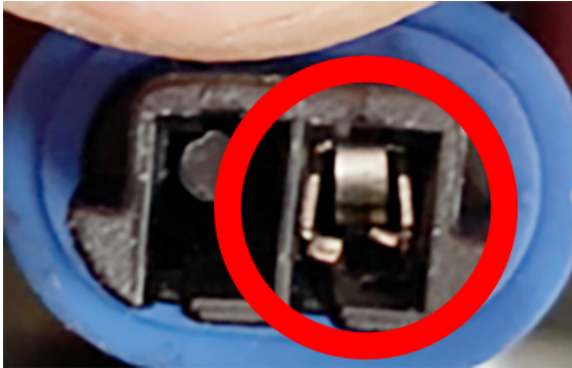
The terminal of the excitation wire may become opened, damaged, or pushed back during installation of the connector to the alternator, resulting in the alternator not charging intermittently.

<p>Terminal is damaged or contact tab is bent, leaving a gap between the top and bottom of the terminal.</p>

During testing for a no charge condition, closely inspect the excitation wire terminal for damage or bent tab as outlined below. If damage is found, the harness will need to be repaired. We don't yet have kits available for standard order, but if you find this condition then contact Technical Service to have a repair kit sent directly. Submit an Ask Polaris Service & Warranty Question> All Vehicle Diagnostic case. Enter "T-24-07-01" into the concern statement field.

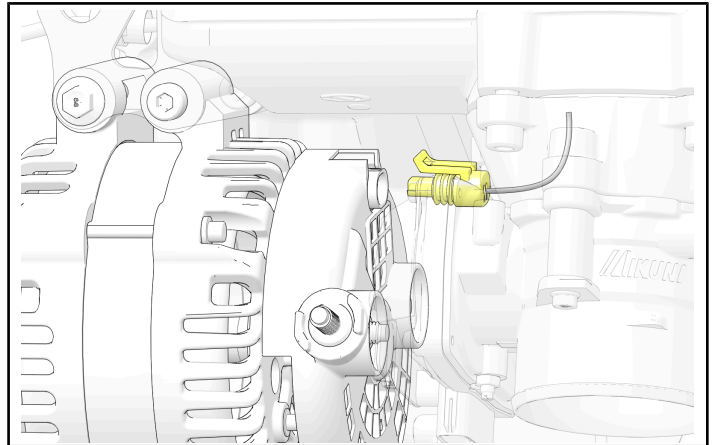
7. Disconnect the damaged alternator electrical connector from the alternator.
