# TECHNICAL SERVICE BULLETIN

## Extra Effort Required To Close Hood With A “Hood Ajar” Warning Indicator

**24-2233**  
29 July 2024

Ford 2024 Ranger
---------------------

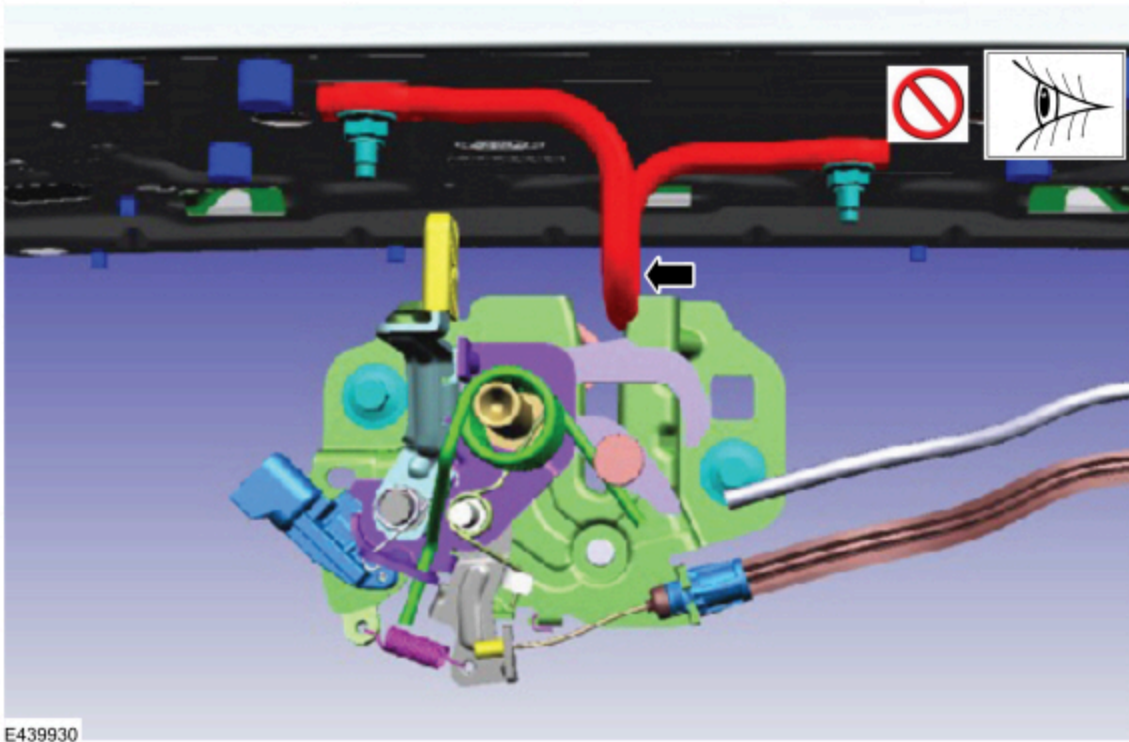
Figure 1

**Issue:** Some 2024 Ranger vehicles may exhibit a hood that requires extra effort to engage the primary latch when closing the hood. This may be due to the misalignment of the latch assembly to the hood striker. This condition does not affect the secondary latch operation and the hood will remain secured. To correct this concern, follow the Service Procedure to adjust the latch and adjust the bump stop rubbers.

1. Open the hood.
2. Adjust the bump stop rubbers located on the hood assembly by turning the bump stop rubbers clockwise until the bump stop rubber is fully wound in to the hood inner panel.
3. Once the bump stop rubbers are wound in all the way, turn the bump stop rubbers counter clockwise 3.25 turns.
4. Open the hood and hold it 12-13 inches (304-330 mm) above the latch and drop the hood. Did the hood latch easily?
  - (1). Yes - repair is complete.
  - (2). No - proceed to Step 5.
5. Remove the radiator sight shield. Refer to [WSM](#), Section 501-14.
6. Loosen the latch attachment bolts (Figure 3) and align the latch so it is centered to the hood striker. (Figures 1-2)
