Technical Service Bulletin

97 MIL on - DTC: U060B00 stored in engine control unit

01 24 29 2074392/1 July 3, 2024.

Model(s)	Year	VIN Range	Vehicle-Specific Equipment
Q5, Q5 e quattro, Q5 Sportback, SQ5, and SQ5 Sportback	2022 - 2024	All	Not Applicable

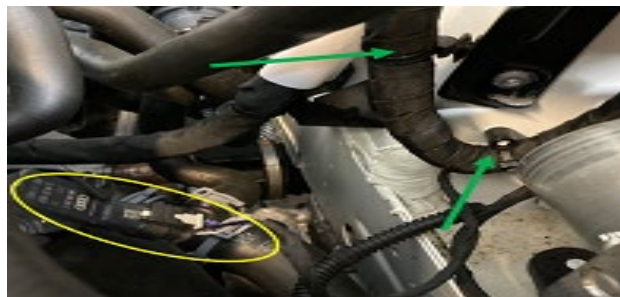
Figure 1: G31 and connector

Under certain conditions, vibrations may cause the wiring on electrical connector T3y to break.

Check wiring on electrical connector T3y for charge pressure sender -G31- for damage (see yellow circle on figure 1).

Disconnect electrical connector T91 on the engine control unit and loosen the wiring harness at the two mounting points (green arrows in Figure 1) to gain better access.

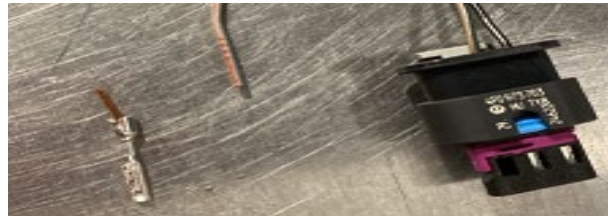
Figure 2: Wire damaged inside G31 connector

The damage may only be noticeable after de-pinning the connector or removing the harness tape.

If damage is found at the G31 connection, repair as follows:
