# Technical Service Bulletin

## 15 Engine: Cylinder head cover - oil residue Q5 (inline 4-cyl., 2.0 ltr. TFSI)

15 24 51 2072716/4 July 27, 2024. Supersedes Technical Service Bulletin Group 15 number 24-50 dated June 12, 2024 for reasons listed below.

Model(s)	Year	VIN Range	Vehicle-Specific Equipment
Q5, and Q5 Sportback	2021 - 2023	All	Not Applicable

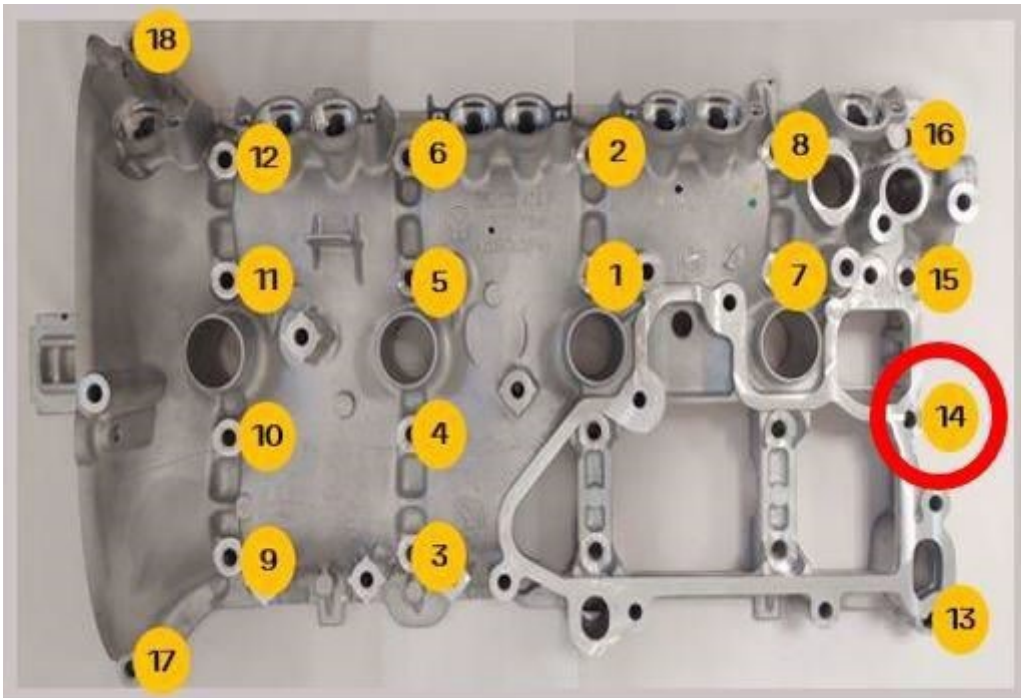
**Figure 1:** Sequence for checking torque (18 bolts).

- If several bolts are affected, do not loosen them at the same time (i.e., several at once). Please loosen and tighten each bolt individually.
- After replacing the affected bolt(s), tighten the remaining bolts to 14 Nm in the sequence shown in the illustration (Figure 1, and Figure 2) using a torque wrench.
- Depending on the oil separator fitted, 17 or 18 bolts must be re-tightened. On the one version of the oil separator, the bolt circled red is not accessible. In this case, please follow the tightening sequence with 17 bolts.

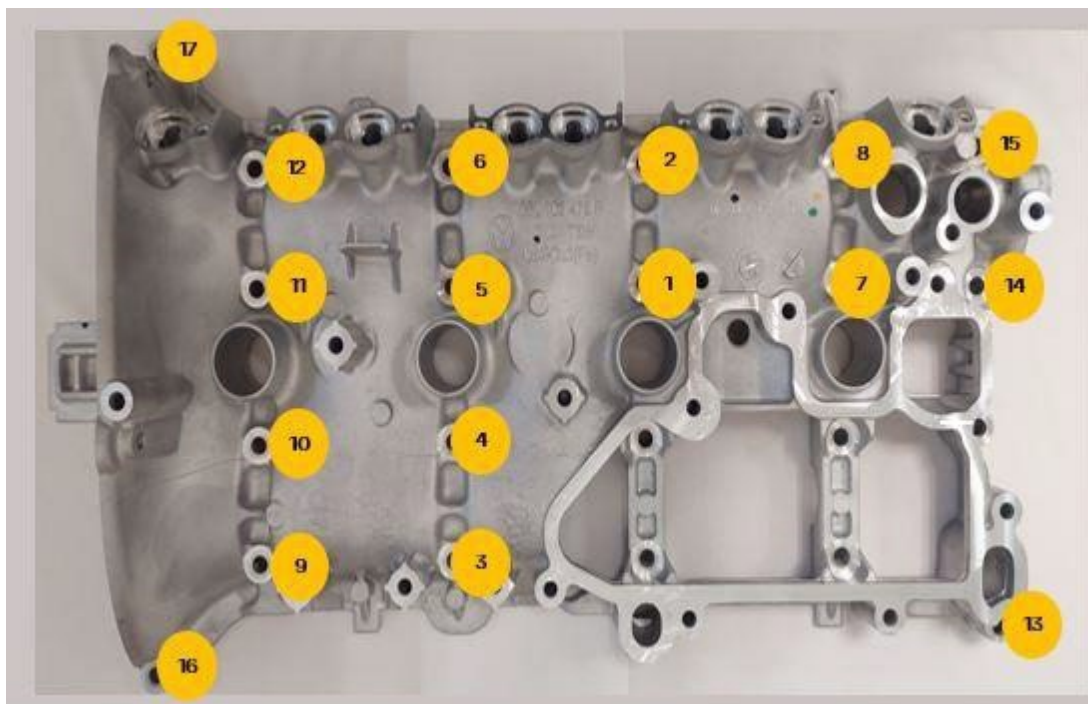
*Figure 2: Sequence for checking torque (17 bolts).*

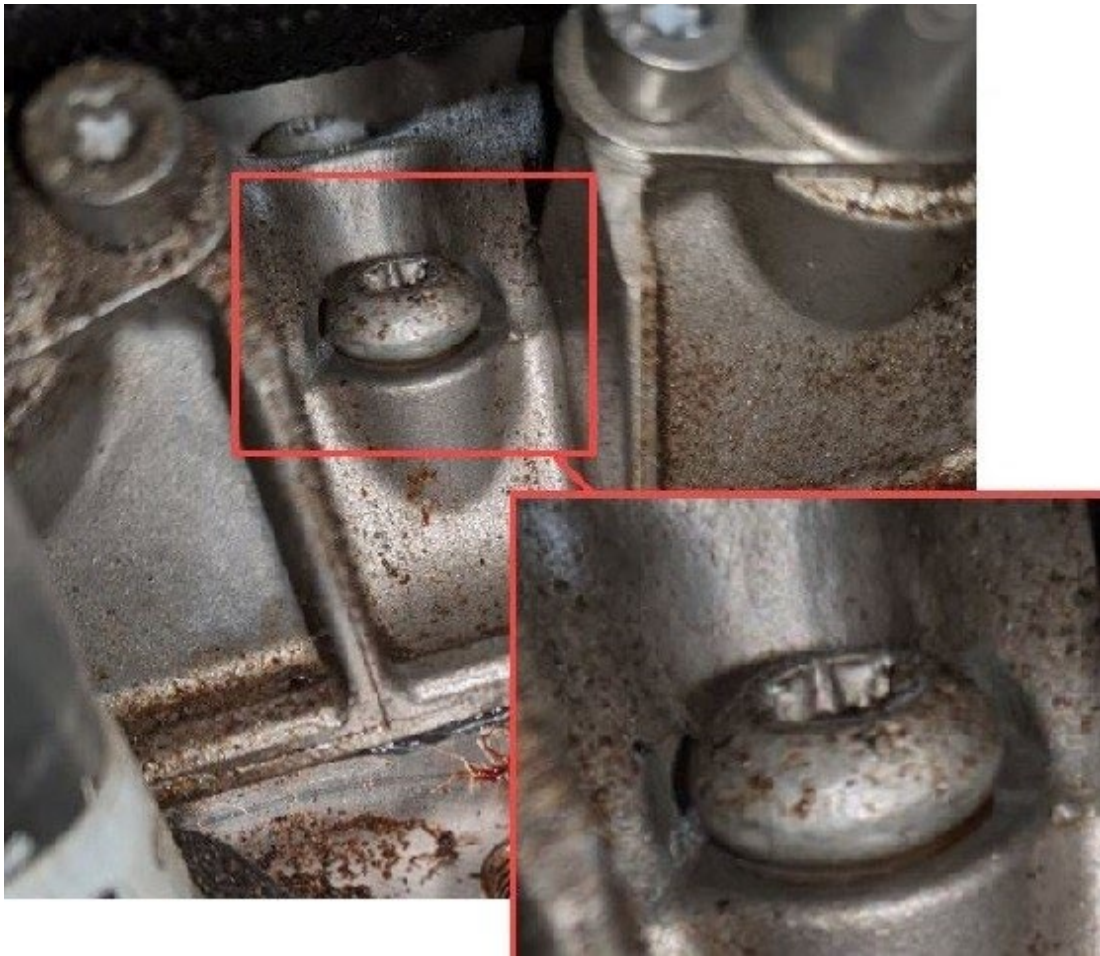
Cylinder head cover leaking in the area around the threaded connection (on one or more bolts).

In rare cases, the cylinder head cover bolts may become loose, resulting in oil residue in the area of the threaded connection.

**Figure 3:** Oil on the threaded connection.

- Replace the affected bolt(s).
- Tighten the new bolt(s) to a torque of 8 Nm + 90°.

Please ensure that replacing the bolts remedies the leaking.

If the torque wrench does not click after a half turn (180°) when re-tightening the remaining bolts to 14 Nm (in sequence shown in illustration), replace the bolt.

- When replacing the new bolt, it must be tightened to a torque of 8 Nm + 90°. If several bolts are affected, do not loosen them at the same time (i.e. several at once). Please loosen, replace, and tighten each bolt individually.
- When re-tightening the bolt(s), the maximum torque of 14 Nm must not be exceeded.
