# Technical Service Bulletin

## 19 Engine: cooling system - engine overheats, red coolant temperature warning, MIL on - 4.0 ltr. V8 TFSI; P029900

19 24 63 2074303/3 July 31, 2024. Supersedes Technical Service Bulletin Group 19 number 24-62 dated July 3, 2024 for reasons listed below.

Model(s)	Year	VIN Range	Vehicle-Specific Equipment
A8	2019 – 2020	All	4.0 l engine
SQ7	2020 – 2025		
S8, SQ8, and RS Q8	2020 – 2024		
RS 6 Avant, and RS 7	2021 – 2024

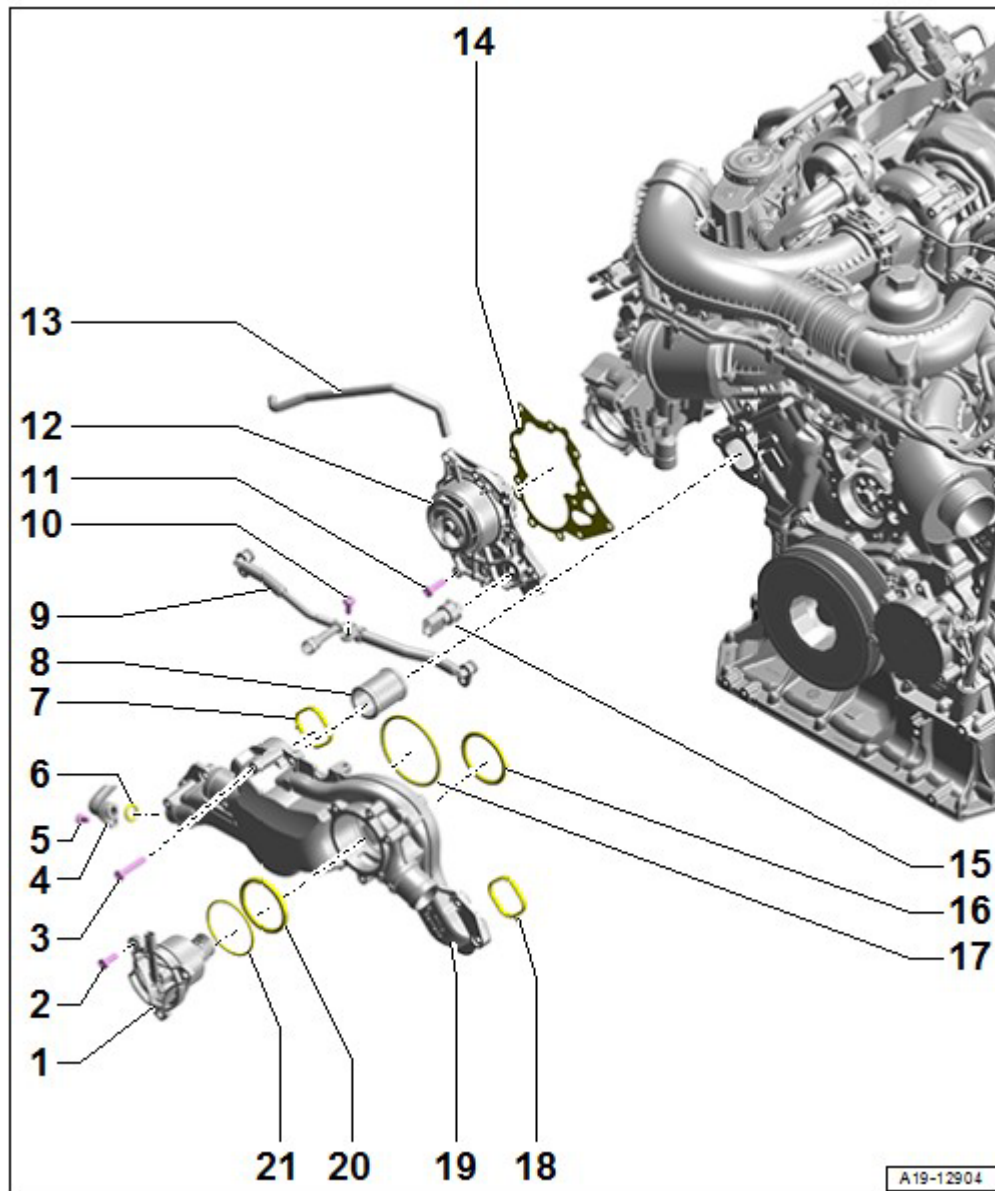
When N649 is activated, it switches a vacuum to the mechanical coolant pump. This pushes a locking sleeve over the pump impeller, which can cause coolant to stagnate.

**Figure 1.** Assembly overview – coolant pump/thermostat incl. switchable mechanical coolant pump, number 12.

- Please remove the vacuum hose on the mechanical coolant pump (number 13 in Figure 1).
- Please check whether this results in lower engine coolant temperatures.
- If the coolant temperature drops, replace the electric changeover valve for the switchable mechanical coolant pump N649 according to the Workshop Manual.
- Also check whether there are traces of coolant in the vacuum hose between the mechanical coolant pump and N649, or in the vacuum connection of N649. If there are traces of coolant, please also replace the switchable mechanical coolant pump according to the Workshop Manual and provide images.

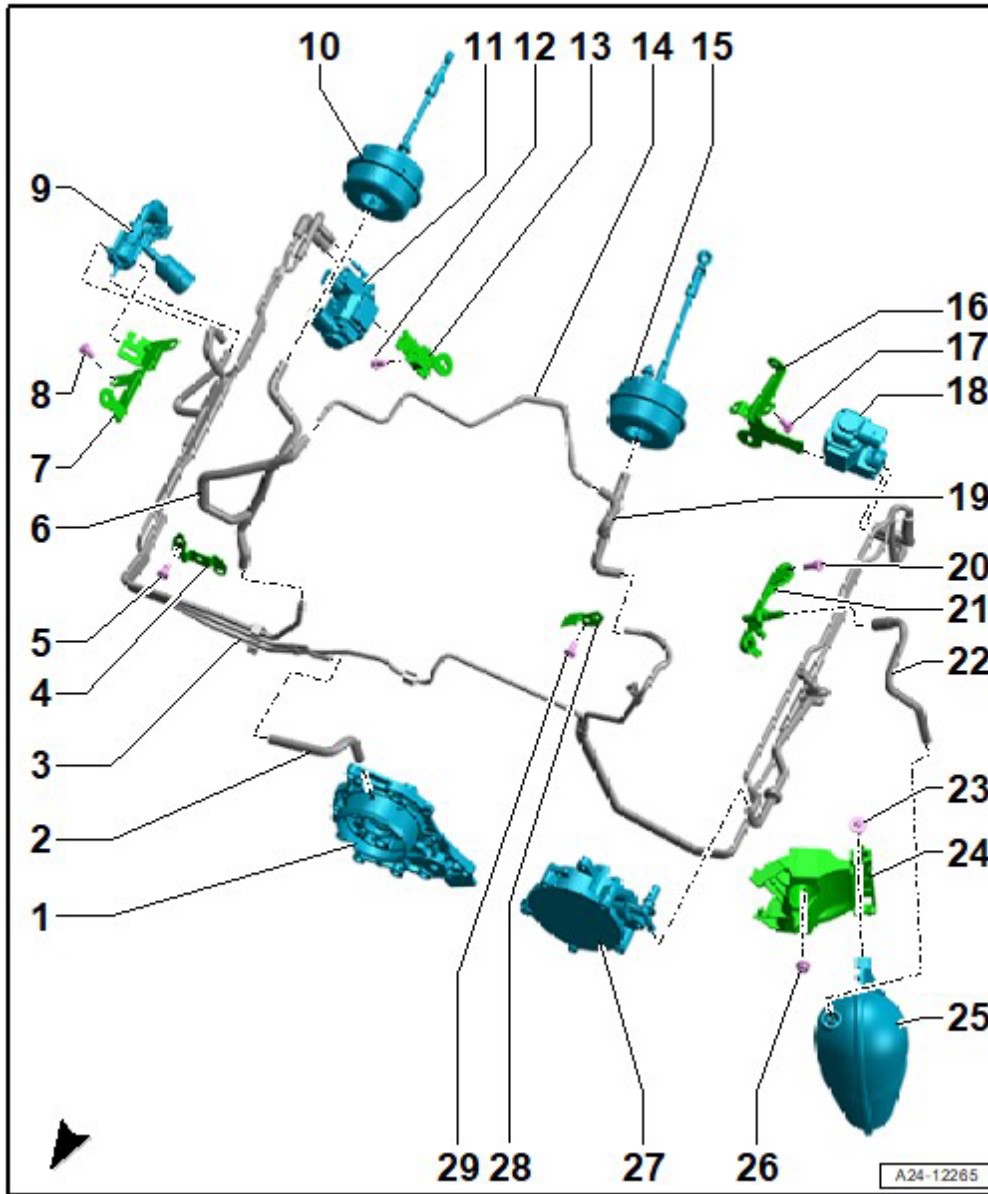
Figure 2. Assembly overview – vacuum system incl. N649, number 9.

- Check the vacuum system for leaks. If a leak is detected on N649, replace N649 according to the Workshop Manual. Also check whether there are traces of coolant in the vacuum hose between the mechanical coolant pump N649, or in the vacuum connection of N649. If there are traces of coolant, please also replace the switchable mechanical coolant pump according to the Workshop Manual and provide images.
