# Technical Service Bulletin

## 34 Function restriction with event memory entry P071800 - P276800 (symptom 20736 - 20737)

34 24 69 2067653/8 July 3, 2024. Supersedes Technical Service Bulletin Group 34 number 24-68 dated June 3, 2024 for reasons listed below.

Model(s)	Year	VIN Range	Vehicle-Specific Equipment
A4, A4 allroad, A5, A5 Cabriolet, A5 Sportback, A6, A6 allroad, A7, Q5, and Q5 Sportback	2021 - 2024	All	Not Applicable

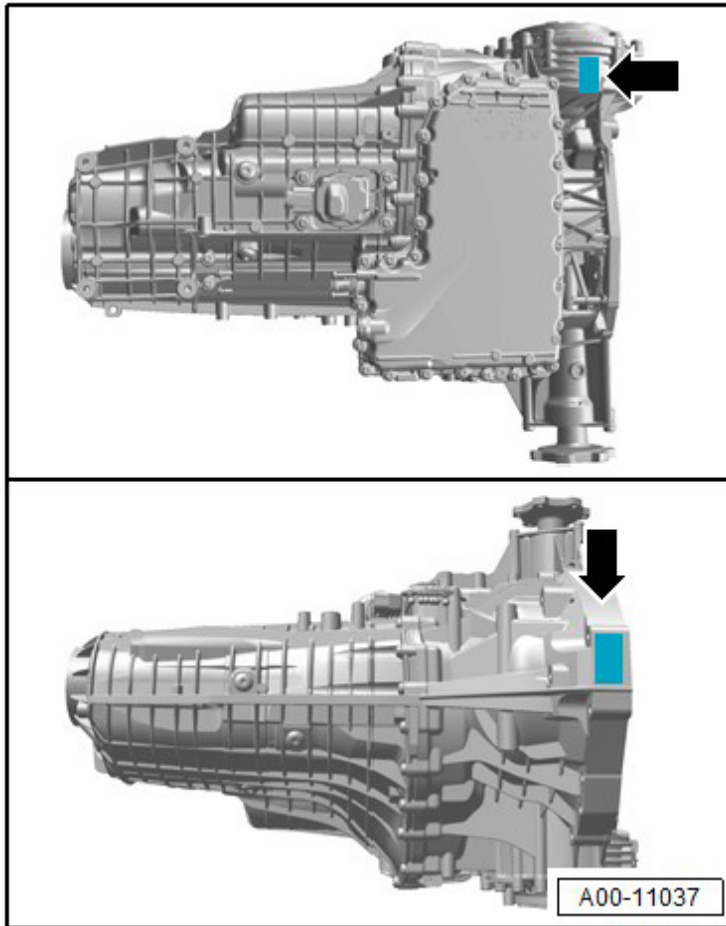
**Figure 1.** Locations of data stampings.
