Technical Service Bulletin

37 Noises after selecting a gear at idling speed when vehicle is stationary, noises when driving in different gears

37 24 20 2074806/1 July 31, 2024.

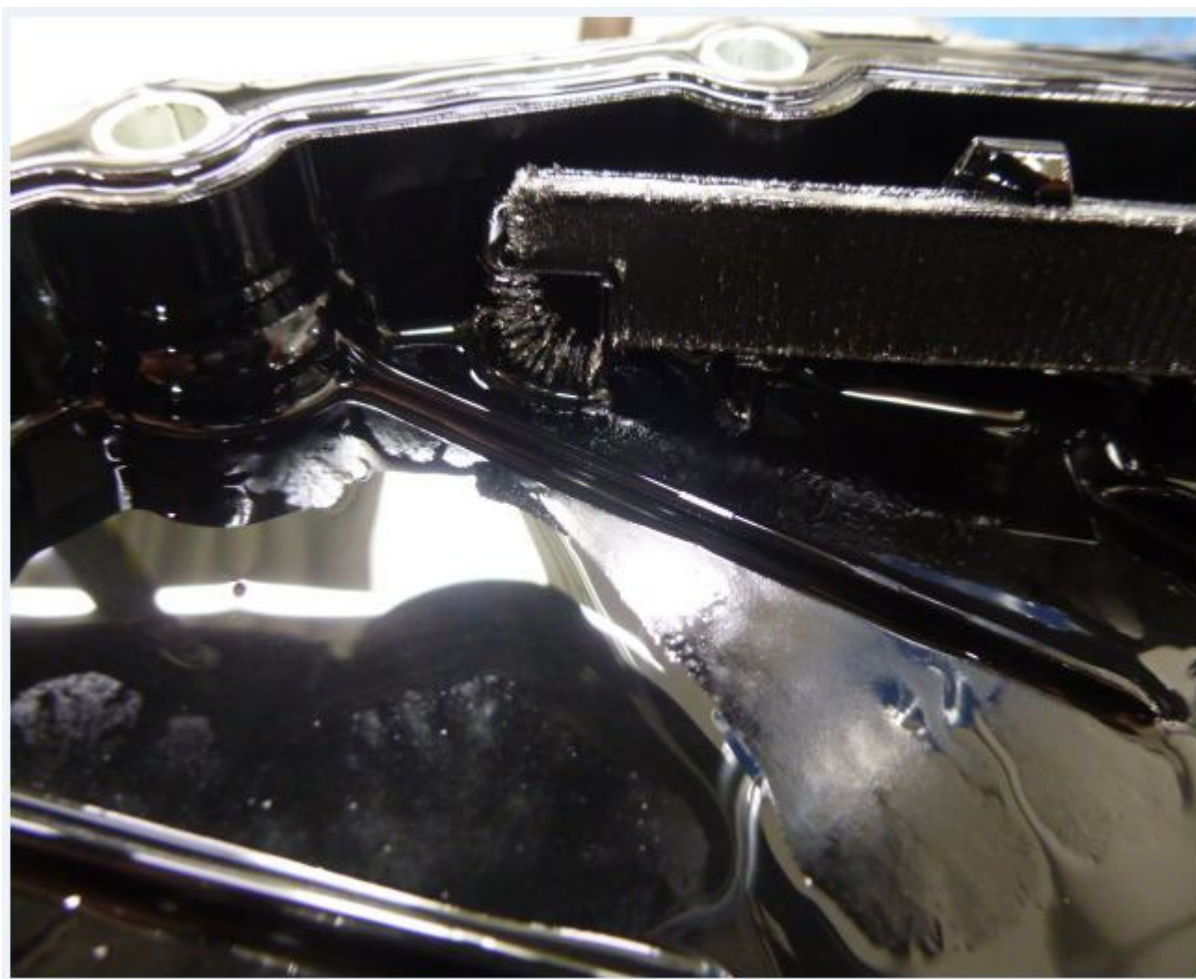
Abrasion visible on the permanent magnets of the oil pan (see Figure 5).

Figure 5. Abrasion is visible on the permanent magnets of the oil pan.

Replace the permanent magnets in the gearbox oil pan.

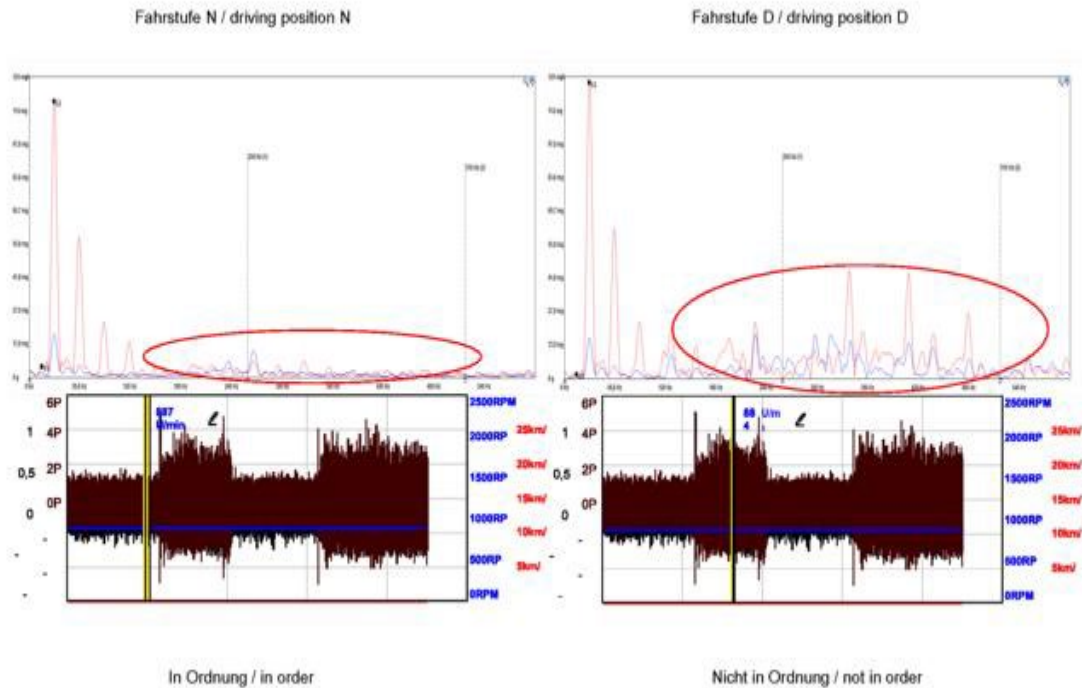
Analysis of the measurement via acceleration sensor 1/channel A and acceleration sensor 2/channel B.

Frequency range of approx. 250-600Hz can be detected here.

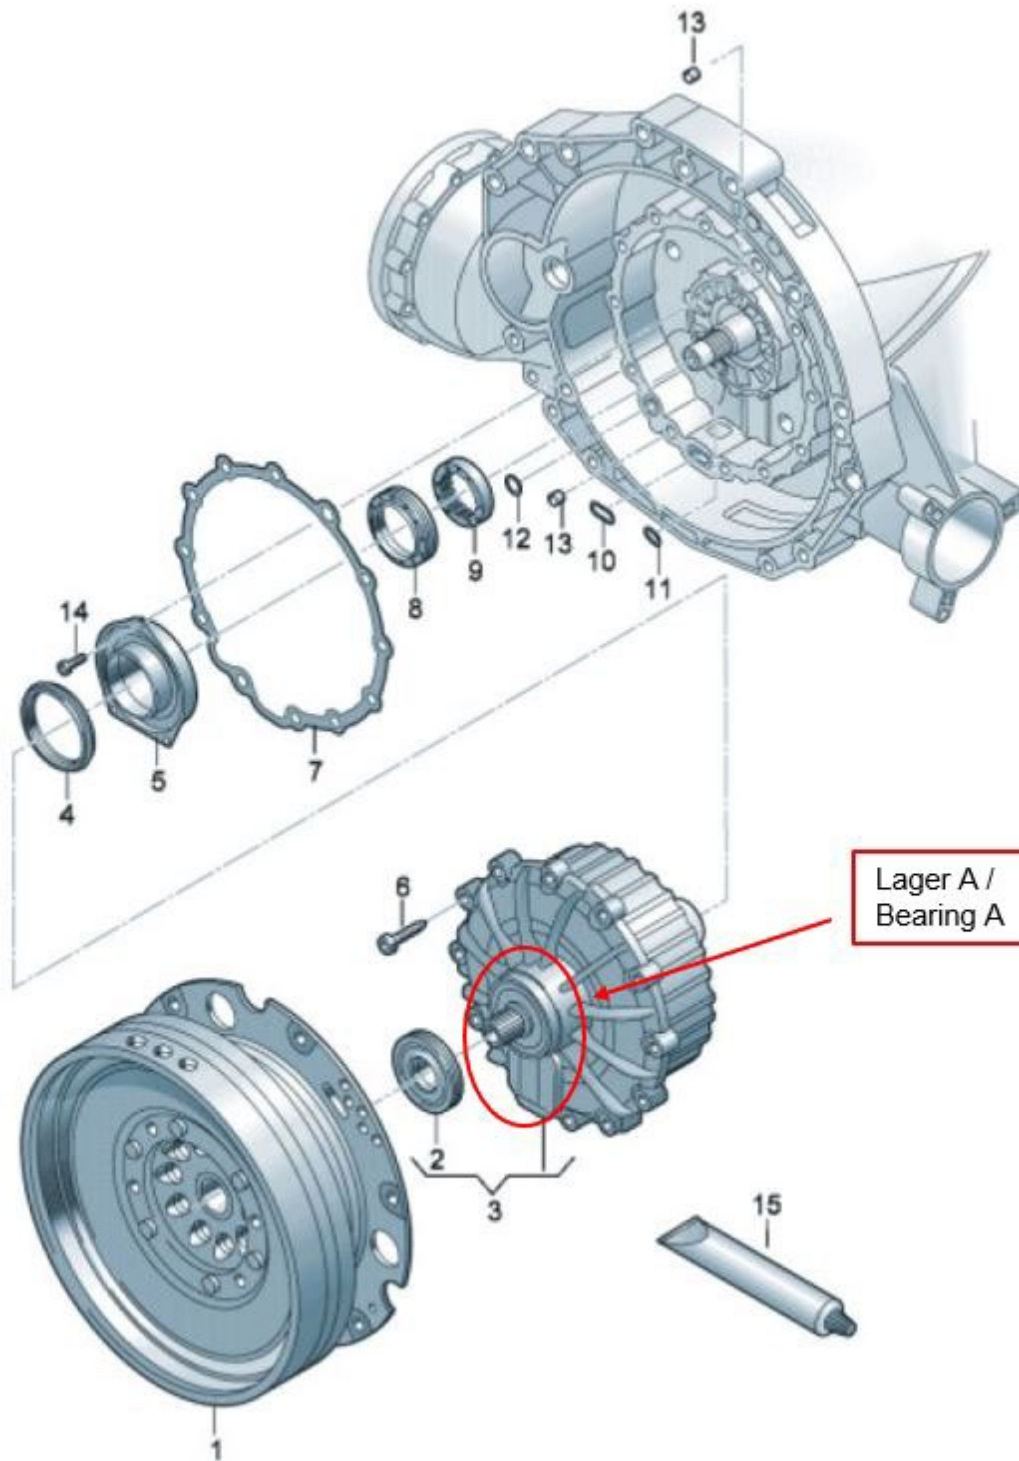
Figure 9. Bearing A on dual clutch.

Bearing A (Figure 9) on dual clutch.

Also perform a visual check of bearing A in cover for dual clutch and document your findings with detailed photos. To do so, remove the oil seal on bearing A (Figure 9 -> marked in red) of the dual clutch that was removed. Document any possible malfunctions of bearing A (see Figure 10 -> red arrow) with a photo clearly showing the issue.

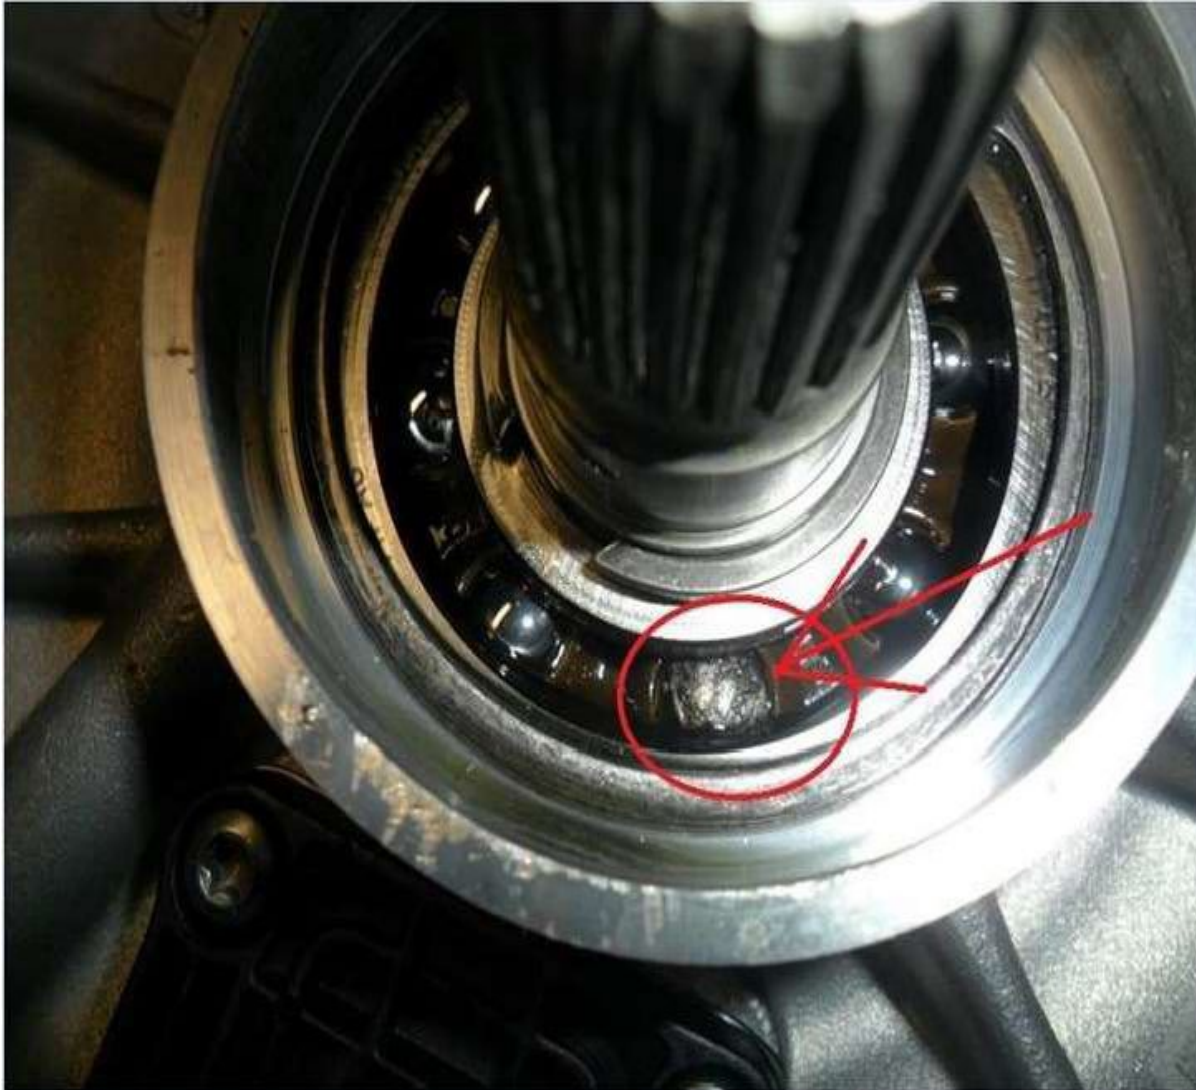
Figure 10. Bearing A circled, with red arrow.

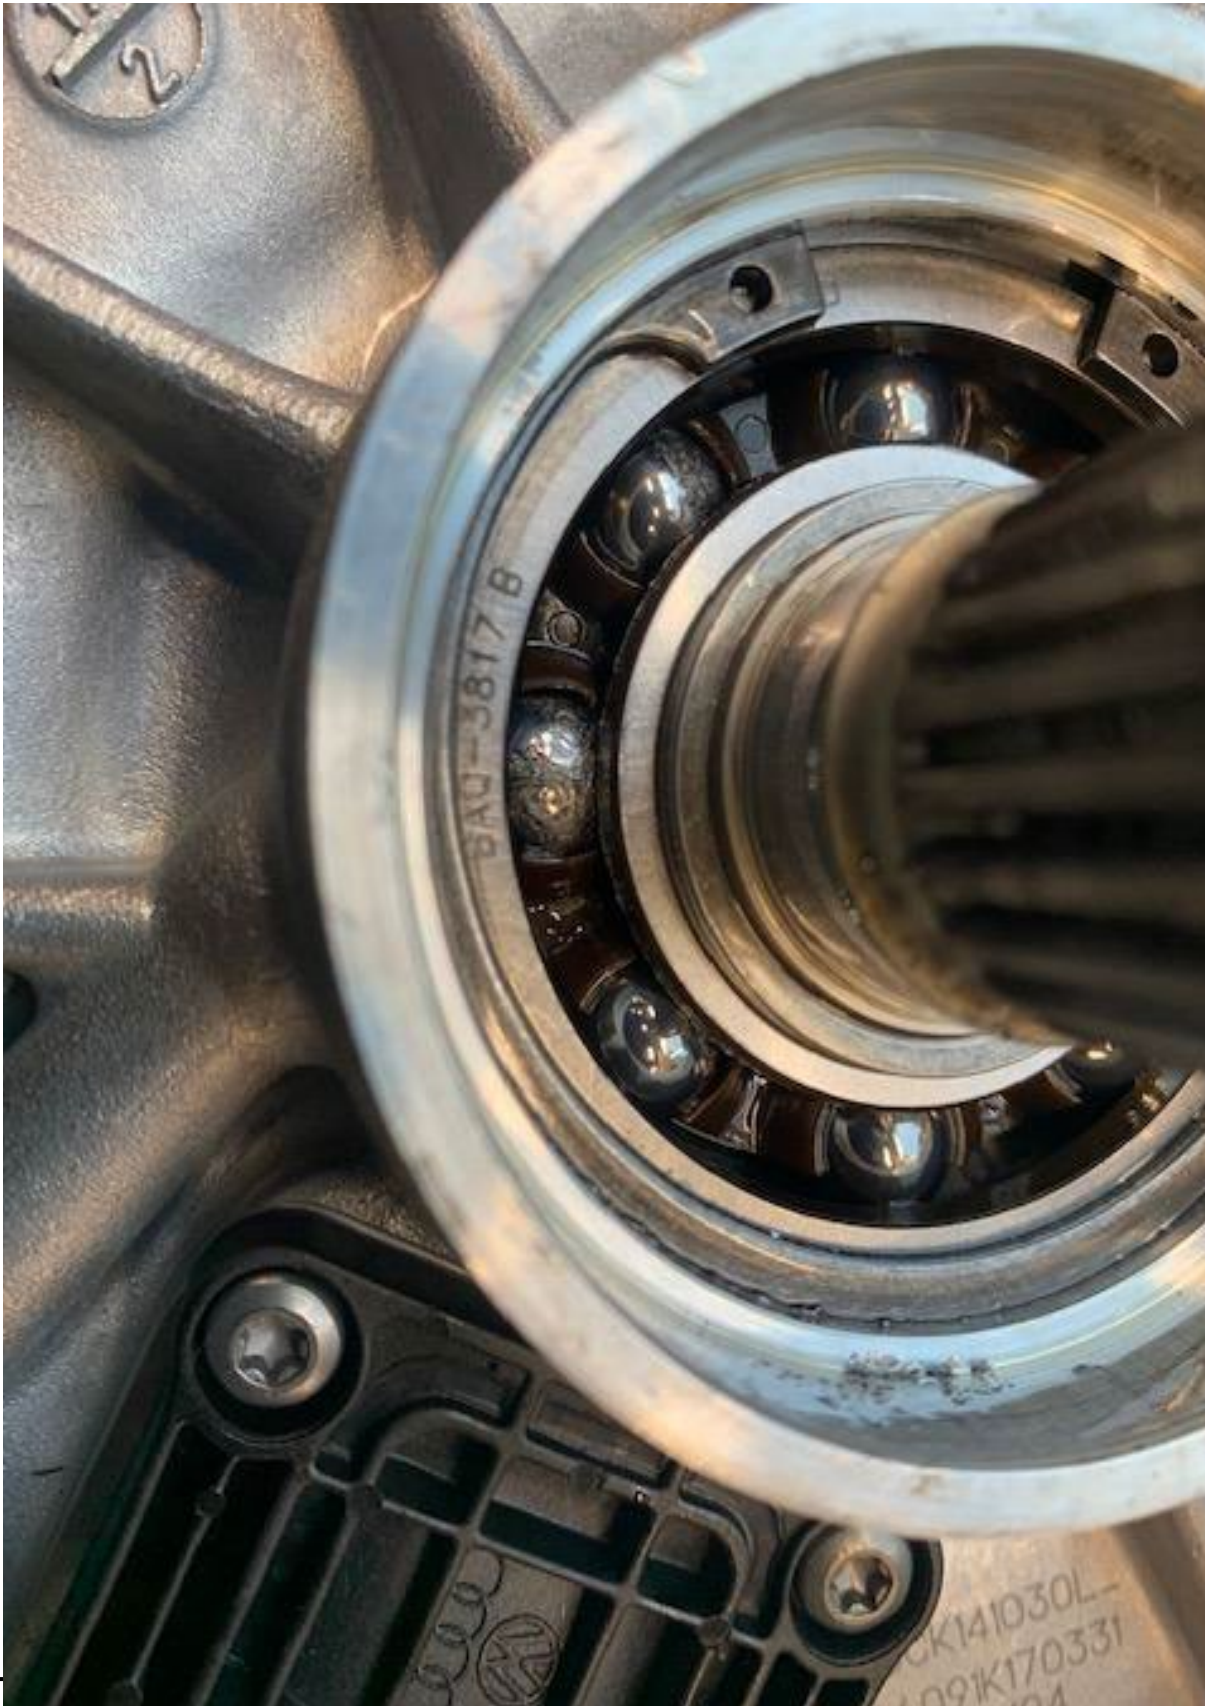
Wear can be seen on bearing A and ball cage is still in bearing A (see figure 11).

Figure 11. Bearing A and ballcage.

Replace bearing A in cover for dual clutch if you find the following functional issue on bearing A:

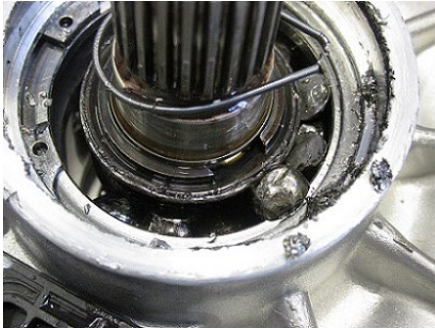
Ball cage no longer in bearing A or irreparable damage to ball cage -> ball guidance no longer provided (see Figures 11 and 12).

Figure 12. Damage is irreparable.

Replace the entire dual clutch if you find the following functional issue in the installation space around bearing A:

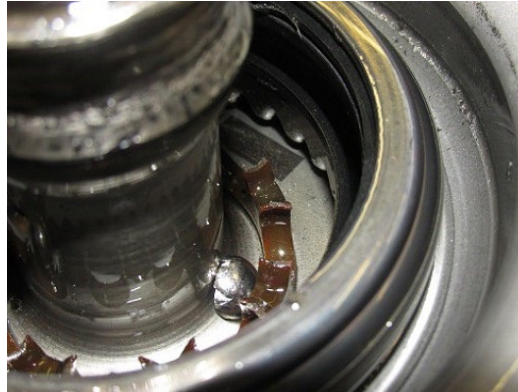
Figure 13. Damage is irreparable.
