# Technical Service Bulletin

**39 Power transmission: "All-wheel drive not working..." / event memory entry C111307/P1CF700/P1CF200**  
39 24 62 2074203/2 July 2, 2024. Supersedes Technical Service Bulletin Group 39 number 24-61 dated June 12, 2024 for reasons listed below.

Model(s)	Year	VIN Range	Vehicle-Specific Equipment
RS 3	2023 - 2024	All	Not Applicable

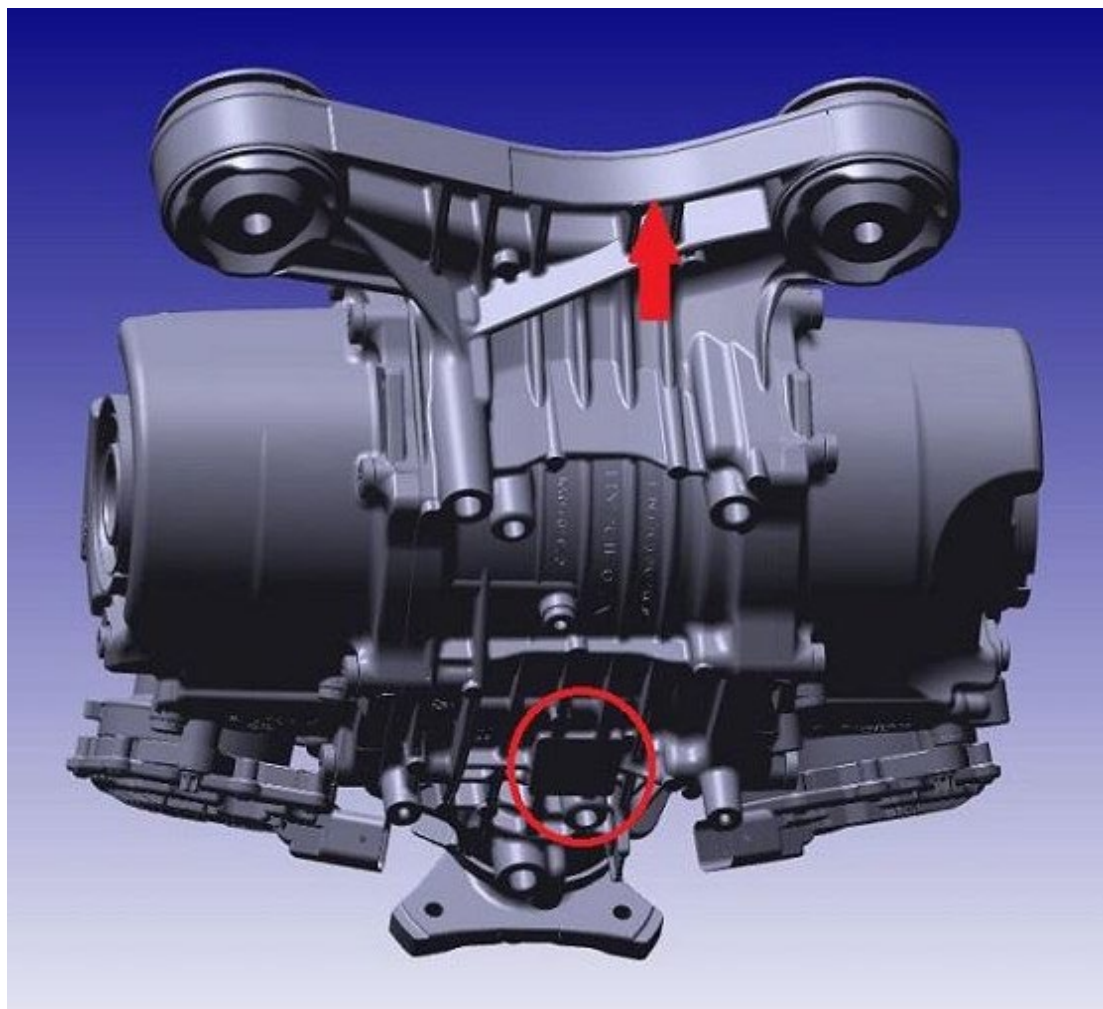
**The production date of the rear final drive (torque distribution) can be checked/read either on the DMC label on the rear carrier (see Figure 1, red arrow) or the engraving (see Figure 1, red circle) on the underside of the rear final drive (torque distribution).**

**Figure 1.** Position of production date on rear final drive (torque distribution).

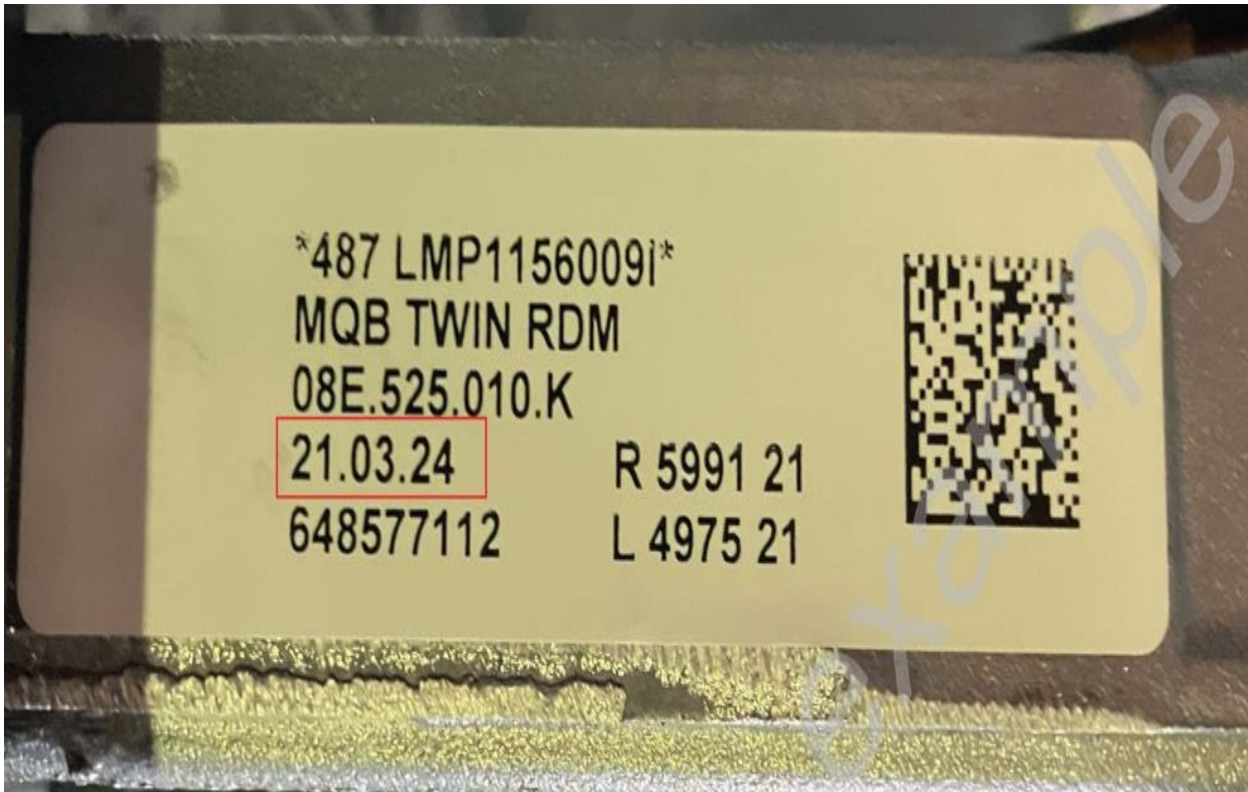
- Check/read production date on DMC label (see figure 2, red box) and perform Step 2 if necessary.

**Figure 2.** Example of DMC label on rear carrier: production date 03/21/2024.

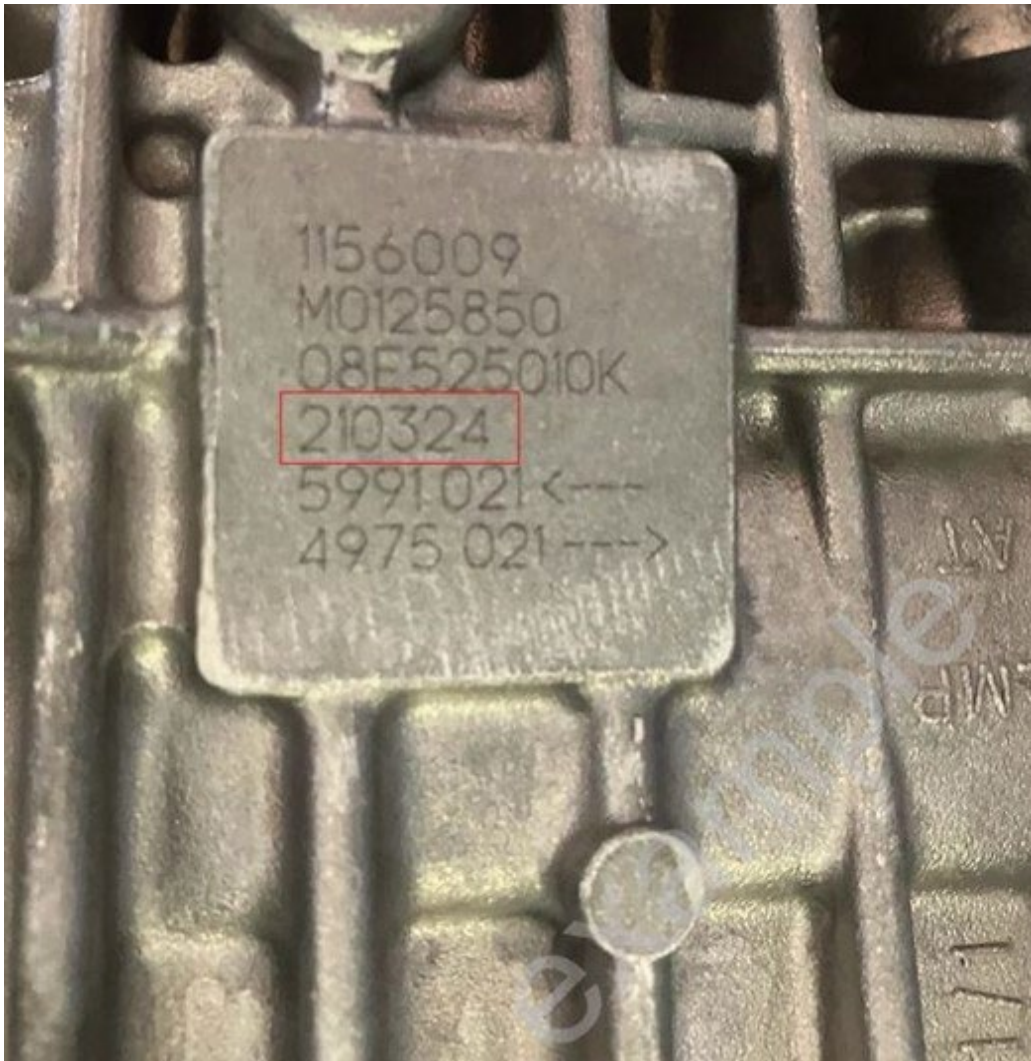
- Check/read production date on engraving (see figure 3, red box) and perform Step 2, if necessary.

*Figure 3. Example of engraving on underside of rear final drive: production date 03/21/2024.*

If the rear final drive (torque distribution) was manufactured before 03/01/2023 or after 10/31/2023, this TSB does not apply! Use => Guided Fault Finding to work through the event memory entries. Please note however, this in this case, the costs of repairing the vehicle cannot be invoiced based upon this TSB.

If the rear final drive (torque distribution) was manufactured between 03/01/2023 and 10/31/2023, continue with “Step 2”.

If necessary, refer to the Workshop Manual/parts catalogue and replace the rear final drive (torque distribution).
