Technical Service Bulletin

60 Sunroof frame modification

60 24 72 2065731/4 July 17, 2024. Supersedes Technical Service Bulletin Group 60 number 23-65 dated April 7, 2023 for reasons listed below.

Model(s)	Year	VIN Range	Vehicle-Specific Equipment
Q3, and Q8	2019 - 2022	All	Not Applicable
e-tron	2019 2021 - 2022		
e-tron Sportback, Q8, and RS Q8	2020 - 2022

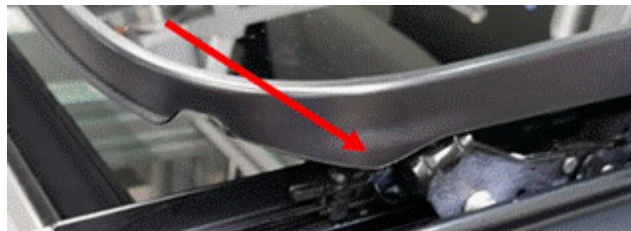
1. If the sunroof frame and/or front sunroof glass panel require replacement the water guidance washer on the sunroof mechanism pivot protrudes to the extent that the rubber “skirt” on the front glass panel also protrudes creating interference between the glass panel and the sunroof opening. This interference can prevent the front glass panel closing sequence from completing.
2. Figure 2 shows the location of the “skirt” protrusion from the water guidance washer.

Figure 1. The front sunroof glass panel side skirt is deformed due to a protruding water guidance washer.

4. Remove the front sunroof glass panel. Using a small pair of diagonal cutters (side cutters; Figure 4) trim away the water guidance washer. The washer must be cut back such that it protrudes no greater than the pivot pin. Perform this operation to both sides.

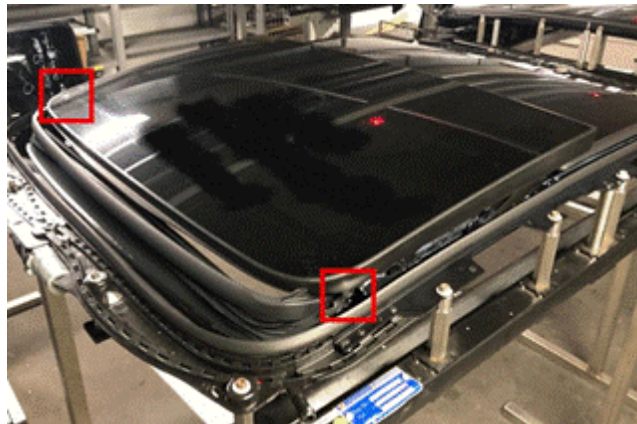
Figure 2. Front sunroof glass panel side skirt protrusion from an unmodified water guidance washer.

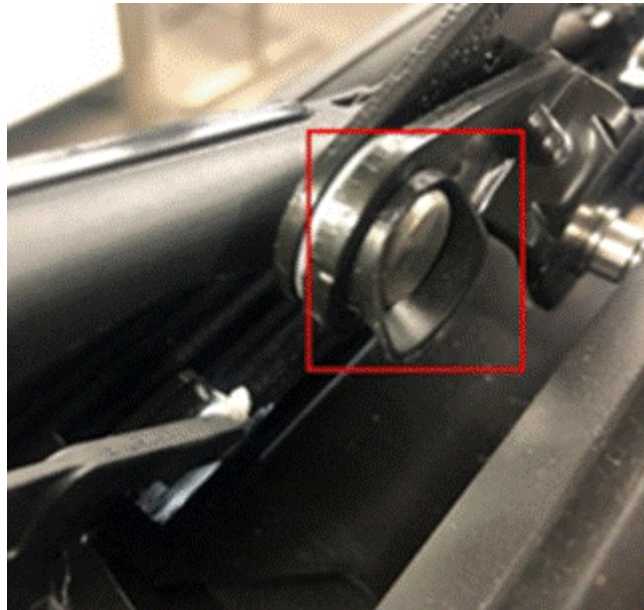
3. Figure 3 shows the water guidance washer with the front sunroof glass panel removed.

Figure 3. Water guidance washer on the front frame mechanism pivot.

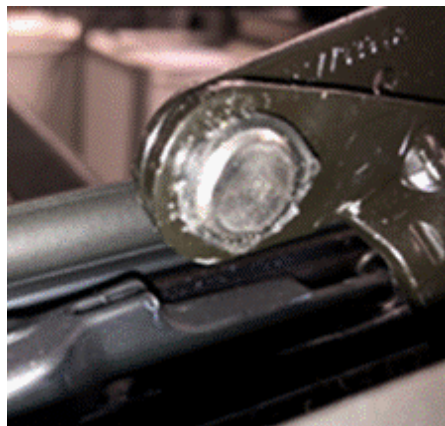
5. Figure 5 shows the removed water guidance washer trimmed below the pivot pin. Since this pivot pin is concealed by the front sunroof glass panel “skirt” it is not necessary to smooth the edges of the cut surfaces.

Figure 5. Water guidance washer on the front frame mechanism pivot.
