# Technical Service Bulletin

## 66 Tail lamp trim molding is loose.

66 24 09 2067733/2 July 10, 2024. Supersedes Technical Service Bulletin Group 66 number 22-90 dated August 4, 2022 for reasons listed below.

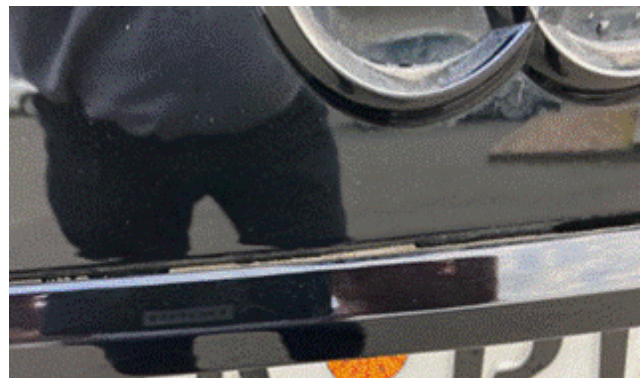
The bonding strip that affixes the center section of the tail lamp trim molding to the rear lid surface has weakened. The trim strip has pulled away to the extent that a gap can be seen.

**Figure 1.** Tail lamp trim molding loosening.

If any adhesion is found to be compromised or failed to any extent replace the center section of the tail lamp trim molding (section 3). Follow the procedure in ElsaPro to ensure proper seal adhesion paying particularly close attention to the adhesion surface preparation.

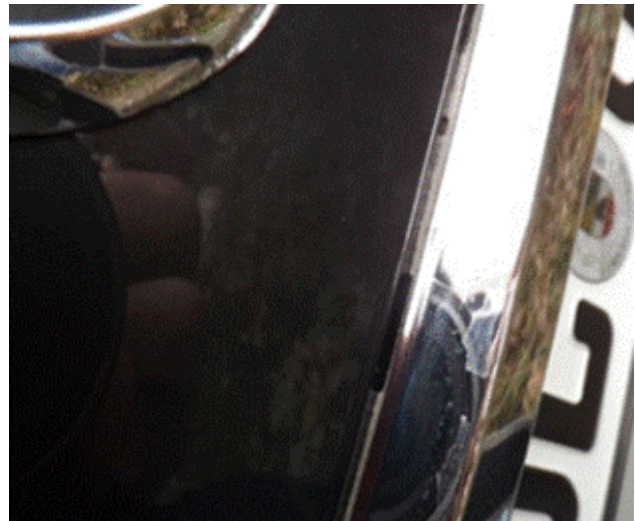
A visible gap is apparent between the tail lamp trim molding and the rear lid surface.

**Figure 2.** Debonding tail lamp trim molding with a visible gap.

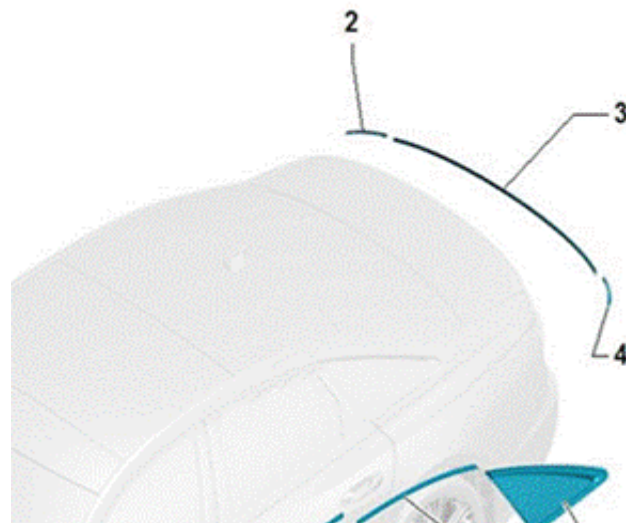
**Figure 3.** The Center section of the tail lamp trim molding to be replaced.
