Technical Service Bulletin

87 Air conditioning does not cool

87 24 77 2072351/2 July 3, 2024. Supersedes Technical Service Bulletin Group 87 number 23-65 dated December 13, 2023 for reasons listed below.

Model(s)	Year	VIN Range	Vehicle-Specific Equipment
Q4 e-tron, and Q4 e-tron Sportback	2022 - 2024	All	Not Applicable

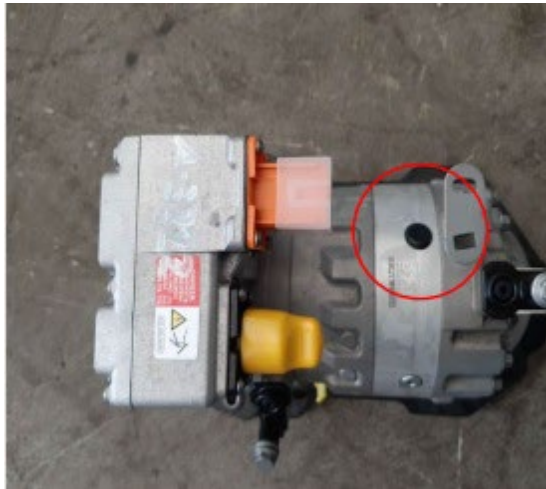
1. A common area where a refrigerant leak may be discovered is at the air conditioning compressor, specifically at the pressure relief valve. Figure 1 illustrates the location of the pressure relief valve. The leak here is likely to be rapid and the approved diagnostic methods should quickly confirm a leak in this area of the compressor.

Figure 1. Pressure relief valve on the air conditioning compressor.

3. In cases where a leak is diagnosed at the pressure relief valve the air conditioning compressor must be replaced. Ensure that the correct amount of refrigerant oil in the total refrigerant circuit is restored after compressor replacement.

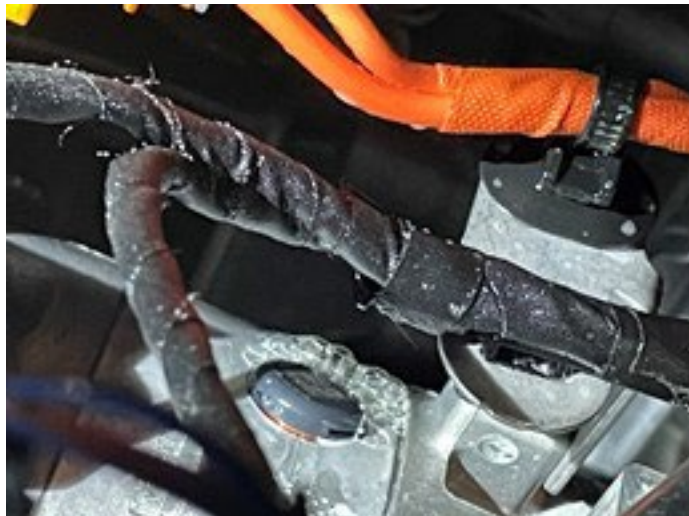
2. Figure 2 shows a close-up view of an active leak at the compressor pressure relief valve using a diagnostic method with compressed nitrogen and the application of a soap and water solution.

Figure 2. Active compressor pressure relief valve leak.
