Technical Service Bulletin

87 Air conditioning system: cooling output insufficient, leak on air conditioning system evaporator

87 24 81 2064077/5 July 27, 2024. Supersedes Technical Service Bulletin Group 87 number 24-70 dated March 29, 2024 for reasons listed below.

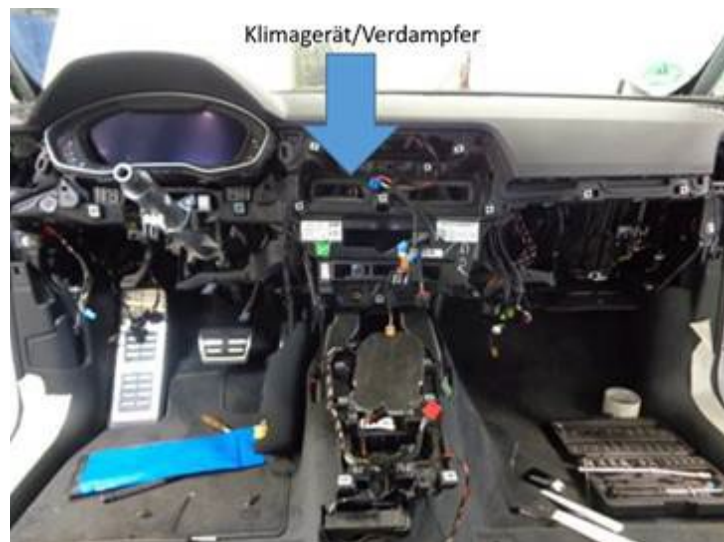
On the vehicles listed in this TSB, the evaporator of the air conditioning system is a potential source of a leak. It is fitted in the air conditioning unit and is not easily accessible from outside (Figure 1).

Figure 1. Air conditioning unit / evaporator.

If a leak is determined on the evaporator, replace the evaporator.

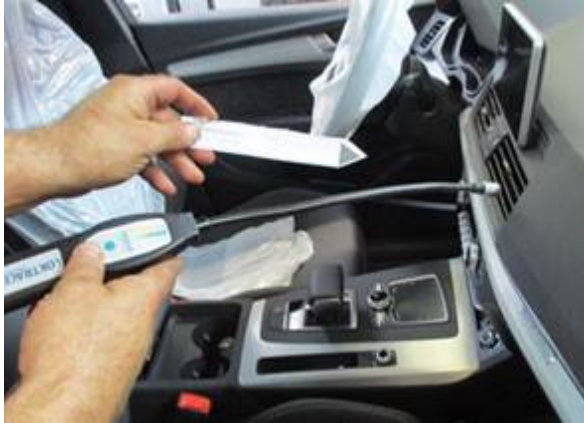
· Check whether the electronic leak detector finds refrigerant on the center vents (Figure 2). To do this, select the following air conditioner settings: Blower on lowest level and air distribution set to dash panel vents.

Figure 2. Electronic leak detector at center vents.

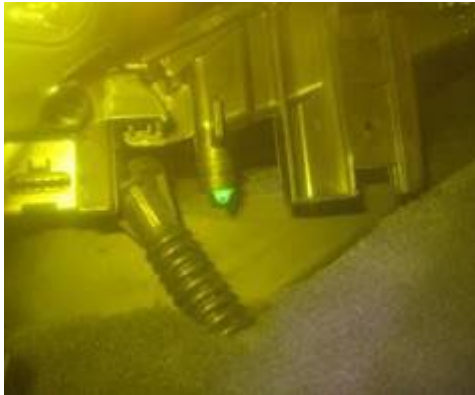
· If a leak detection additive is put into the refrigerant circuit, deposits of the additive will appear on the condensation drain after the air conditioner has been operated at high load for a sufficient time (Figure 3).

Figure 3. Leak detection additive at condensation drain.

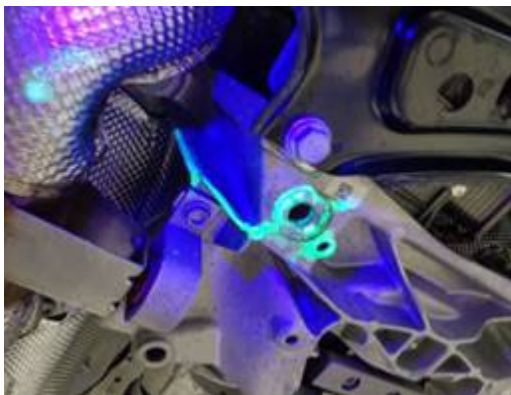
5 You can also check this on the vehicle's underbody (Figure 4).

Figure 4. Leak detection additive under vehicle.

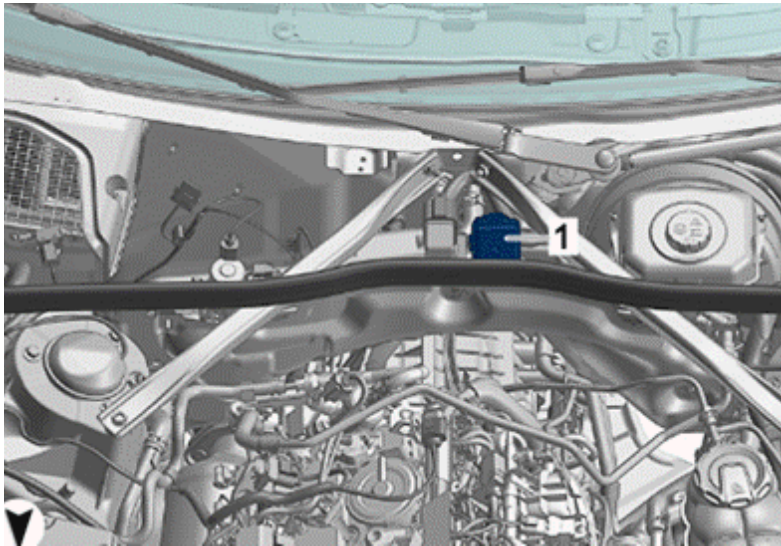
Figure 5. Relay and fuse carrier 3 -SR3-.

Should the evaporator for the Q5 be confirmed leaking by way of this diagnostic procedure and replacement of the evaporator is performed it is necessary to loosen and refasten the Relay and Fuse Carrier 3 -SR3- (shown in figure 5, position 1) in the course of the repair. During reassembly of the vehicle it is *critically important* that this relay and fuse carrier in particular be reinstalled in its correct original position. Failure to reinstall the Relay and Fuse Carrier 3 precisely will result in water intrusion and subsequent component damage.
