Technical Service Bulletin

90 Audi pre sense - restricted function icon is displayed after engine starts

90 24 17 2059891/7 July 31, 2024. Supersedes Technical Service Bulletin Group 90 number 24-95 dated May 31, 2024 for reasons listed below.

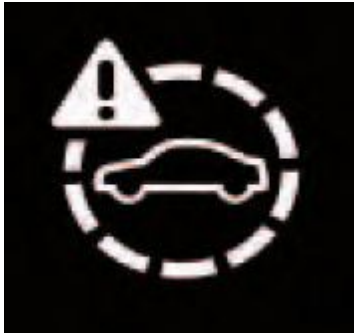
- One of the symbols for “Audi pre sense / active front assist not available at the moment” is shown for about 20 seconds after the engine starts, and then it disappears (Figures 1 – 3).

Figure 1: Symbol for “Audi pre sense not available at the moment”. (Up to MY2020)

The driver assist system sensors self-initialize after the ignition is turned on. As a result of this, Audi pre sense / active front assist and associated systems may not be available for up to 20 seconds after the ignition is turned on.

- Do not perform any repairs. Any repairs for this concern may be denied.
- Inform the customer that it takes the front camera for the driver assist system (R242) about 20 seconds to start up and the icon informs the driver of this fact. This is normal behavior.
