Technical Service Bulletin

93: High-Voltage fault, gearbox fault or MIL on in the instrument cluster DTC(s) P0A4000, P0A2E00 or P0A2B00

93 24 00 2066596/2 July 31, 2024. Supersedes Technical Service Bulletin Group 93 number 22-69 dated March 25, 2022 for reasons listed below.

Model(s)	Year	VIN Range	Vehicle-Specific Equipment
A7 e quattro	2021 – 2022	All	Not Applicable

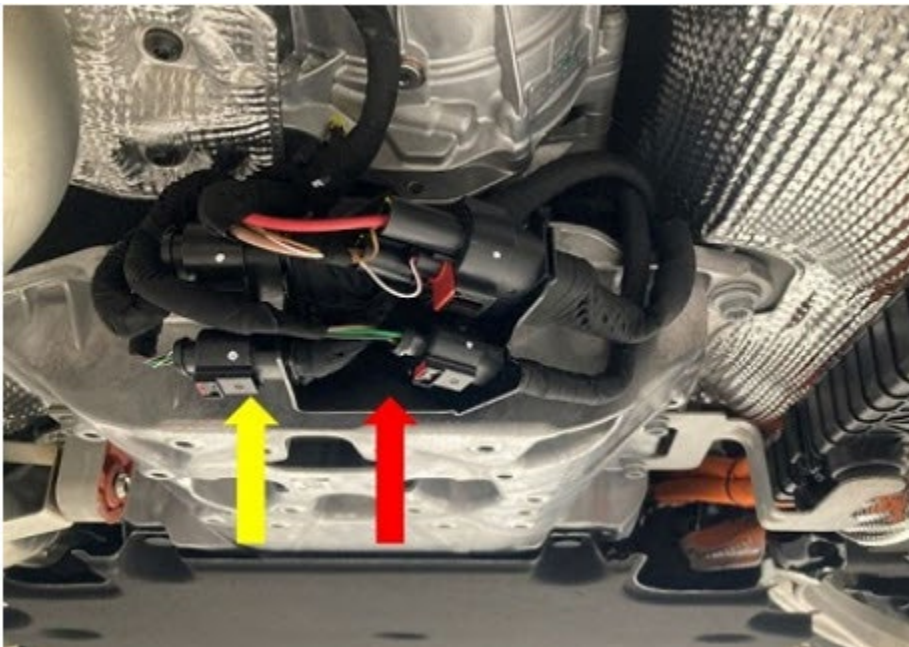
Figure 1. Connector locations.

Contact abrasion in connector T6bm / T6bmx.

1. Replace the connector housing bracket installed in the vehicle with the new bracket 8W0.971.502.AL (Figure 1 red arrow).
2. Replace the connector at the coupling point T6bm/T6bmx with 3B0.973.813 and 4H0.973.713.G (Figure 1 yellow arrow).
3. Replace all the pins in the new connector and mating connector with gold-plated pins using the wiring harness set VAS 1978B/C.
4. For modified connector 3B0.973.813, use single wires 000.979.041.EA and for connector 4H0.973.713.G use single wires 000.979.025.EA.
