Technical Service Bulletin

93 A7/Q5 PHEV Gearbox: drive system fault displayed in instrument cluster (P0A4000)

93 24 01 2074662/1 July 31, 2024.

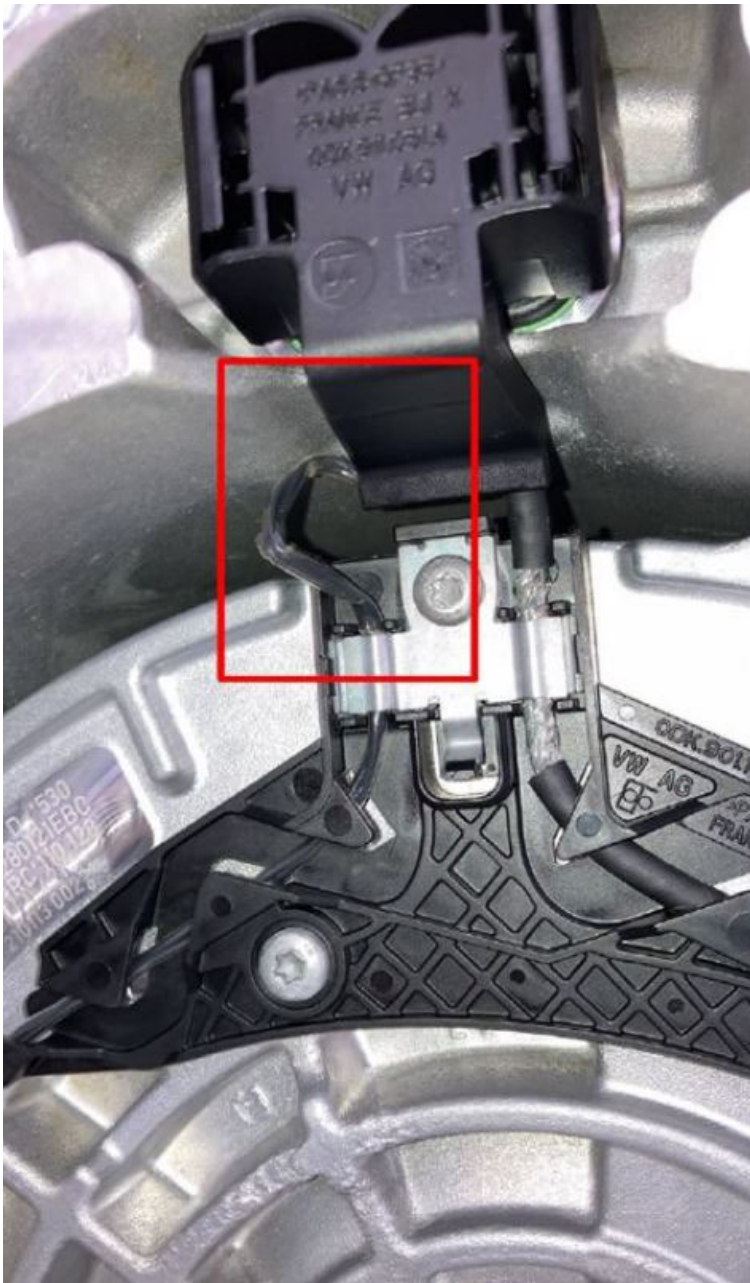
Figure 1. Wire not fitted correctly

Please work with great care when installing the rotor position sensor so that the sensitive wires on the gearbox housing are positioned correctly.

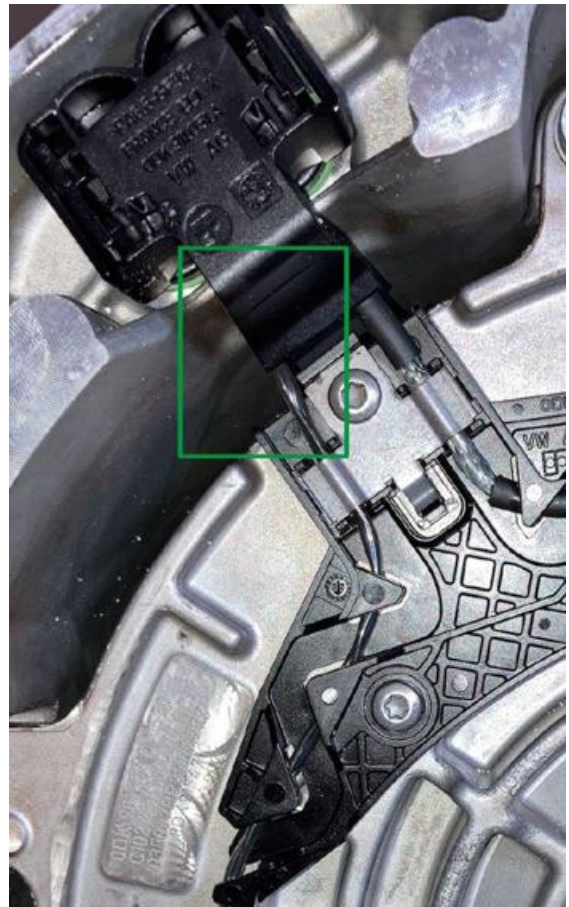
Figure 2. Installation according to Workshop Manual

- **If no other causes can be detected, replace drive motor rotor position sender 1 G713 (rotor position sensor) according to Workshop Manual.**
