# Technical Service Bulletin

**93 A8 TFSle: coolant connection (quick-release coupling/neck connection) on HV battery leaking**  
93 24 81 2074624/1 July 26, 2024.

Model(s)	Year	VIN Range	Vehicle-Specific Equipment
A8 e quattro	2020	All	Not Applicable

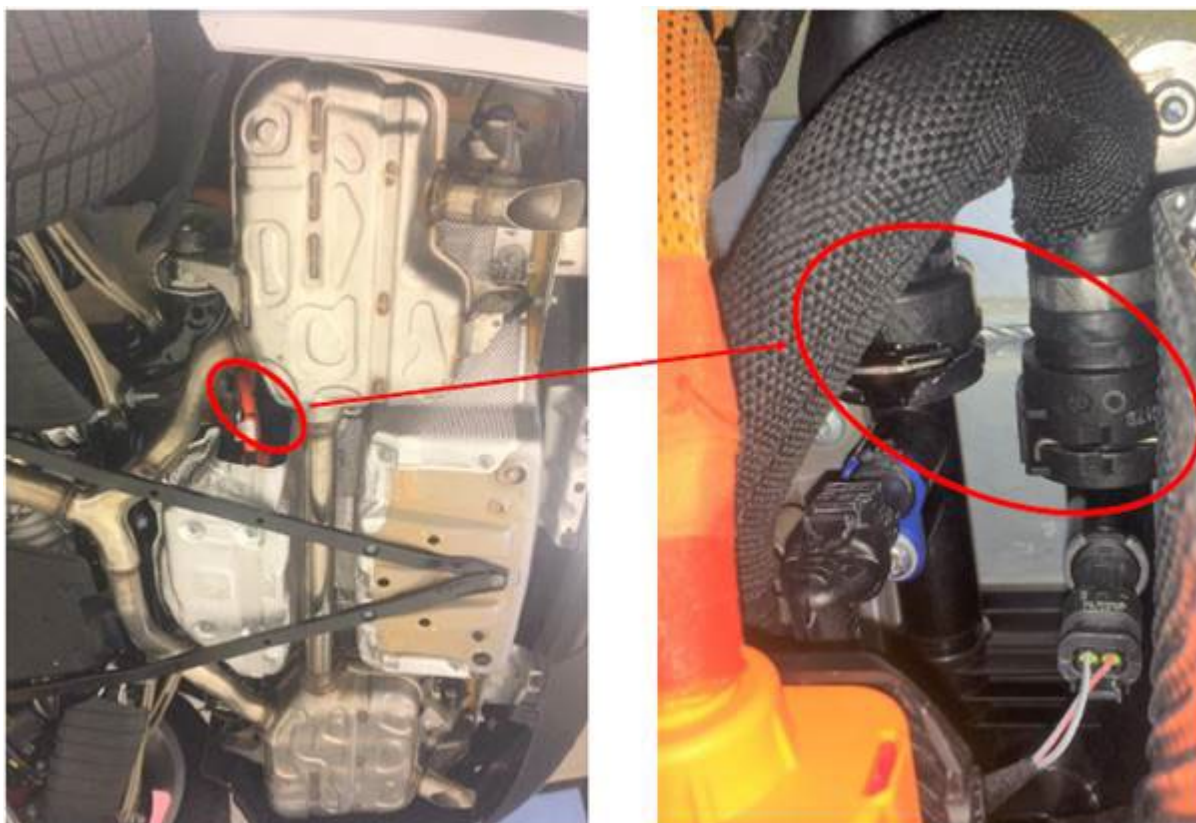
Example photo of A7 PEHV

Coolant residues are established in the area of the rear axle on the connections of the high-voltage battery.

The coolant hose connection is outside of the tolerance.

In order to resolve the conflicting tolerance of the coolant hose connection the Y seal ring (WHT.009.067) of the coolant hoses is replaced with an O seal ring (WHT.009.245)
