# Technical Service Bulletin

## 93 Service info: fuel tank flap cannot be opened on plug-in hybrid vehicles

93 24 87 2074708/1 July 27, 2024.

Model(s)	Year	VIN Range	Vehicle-Specific Equipment
Q5 e quattro	2020 – 2024	All	Not Applicable
A8 e quattro	2020 – 2021		
A7 e quattro	2021 – 2022

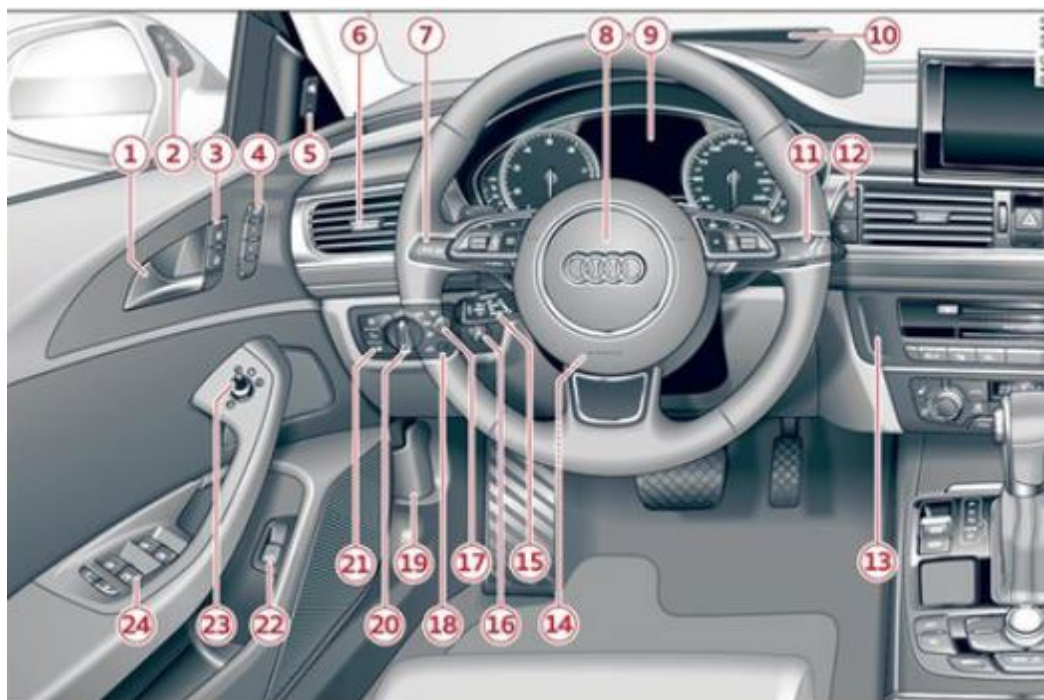
In the following example, the button to open the tank flap is labelled with the number 22 (Figures 1 & 2).

**Figure 1.** The button to open the tank flap is labeled number 22.

On vehicles with plug-in hybrid drive, the tank system must be bled before the tank flap is opened.

The procedure for bleeding the system is initiated by pressing the button in the door trim.

After bleeding, the tank flap opens automatically by approx. 10-15 mm within a few seconds; it can then be opened fully by hand.

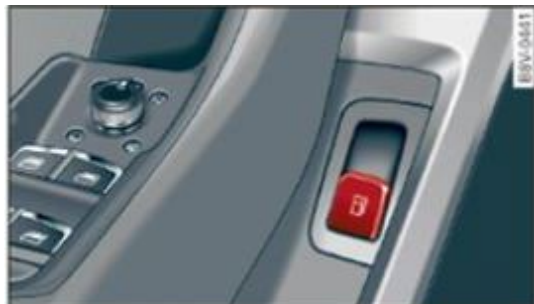
**Figure 2.** Closer detail of the button to open the tank flap.
