Technical Service Bulletin

96 Warning for lane change, exit warning, Audi pre sense or rear cross-traffic assist, DTC: U104500, U10BA00, U160F00

96 24 01 2074670/1 July 27, 2024.

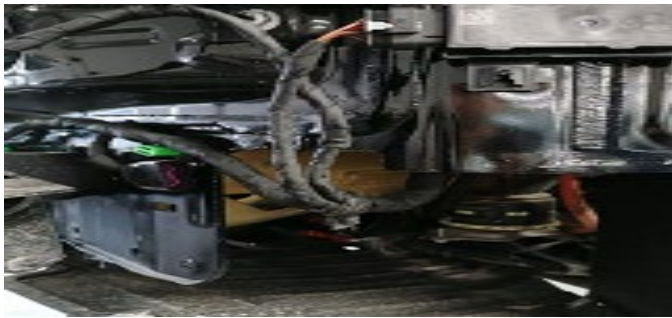
Wiring damaged due to environmental influences.

Check the wiring in the rear right of vehicle behind the bumper (see Figure 1).

Figure 1: *Wiring behind the bumper.*

Inspect the area between the body grommet and the lane change assist control unit -J769-.

Repair the harness using wiring harness repair set **VAS 1978 B/C**.

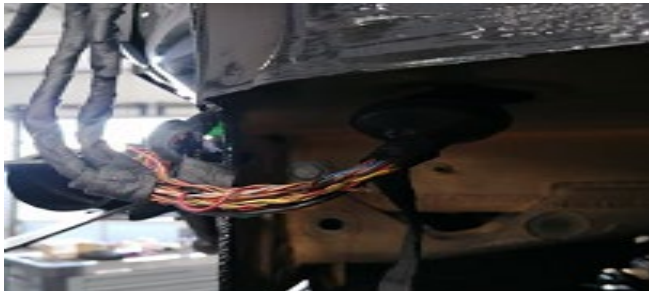
The damage may not be visible from the outside. Check the wiring beneath the wrapping (see Figure 2).

Figure 2: *Wiring beneath the wrapping.*
