## ENGINE NOISE ON STARTUP AFTER A NEW SERVICE ENGINE HAS BEEN FITTED – AJ20- D4

### Range Rover

### Jaguar

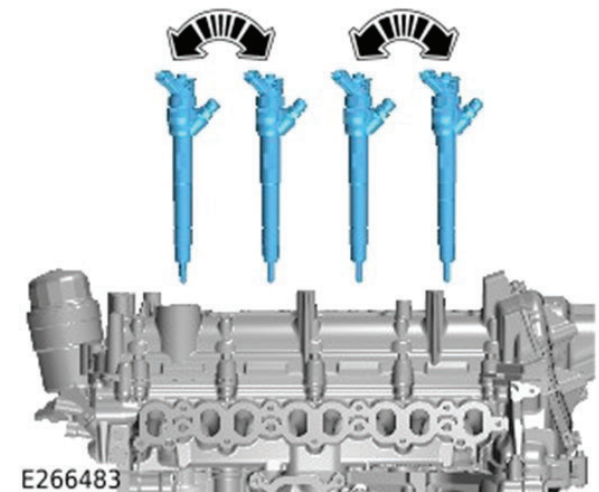
- Repair process on TOPIx for long/stripped engine assembly is not being adhered to, specifically regarding the installation and programming of the fuel injectors.

- They must be fitted to the adjacent cylinder as shown in the TOPIx 303-04A: Fuel Charging and Controls - INGENIUM I4 2.0L Diesel
- This allows the PCM to reset the fueling adaptations and will allow successful injector programming to take place (injector programming/resetting adaptations is required upon completion of the new engine installation as detailed in the TOPIx procedure).
