## SV Signature Suite – 2<sup>nd</sup> Row Deployable Table Not Stowing

### Range Rover

- 23MY Range Rover (SV model variants Only)

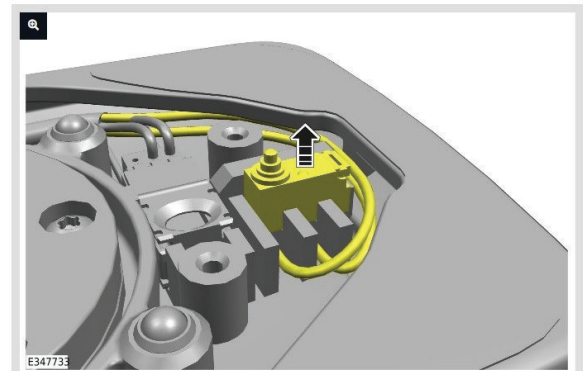
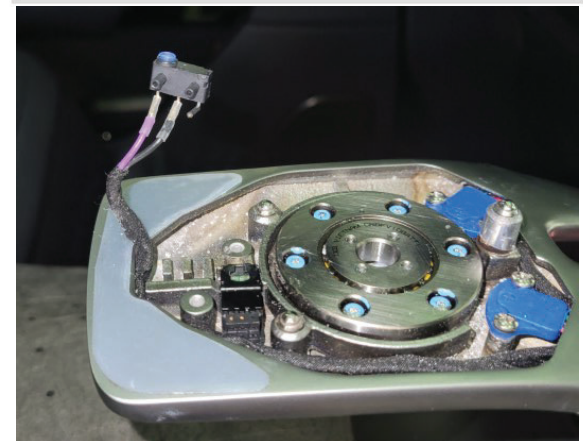
- The deployable table for the 2<sup>nd</sup> row seats may not stow once deployed due to a fault with a microswitch in the table assembly.

- The microswitch has been released as a service part, part number LR189749
- **SSM 76140** has been published to address this concern, providing repair guidance.
