**HYUNDAI**
Technical Service Bulletin

| GROUP CAMPAIGN | NUMBER 24-01-047H |
| DATE JULY 2024 | MODEL(S) TUCSON (NX4A) |

SUBJECT: ICU SOFTWARE UPDATE FOR INCORRECT REAR SEAT BELT WARNING LIGHT AND TURN SIGNAL ERROR MESSAGE (SERVICE CAMPAIGN TBX)

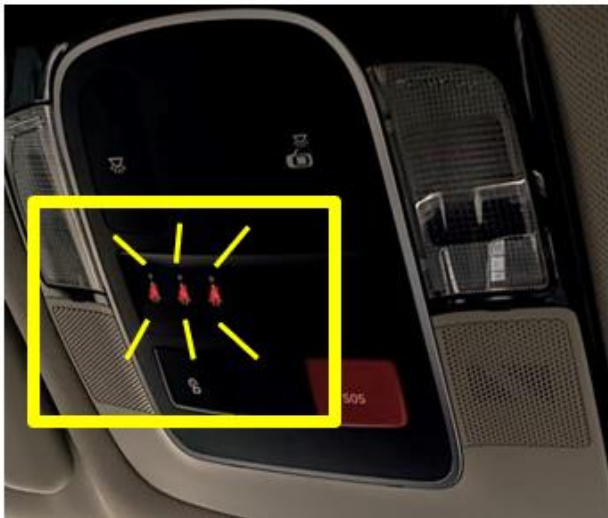
SYMPTOM 1 – RR SEAT BELT Warning

Description: Certain 2024MY Tucson (NX4A) vehicles may exhibit a seat belt warning light for the rear seats illuminating incorrectly and/or a “Check turn signal” error message on the cluster. Follow the procedure in this bulletin to update the software for the Integrated Control Unit (ICU) to correct these conditions.
