Technical Service Bulletin

GROUP	NUMBER
ENGINE	24-EM-001H
DATE	MODEL(S)
JULY 2024	SONATA (DN8a) SANTA FE (TMa) TUCSON (NX4a)

SUBJECT: DTC P2181 – INTEGRATED THERMAL MANAGEMENT (ITM) REPLACEMENT

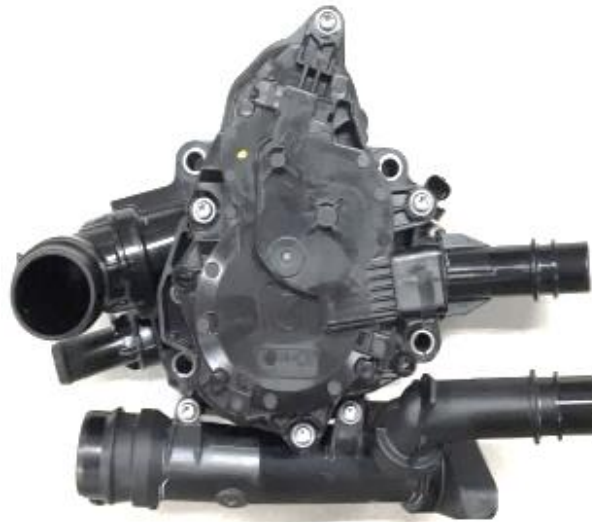
Description: Certain 20-22MY Sonata (DN8a), 21-23MY Santa Fe (TMa), and 22-23MY Tucson (NX4a) vehicles may experience a warning lamp illumination for a diagnostic trouble code P2181 that is related to the Integrated Thermal Management Module (ITM). Follow the service procedure outlined in this bulletin to replace the ITM.
