JLRTB02052NAS4

# TECHNICAL BULLETIN

Rear Doors Difficult To Open

MODEL:	MODEL YEAR:	VIN:	ASSEMBLY PLANT:	APPLICABILITY:
Defender (LE)	2020-2024	000431-356580	Nitra (Slovakia)	5-Door

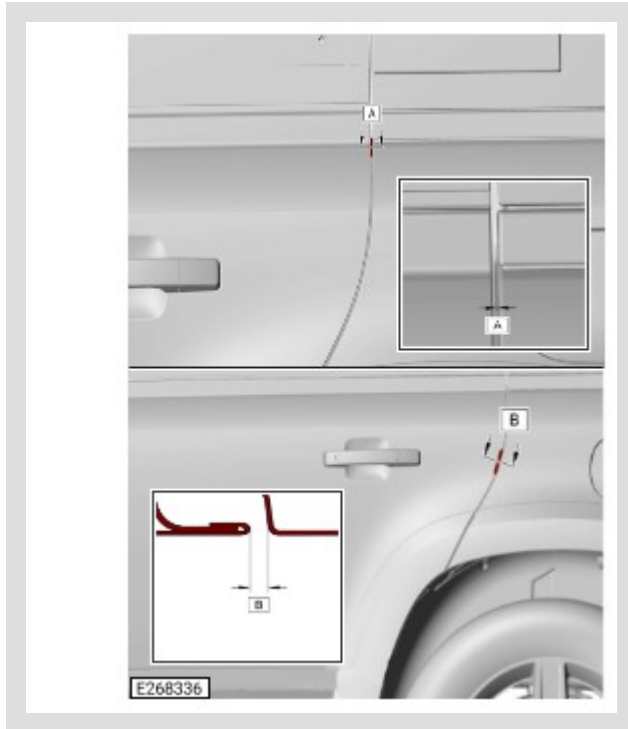
Check the alignment of the rear door(s) in the areas shown in the illustration.

Adjust the rear door(s) to be as far rearward as possible while still being within tolerance, the gap must be 2.8 mm (see TOPIx Workshop Manual section 501-26: Body Repairs: Vehicle Specific Information and Tolerance Checks - General Procedures - Rear Door Alignment).

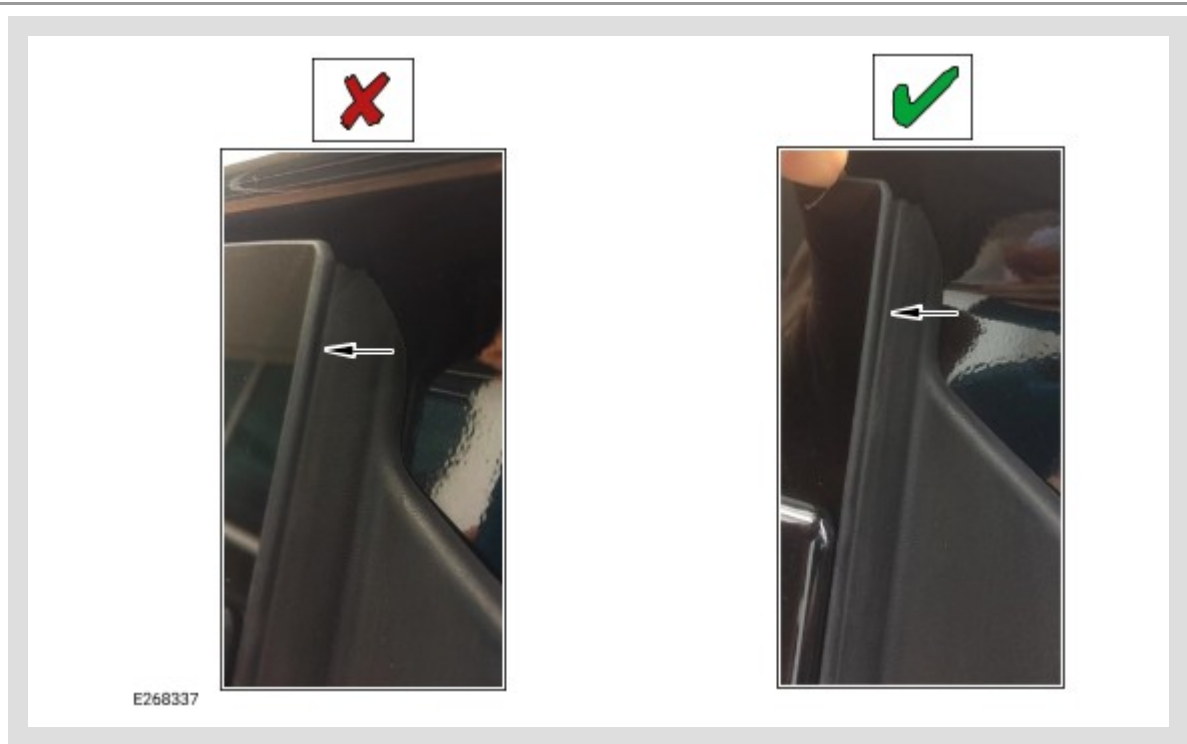
3.

The image with the **RED 'X'** shows the C-pillar exterior finisher trim installed incorrectly behind the rear quarter window.

The image with the **GREEN "** shows the C-pillar exterior finisher trim installed correctly with a 1-1.5 mm protrusion from the rear quarter window.

Install the new C-pillar exterior finisher trim.

- Remove the adhesive tape backing.
- **Make sure the C-pillar exterior finisher trim protrudes 1-1.5 mm away from the rear quarter window, as shown in the illustration, before fully securing.**
