Technical Service Bulletin

GROUP	NUMBER
CAMPAIGN	24-01-061G
DATE	MODEL(S)
JULY 2024	G70 (IK)

SUBJECT: REAR COMBINATION LAMP GARNISH GAP INSPECTION AND REPLACEMENT (SERVICE CAMPAIGN T48G)

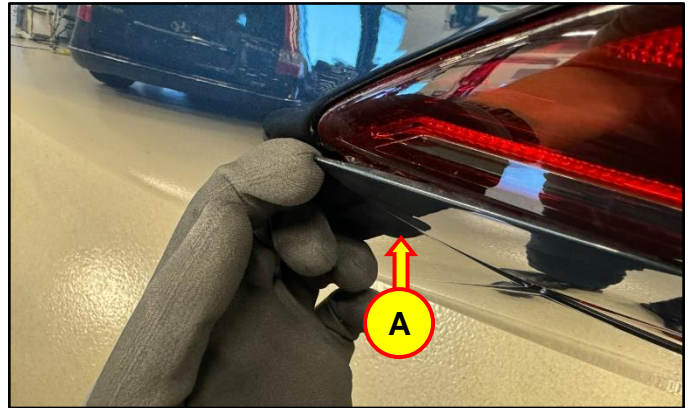
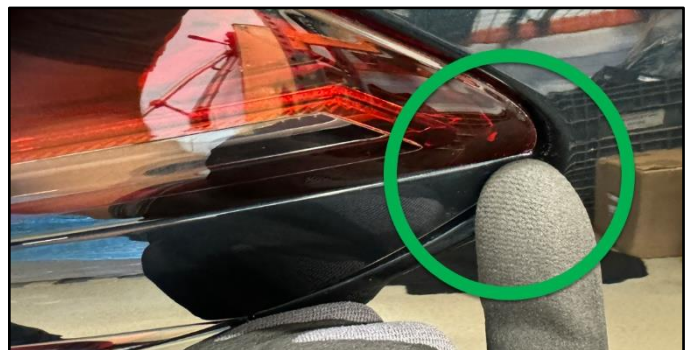
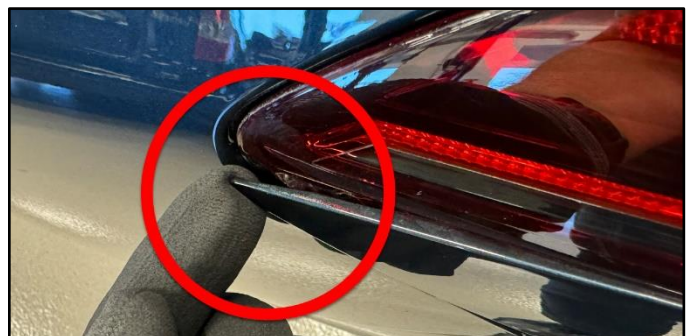
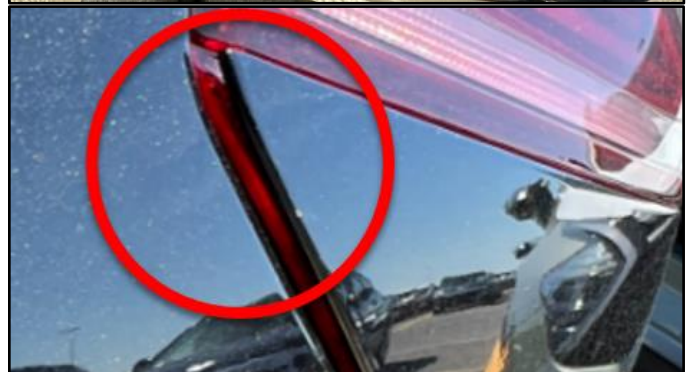
1. On the rear combination lamp garnishes (A), lift up the end closest to the front of the vehicle and check if the garnish lifts off the tail lamp or is already visibly detached from the tail lamp.

GOOD: If both garnishes do not lift when pulled and/or are not visibly detached from the tail lamp, the garnishes do not need to be replaced.

NOT GOOD: If one or both of the garnishes lift off the tail lamp when pulling with fingernail/fingertip and/or are visibly detached from the tail lamp, both of the garnishes need to be replaced.

Proceed to the **Rear Combination Lamp Garnish Replacement** section.

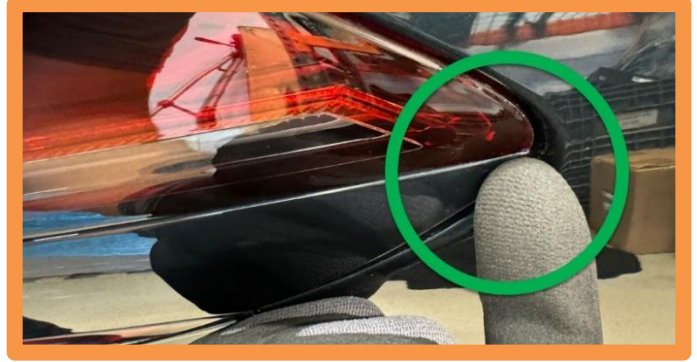
2.

If **both** garnishes are **GOOD**, record a video showing the garnishes **NOT** detached and **NOT** lifting when pulled, with the last 6 digits of the VIN and the date of inspection on a piece of paper.
