# Subwoofer Rattle or Buzz Noise

**Service Category** Audio/Visual/Telematics

**Section** Audio/Video

YEAR(S)	MODEL(S)	ADDITIONAL INFORMATION
2023 - 2024	Sequoia HV	
2022 - 2024	Tundra, Tundra HV

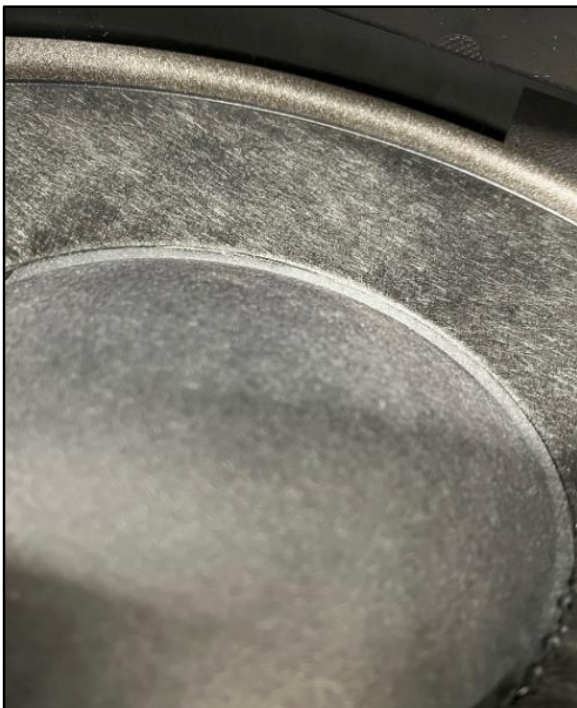
**Figure 1. Previous Speaker Cone**

Some 2022 – 2024 model year Tundra and Tundra Hybrid, and 2023 – 2024 model year Sequoia Hybrid vehicles, equipped with a JBL® premium sound system, may exhibit a rattle or buzz noise when listening to music coming from the subwoofer located in the rear left luggage area of the vehicle. This can be caused by exposure to certain operating environments with high humidity levels. To improve the subwoofer's performance in humid environments, Toyota has revised the speaker cone material and shape. The condition can be resolved by replacing the subwoofer assembly with box. Follow the Repair Procedure in this bulletin to address this condition.
