FCA CARIBBEAN WARRANTY BULLETIN

NO: ID-23-03
DATE: August 7, 2024

SUBJECT: 2018 - 2024 (Current) Jeep
Wrangler (JL) and 2020 - 2024 (Current)
Jeep Gladiator (JT) - Corrosion Warranty
Claim Simplification (Rev. E)

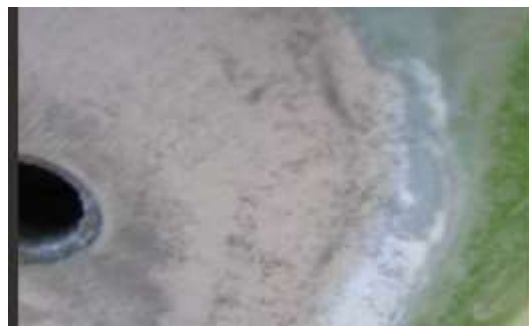
1. Pitting found after sanding the affected area (Fig. 1)

Pitting Found After Sanding Example (Fig. 1)

Note: If pitting is found during the sanding process, please use LOP 23-75-XX-XX for up to 0.5 hours in conjunction with the 23-85 replacement LOP.

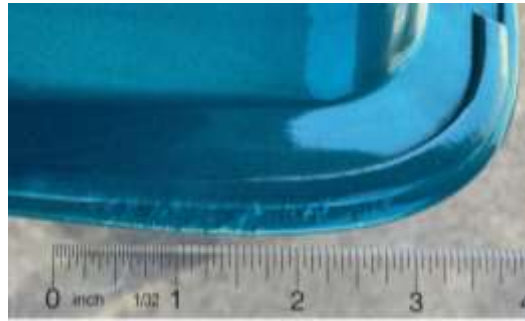
2. Corrosion found on the seam of the panel (Fig. 2)

Seam Panel Area Examples (Fig. 2)

Note: If corrosion is found on the seam of the panel, the door shell will be replaced. No additional sanding in the hinge or seam area is supported.

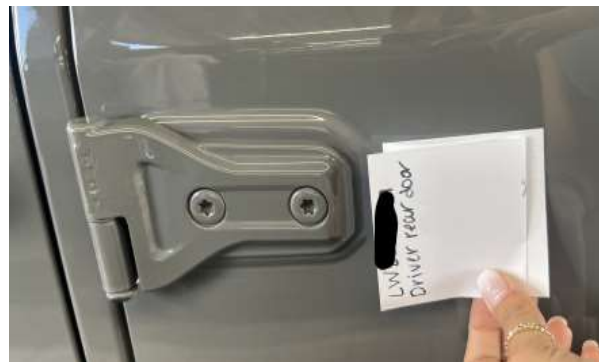
Dealers will need to take photos of the affected areas identified during the inspection to support the repair. A clear photo of the corrosion is needed and **MUST** include the VIN and affected body panel. The VIN and affected body panel can be included on a sticky note, written with a grease pen, a copy of the RO in the photo, masking tape, etc. (Figure 3)

VIN Example (Fig. 3)
