STAR ONLINE PUBLICATION

Case Number: S2408000089

Symptom/Vehicle Issue: Air Bag Lamp On, Diagnostic Trouble Code (DTC) B00E3-13 2nd Row Left Seat Belt Retractor Pretensioner Deployment

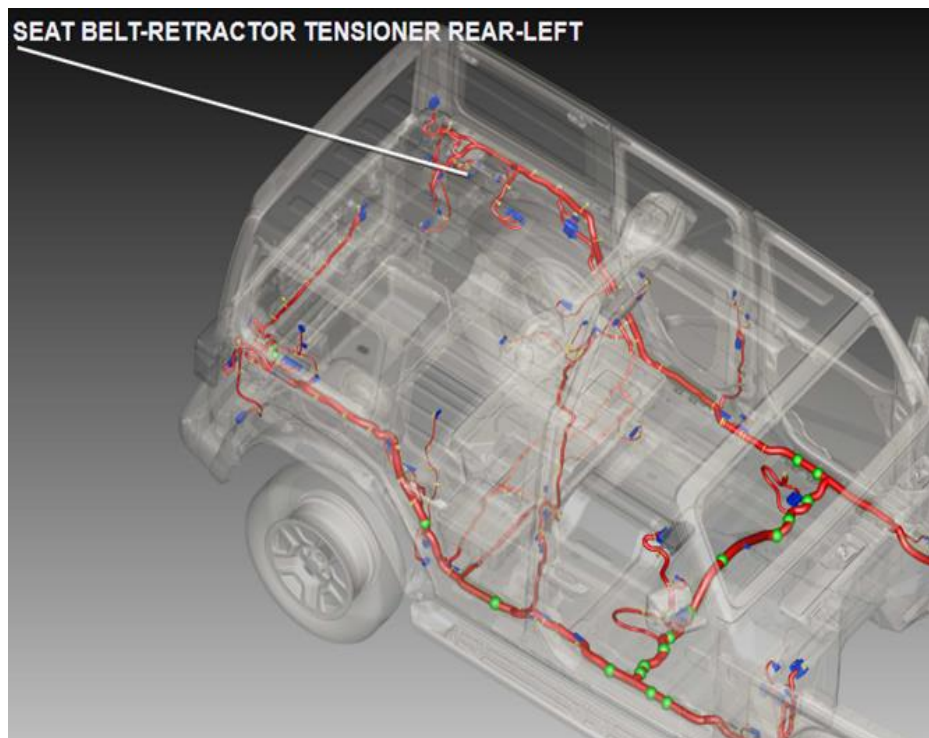
Customer Complaint /Technician Observation: The owner complains of the air bag warning lamp displayed on the cluster after a recent service repair. The technician observed the Occupant Restraint Controller (ORC) set DTC B00E3-13 2nd Row Left Seat Belt Retractor Pretensioner.

Discussion: Inspect the location of the left seat belt retractor/pretensioner component connector D3244A. Secure the connection using the push-pull-push method, no parts required.
