STAR ONLINE PUBLICATION

Case Number: S2308000134 Rev. B

Symptom/Vehicle Issue: Automatic Emergency Braking (AEB) And/Or Forward

Collision Warning (FCW) Will Shut Off

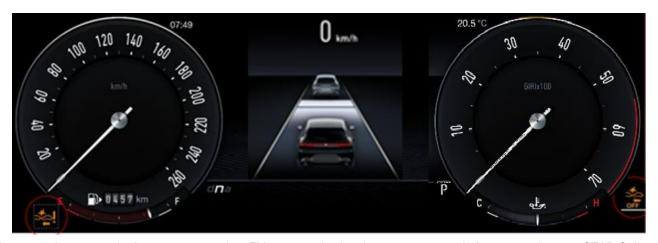
Customer Complaint/Technician Observation: While driving the customer may notice that the Automatic Emergency Braking (AEB) and/or Forward Collision Warning (FCW) will shut off. They will see two separate icons on the lower left and right sides of the Instrument Panel Cluster (IPC).

This can be caused by sun blindness, rain, snow, fog, and other environmental conditions. Weather that inhibits your ability to see clearly out of the windshield also effect the camera's ability to see clearly out of the windshield.

The camera also needs to see objects on the side of the road and vehicles to properly function. The system will shut off in rural environments where there are limited objects or vehicles in view of the camera. This is normal and expected operation.

These are limitations of the system and should not be considered a fault.

Repair: Do not replace any parts or perform any calibrations for this concern. It is recommended to reassure the customer that this is <u>normal system behavior</u> to warn the driver of the temporary unavailability of the system.

TSB software flashes for the Forward Facing Camera (HALF), Driver Assistance Module (DASM/ACC) and the Instrument Panel Cluster (IPC) have been released to improve system stability and operation. These updates should be performed, but they will not eliminate the system limitations described above.
