STAR ONLINE PUBLICATION

Case Number: S2408000091

Symptom/Vehicle Issue: Tonale and Hornet Auxiliary Coolant Pump Locations "A", "B", "C"

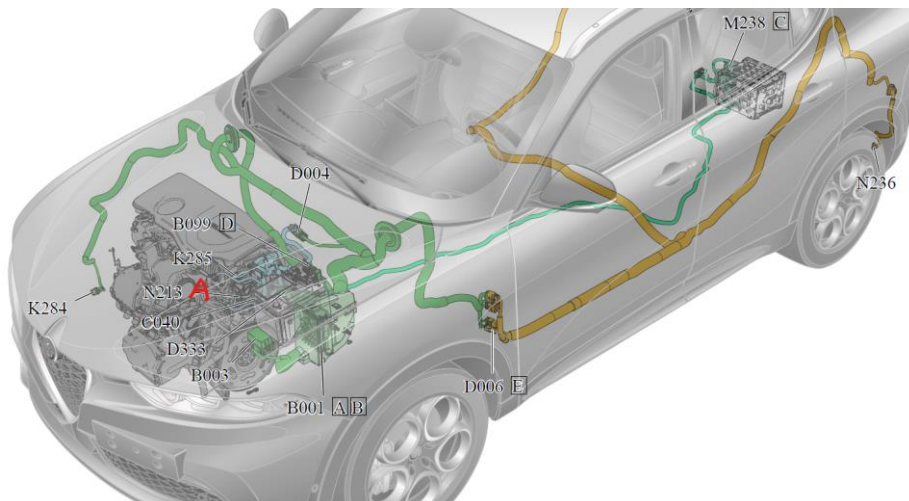
Pump A

COOLANT PUMP "A" AUXILIARY ELECTRIC PUMP PECP2 which is named PECP2 (N213

[N213 Air conditioning system auxiliary water electric pump \(ENGINE\)](#)

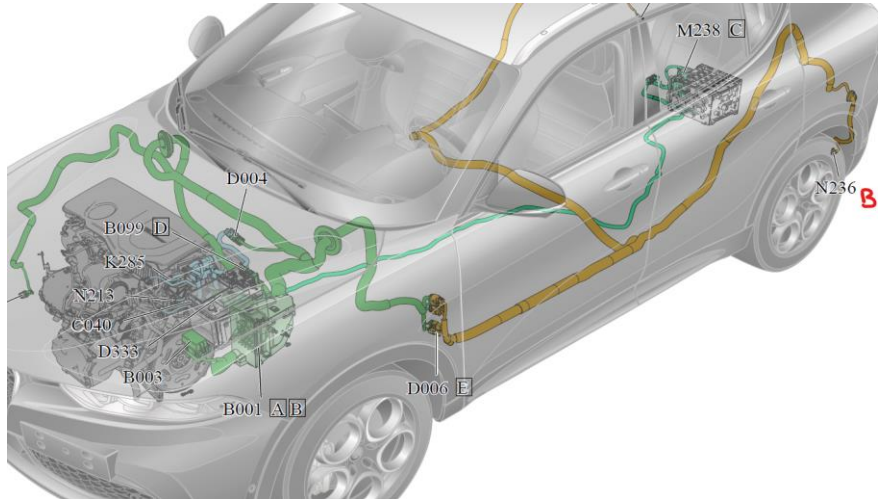
COOLANT PUMP "B" AUXILIARY ELECTRIC PUMP PECP which is named PECP (N236

Pump B N236 REAR AUXILIARY WATER PUMP (REAR)

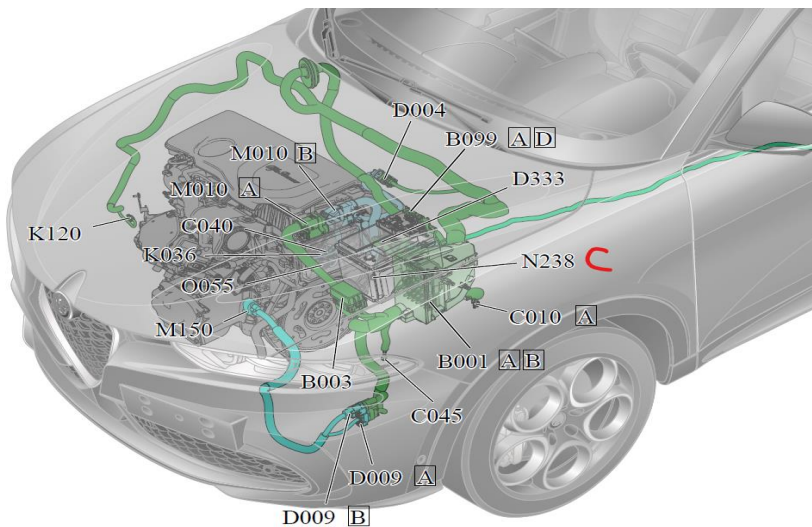
COOLANT PUMP "C" ADDITIONAL HEATER PUMP AHP which is named AHP (N238

Pump C N238 COCKPIT HEATING AUXILIARY PUMP (ENGINE)
