TECHNICAL SERVICE BULLETIN

Technical Service Bulletin: 55-1793

Technical Service Bulletin Number 2024-01

Subject: Dynamax eGEN system and Daimler Sprinter 4-Cylinder and 6-Cylinder OEM Electrical system(s).

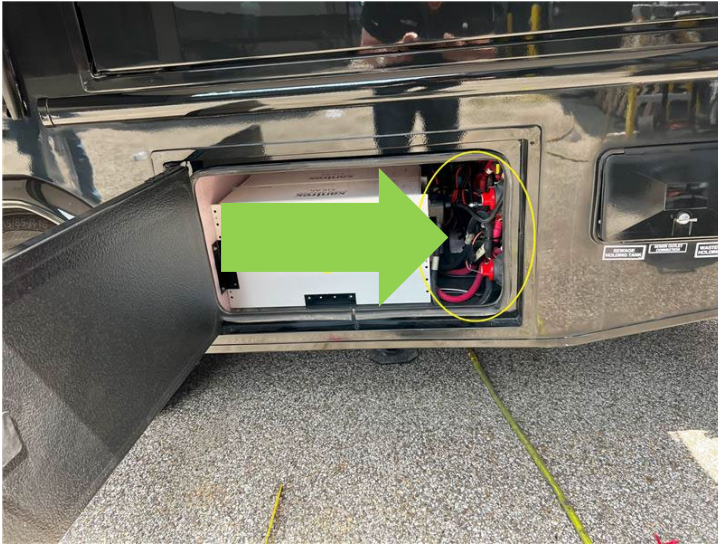
Step 1: Locate the battery / wiring assembly compartment.

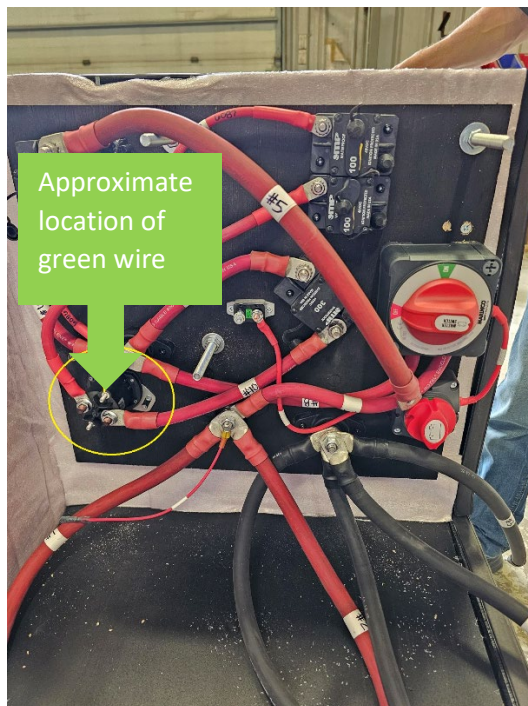
Step 2: Locate the solenoid / green wire on the wiring panel.

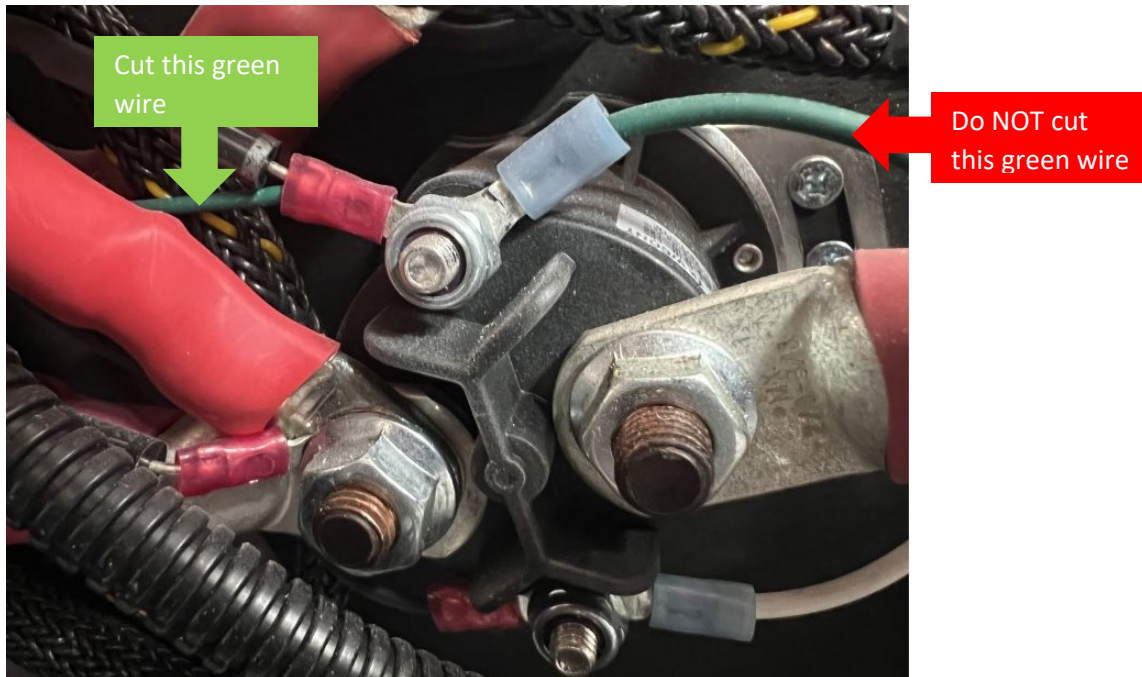
By cutting this green wire, we are now fully separating our lithium system from the vehicle chassis electrical system which will prevent the any further OEM electrical system errors/fault codes from occurring. See the wiring diagram and photo(s) below for details.

Step 3: Cut green wire indicated with the green arrow. Add heat shrink tubing to both ends of the cut green wire to protect cut ends to avoid reconnection. Process complete.
