### PIP5978 Diagnostic Tip: DTC P0299 Set As Current Or In History

| Condition: | DTC P0299 Set as current or in history |

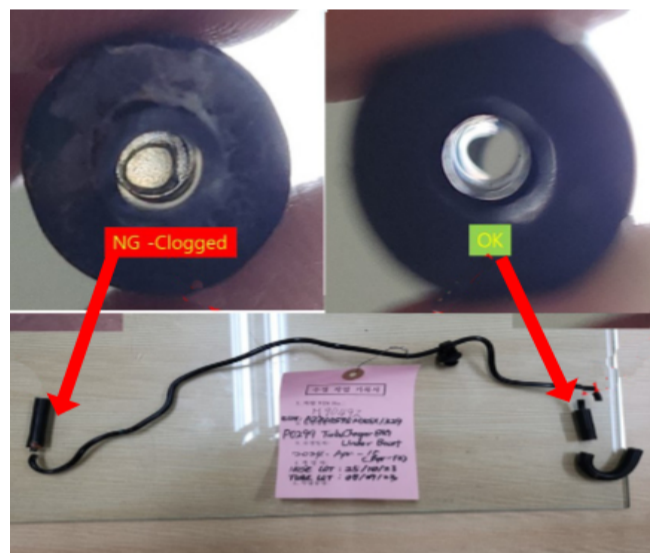
| Cause: | Possible restriction within vacuum supply hose between vacuum pump and wastegate solenoid |

If unable to isolate the root cause remove the vacuum supply hose that attaches to the wastegate solenoid and vacuum pump assembly to inspect for potential restriction in the hose ends caused by adhesive bonding material.

Reference the picture below which shows the complete hose assembly and both hose ends.

If the above condition is found then replace the vacuum hose assembly using the latest parts listed in EPC.
