STAR ONLINE PUBLICATION

Case Number: S2423000030 Rev. A

Symptom/Vehicle Issue: Buzz Squeak Rattle (BSR) From Upper Left Dash Area.

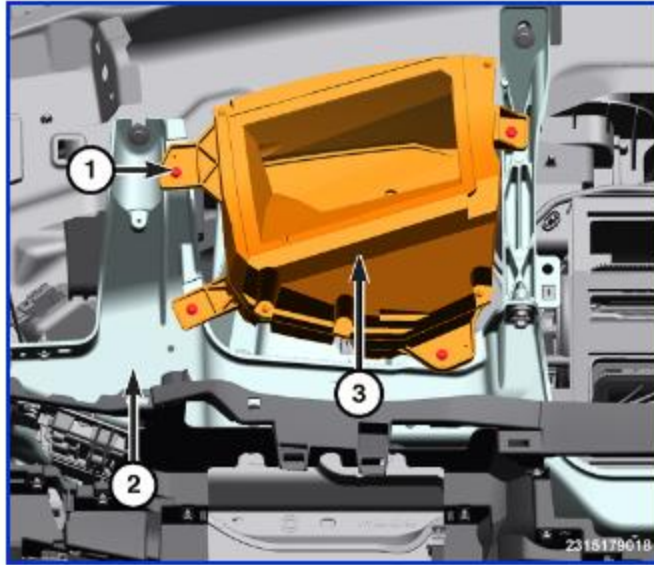
Fig 1

1. Attempt to duplicate the noise with the radio off. If the condition is still there with no audio input, examine the heads-up display (HUD) fastener clips. The clips may be installed on vehicles without the HUD option. See Fig 1. Refer to Service Library 08 - Electrical / 8J - Instrument Cluster / DISPLAY, Heads Up / Removal and Installation. If the fasteners are ok and tight then continue to step 2.
2. Using a handheld plastic 0.50mm feeler gauge, see if it will fit between the rear edge (closest to driver) of the HUD Bezel and the HUD Screen. If the Plastic Feeler will not go in the space, then a repair is needed.

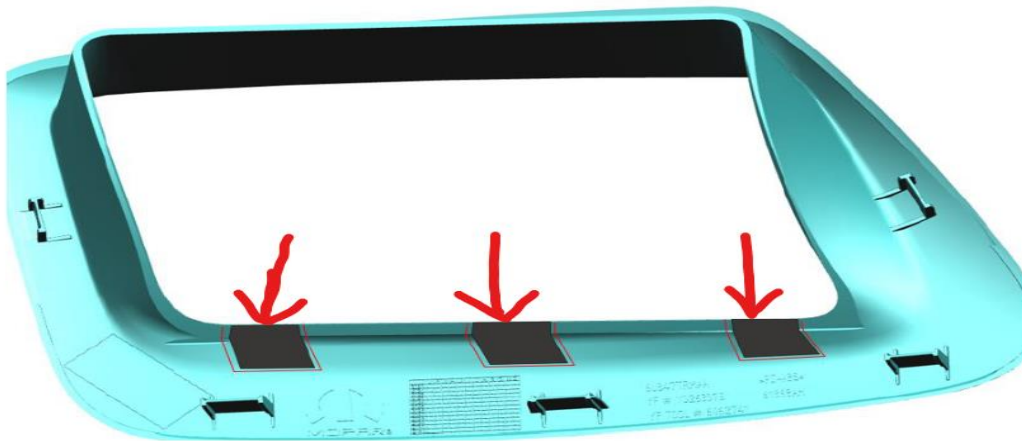
Fig 2.
68230057AB tape locations

A. Using a Plastic Trim Stick remove the HUD Bezel

B. On the back side of the HUD Bezel at the Rear Edge add 3 pcs of flock tape (MOPAR 6823057AB 25mm x 25mm x 1mm thick) placed approximately 35mm from each other as shown in Fig 2. Tape application will be on the rearward side (facing occupants) of the bezel. After tape installation, install the bezel and verify condition is resolved.
