WARRANTY BULLETIN

NO: D-23-04

SUBJECT: 2018 - 2024 (Current) Jeep
Wrangler (JL) and 2020 - 2024 (Current)
Jeep Gladiator (JT) - Corrosion Warranty
Claim Simplification (Rev. D)

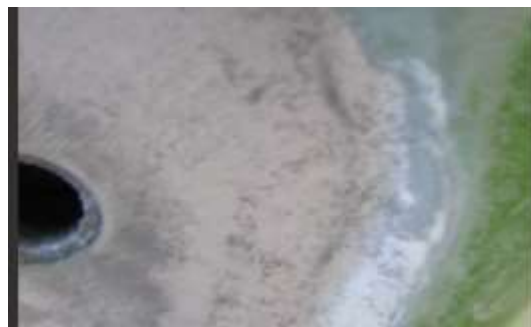
1. Pitting found after sanding the affected area (Fig. 1)

Pitting Found After Sanding Example (Fig. 1)

Note: If pitting is found during the sanding process, please use LOP 23-75-XX-XX for up to 0.5 hours in conjunction with the 23-85 replacement LOP.

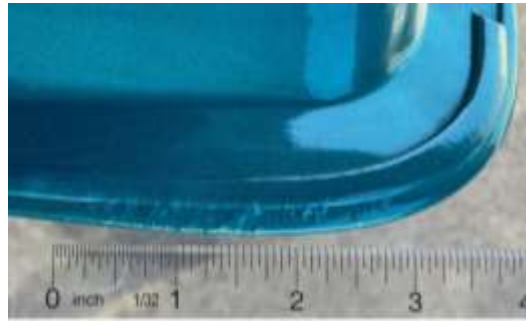
2. Corrosion found on the seam of the panel (Fig. 2)

Seam Panel Area Examples (Fig. 2)

Note: If corrosion is found on the seam of the panel, the door shell will be replaced. No additional sanding in the hinge or seam area is supported.

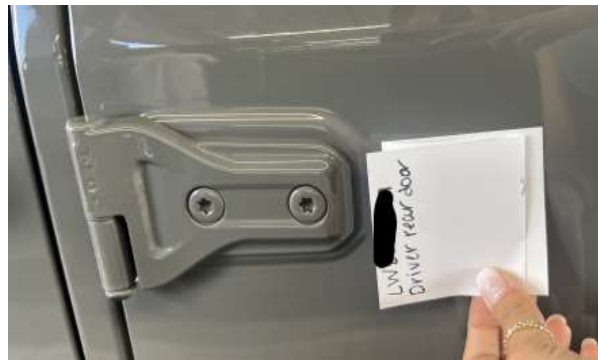
Dealers will need to take photos of the affected areas identified during the inspection to support the repair. A clear photo of the corrosion is needed and **MUST** include the VIN and affected body panel. The VIN and affected body panel can be included on a sticky note, written with a grease pen, a copy of the RO in the photo, masking tape, etc. (Figure 3)

VIN Example (Fig. 3)
