Bulletin No.: PIP5974A

PIP5974A GF9 9T45/50/60/65 Transmission 1-2-3-4-5-6 Clutch Snap Ring Popout Causing SES / DTC Code P0746 P0747

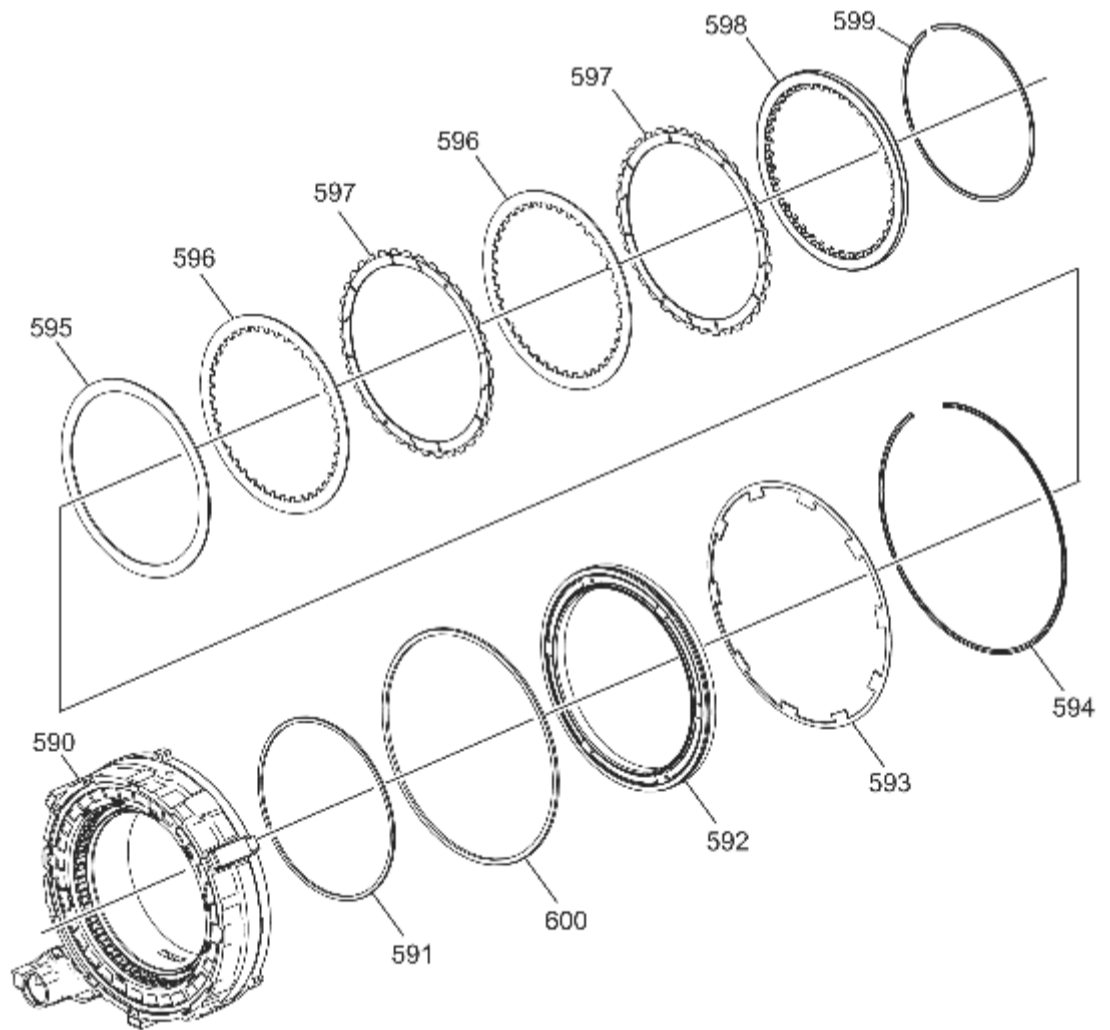
Cause

The transmission concern could be caused by an out of round snap rings: (594) 1-2-3-4-5-6 Clutch Spring Retaining Ring or (599) 1-2-3-4-5-6 Clutch Backing Plate Retaining Ring

Check transmission Julian build date.

If the transmission is built between 10/1/2023 and 4/22/2024; Julian date between 23 274 and 24 113 and the vehicle comes in with a code P0746 or P0747 and the code resets on a short test drive or the vehicle slips in drive, the transmission will need to be disassembled and inspected for damage.

The following parts will need to be replaced:

(594)1-2-3-4-5-6 Clutch Spring Retaining Ring

(599)1-2-3-4-5-6 Clutch Backing Plate Retaining Ring
