# Preliminary Information

## PIC6520D Loud Engine Noise in Cabin at 1200-2500 RPM

Brand:	Model:	Model Years:	VIN:		Engine:	Transmissions:
			from	to		
Cadillac	XT4	2024	All	All	All	All

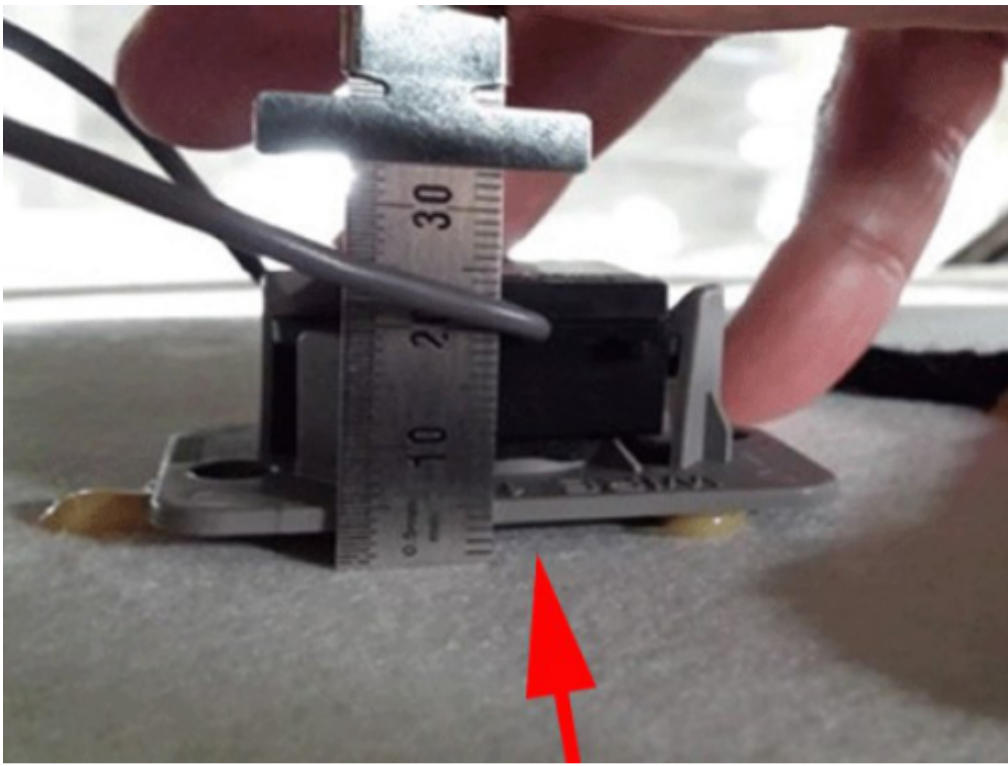
Involved Region or Country	North America
Additional Options (RPO)	IVD
Condition	<p>Loud noise inside cabin at 1200-2500 RPMs.</p> <p>Condition typically only occurs during one drive cycle and does not repeat on the next drive cycle if vehicle has gone through an extended sleep cycle.</p> <p>If customer shuts vehicle off and back on quickly without letting vehicle systems to fully sleep the issue could occur on the following drive cycle.</p>
Cause	Radio software anomaly or gap between the Active Noise Cancellation (ANC) bracket(s) and the headliner.

If the droning noise does not go away after the radio update, drop the headliner to inspect the ANC microphone brackets. If there is a gap like the one in the attached picture below, replace the headliner.

Labor Operation	Description	Labor Time
*2889998	Update radio to W26E-172.4.2-M169-SQBR4-123.4 Via USB/SPS	0.6 Hr.
*1086428	Remove and install headliner to confirm excess glue on ANC microphone brackets	2.7 Hrs.
*This is a unique Labor Operation for Bulletin use only.
