Preliminary Information

PIT5800C Service Theft Deterrent System / SES MIL / Fuse F49DR Open / DTCs B113C, B13AC, B1AC3, B195D, B195E, U3018, U3501

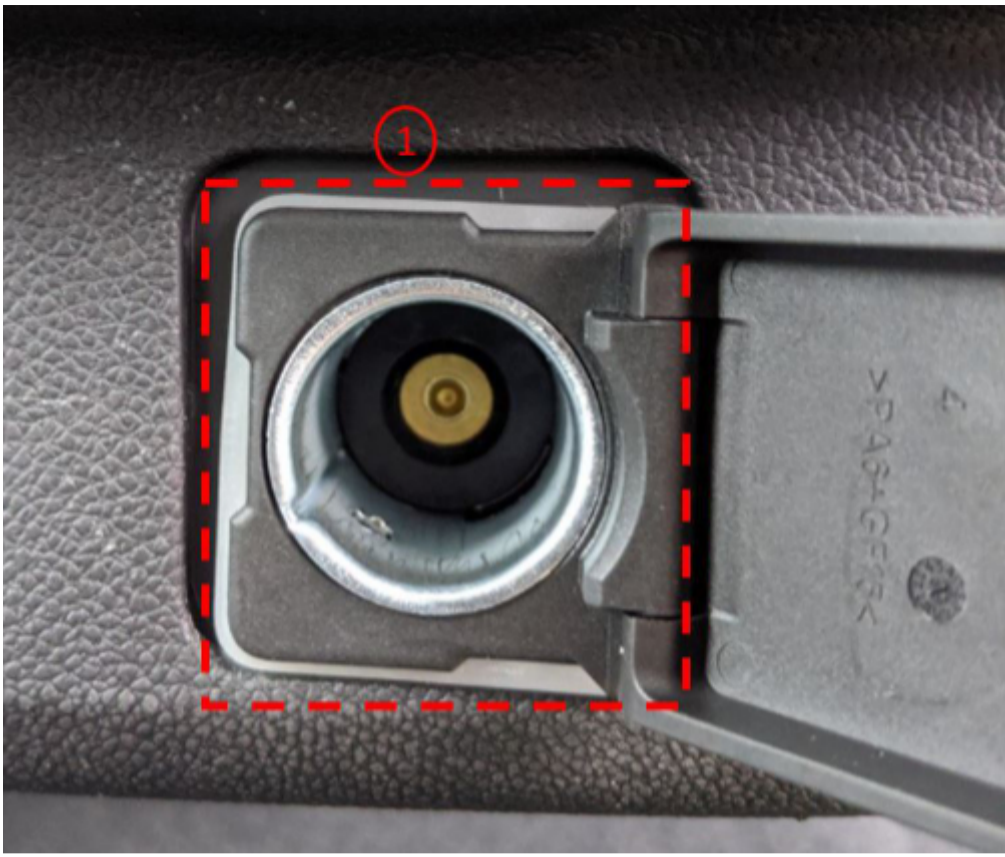
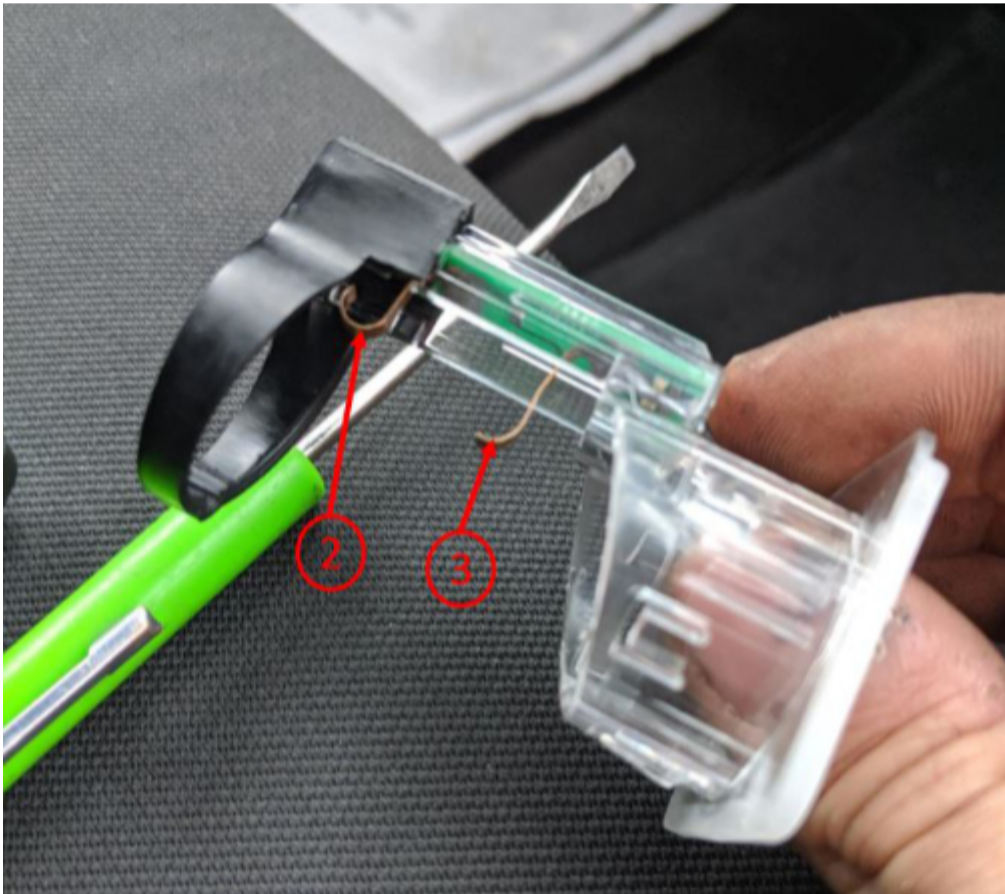
Involved Region or Country	North America
Condition	Some customers may comment on a SES MIL and a Service Theft Deterrent System message displayed in the DIC. When checking for DTC's, any of the following DTC's may be set: B113C, B13AC, B1AC3, B195D, B195E, U3018 and/or U3501. Also, fuse F49DR in the right IP fuse block will be open.
Cause	One possible cause of this condition is a short in the 12 volt power accessory illuminated ring. The 12 volt power accessory ports X80G or X80H have a LED illuminated ring around the perimeter (1), shown below. The LED illuminated ring is part of the 12 volt accessory port receptacle retainer, see 2nd photo. The 12 volt accessory port receptacle retainer has two contact tabs for the LED illuminated ring (2 and 3) which mate to the 12 volt accessory port receptacle (5 and 6), see 3rd photo. Tab 2 is for the power to the LED illuminated ring circuit 6817 and tab 3 is the ground which should only contact the outer metal body (6) of the 12 volt accessory port receptacle. If tab 3 is improperly formed or gets bent during service, it can short out between the metal body (6) and the slide contact (5) for tab 2, as shown below in call out 4. Tab 3 should only contact the metal body of the 12 volt accessory port receptacle (6).

Following SI, remove the 12 volt power accessory port X80G or X80H and inspect grounding tab 3. If the tab is shorting out between the metal body (6) and slide contact (5) for tab 2 then replace the 12 volt Accessory Power Port Receptacle Retainer.

Note: After repairs are complete, some DTCs may not clear until the vehicle completely goes to sleep. Turn the ignition off and disable RAP by opening and closing the driver's door, then leave the vehicle undisturbed so it can completely power down which may take up to 20 minutes.
