Preliminary Information

PIP5926C Transmission Fluid Leak Between the Transmission and Transfer Case

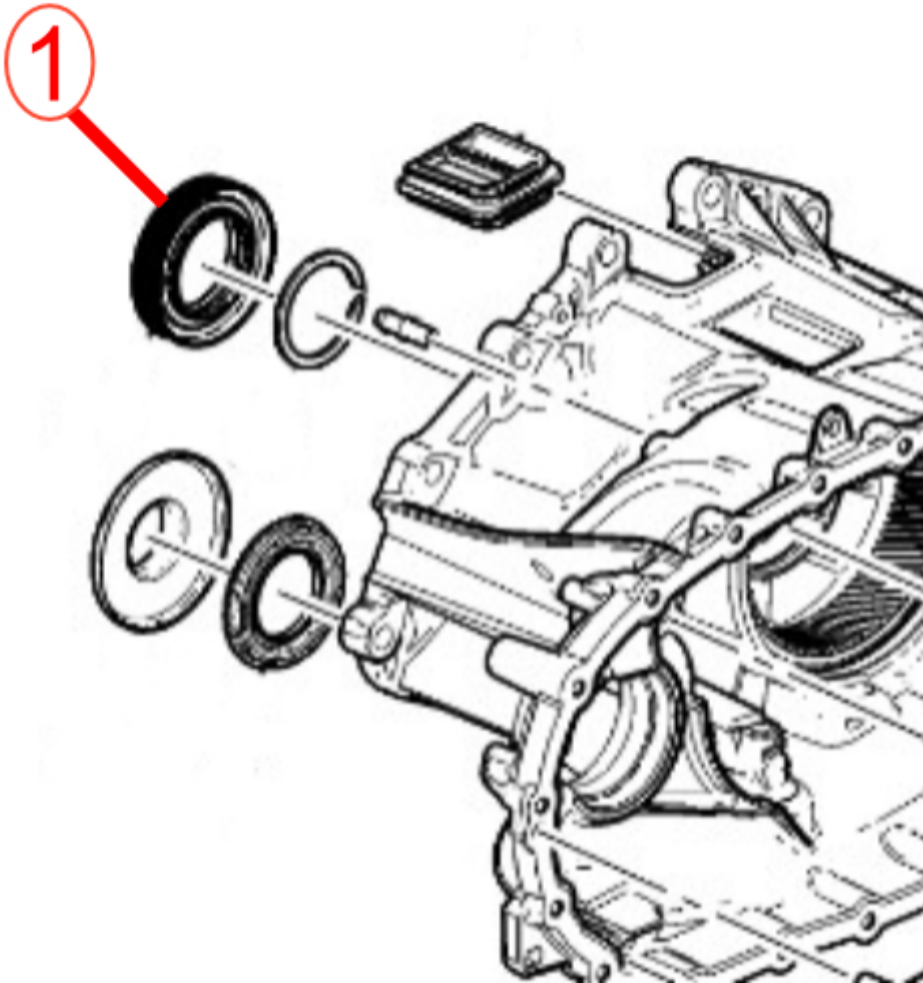
Involved Region or Country	North America, Middle East, Israel and Australia/New Zealand.
Additional RPO	NQF NQH
Condition	Some customers or technicians may comment of a transmission fluid leak between the transmission and transfer case.
Cause	The Transmission Case Extension Seal (call out 1 second pic below) is leaking or the Transfer Case Input Shaft Seal (call out 1 third pic below).

Note: The cavity between the Transmission and Transfer Case is a wet cavity by design. The Transfer Case Input Shaft Seal is a double seal to prevent fluid transmission and transfer case fluid from intermixing with each. If either side of the seal leaks fluid will leak from the weep holes between the Transmission and Transfer Case.

Note: It is being reported that the t-case input seal may be installed backwards, as a two piece seal back to back, and the replacement seal may also come as two seals to be installed. Correct orientation if two seals are received is metal clad together, which may be rubber coated, garner springs need to facing opposite of each other, one spring facing the t-case input gear, and one spring facing towards the trans output shaft, additionally, each seal may have three tabs, one seal protruding tabs, and the other inverted tabs, those tabs are to be aligned for proper installation.

Replace the Transmission Case Extension Seal (call out 1 second pic below) and Transfer Case Input Shaft Seal (call out 1 third pic below).

Note: Review the latest version of PIP5810 for proper Transfer Case Input Shaft Seal Installation Instructions. Improper Transfer Case Extension Seal installation will result in repeat leaks.
