Preliminary Information

PIP5712C Diagnostic Tip - Servicing Crankshaft Balancer and Cam Drive System Components

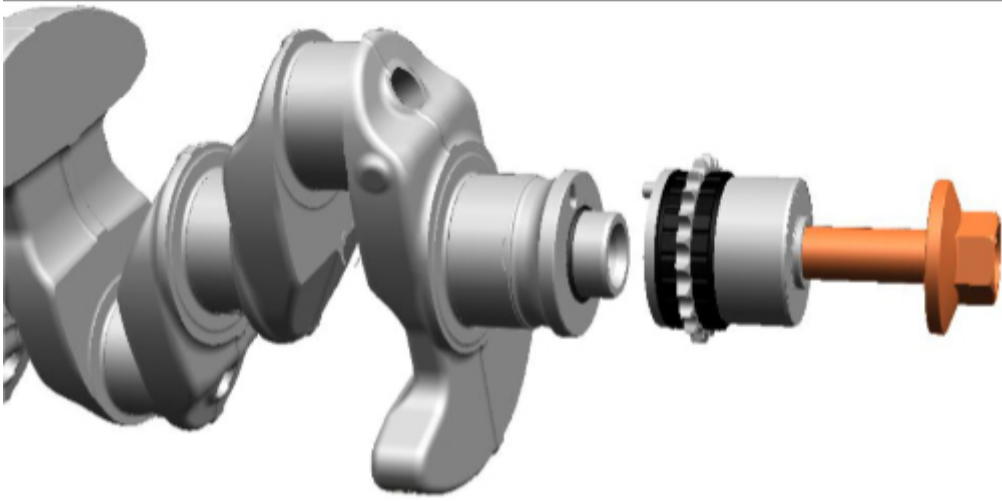
Involved Region or Country	North America
Condition	Potential engine damage while servicing the Crankshaft Balancer and/or cam drive system related components
Cause	Crankshaft sprocket may disengage from crankshaft while servicing the crankshaft balancer and/or cam drive system related components

As shown below, the crankshaft sprocket is separate from the crankshaft and held in proper position by the crankshaft balancer and Bolt.

Caution: Do not rotate the crankshaft on these engines with the crankshaft balancer removed. The crankshaft balancer and bolt must be reinstalled to avoid damage to the crankshaft sprocket, crankshaft and valvetrain.

Caution: When servicing any cam drive system components that require crankshaft balancer removal, the appropriate Flywheel Lock / Alignment and Camshaft Alignment Tools for the engine application must be installed to avoid engine valvetrain damage.

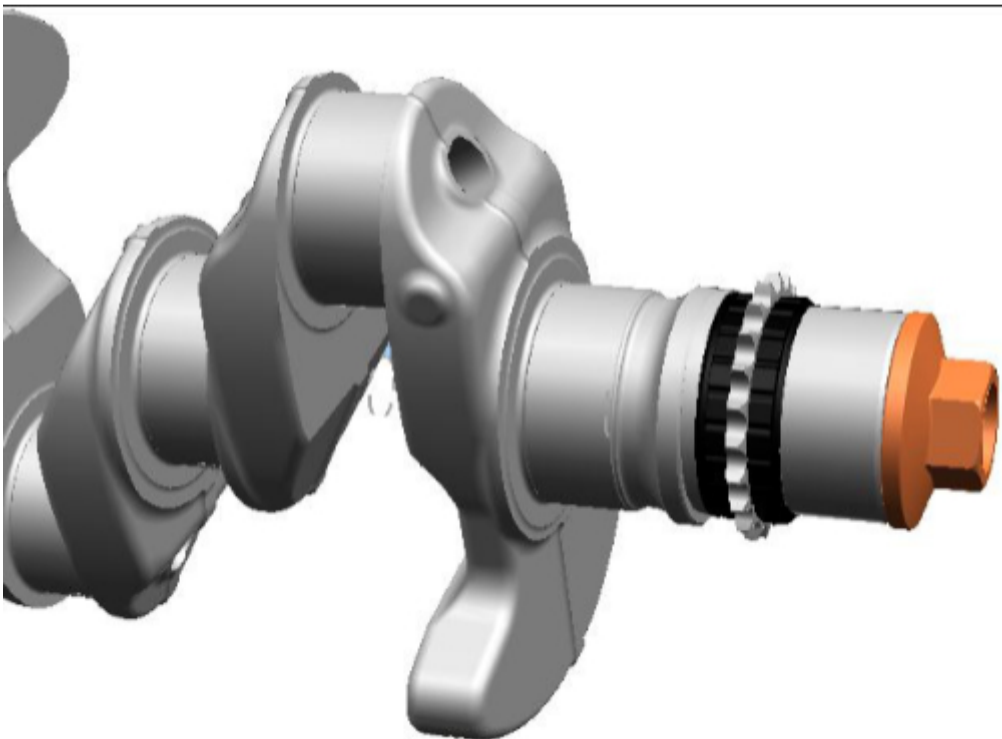
Crankshaft Balancer Bolt installed to maintain Sprocket to Crankshaft relationship
