Preliminary Information

PIT6017A Converting To Fleet Key Option RPO 6E2 or 6E8

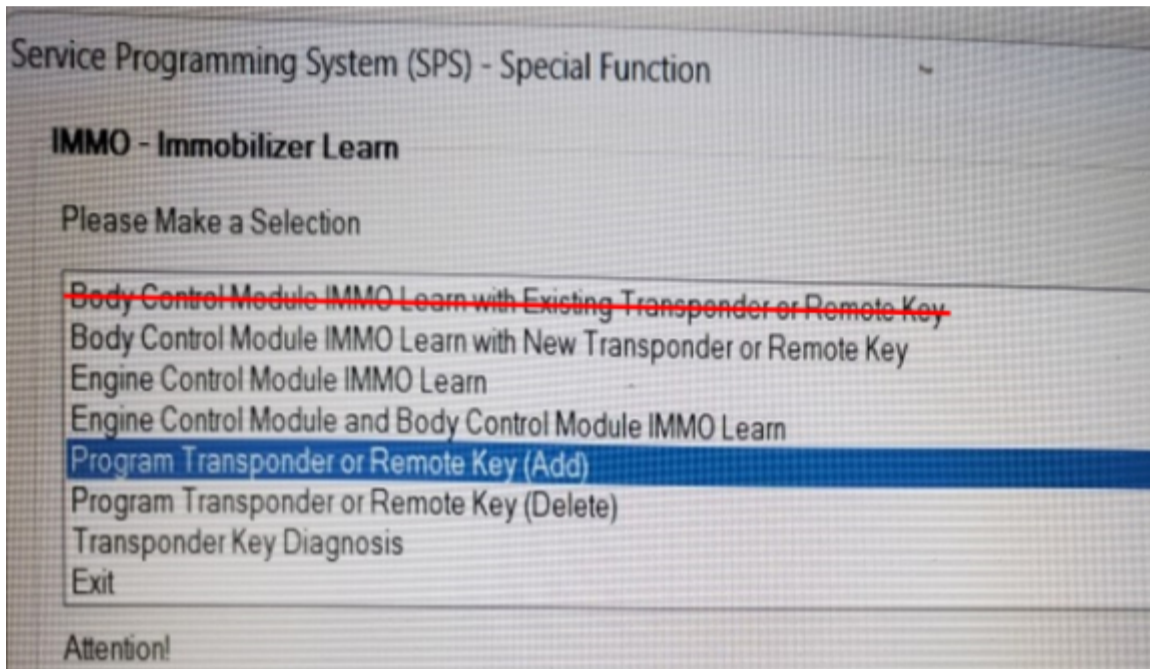
URGENT: Currently there is an issue in SPS programming and you will need to select " Program Transponder or Remote key (Add).

DO NOT SELECT " Body Control Module IMMO Learn with New Transponder or Remote Key as this will take previous old key fob information from the ECM and install it in the BCM allowing you not to learn the 6E2 or 6E8 fleet mode. Engineering is working on the concern and this PI will be updated when the correct select is repaired.
