Bulletin No.: PIT5832M

### PIT5832M Diagnostic Tip: Unable to complete the Serial Data Authentication Configuration/ No Start Or Unable To Perform Theft Relearn After Replacing Or Programming A Module / DTC U1962

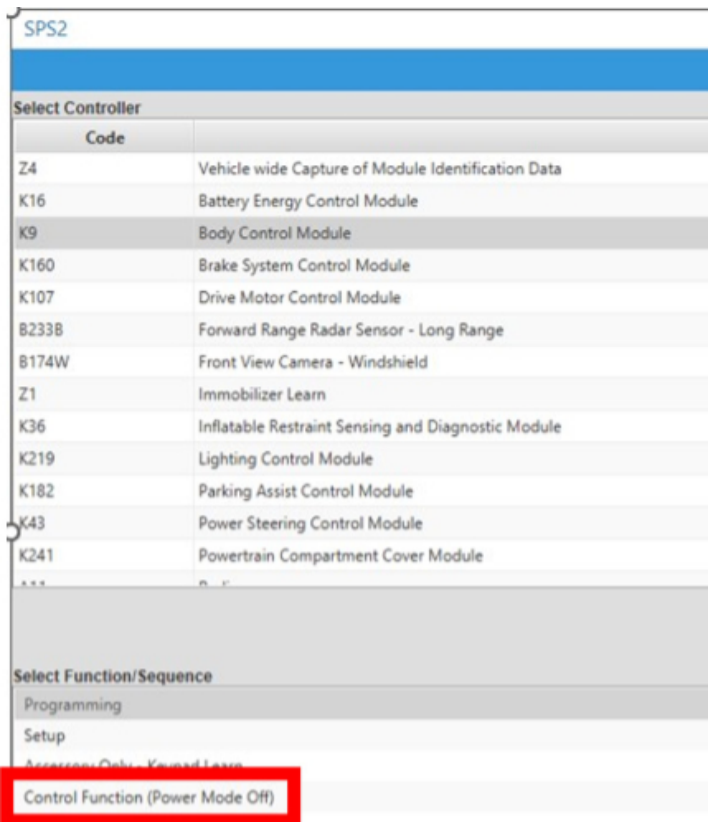
**For EV vehicles that have Hands free start, you may not be able to shut off the vehicle using the off soft button of the virtual cockpit smart control of the radio. If you experience this concern, you will have to access SPS programming in Techline Connect and select BCM and select "control function/ power mode off". See screen shot below.**

**Note: After you use this function, you may notice that the SDAC box may be missing from the bottom of the controller list, if you experience this, you will need to back out to the VIN screen and then go back to the controller screen for it to appear again.**

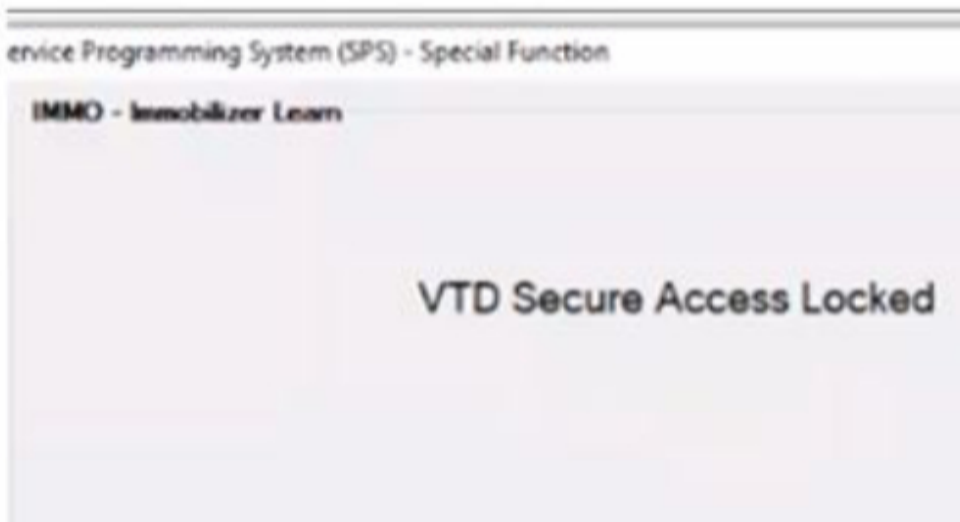
1. If a module was replaced, make sure the new module was SPS programmed correctly or the SDAC will fail and not complete correctly.
2. If a module such as the BCM is replaced, and the immobilizer learn needs to be completed after replacement, the tech needs to make sure that the SDAC completes correctly, or a pop-up message like the one below will be displayed:

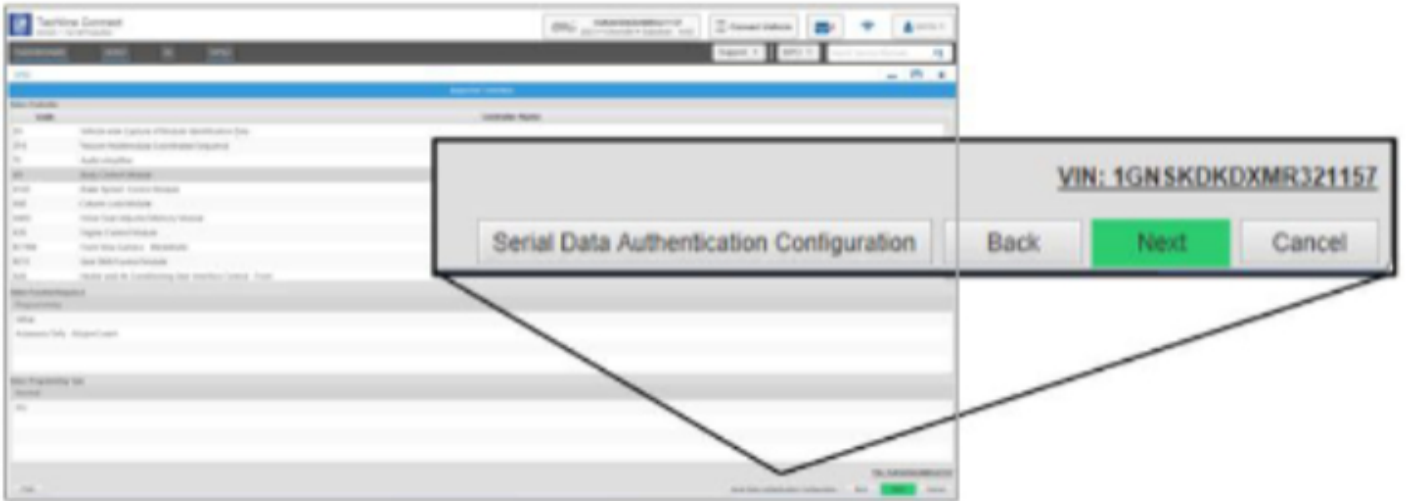
3. If a vehicle will not complete the SDAC, run the SDAC (using the Serial Data Authentication selection in Techline Connect) again. Verify the key fob is inside the vehicle. If the key fob is not inside the vehicle, the serial data authentication configuration procedure which runs automatically at the end of the programming step will fail even though the programming appears to run successfully. If the serial data authentication configuration procedure fails, DTC U1962 will set and/or the setup step will fail or be incomplete. Select the box in SPS controller list in the lower right-hand corner labeled "Serial Data Authentication Configuration".

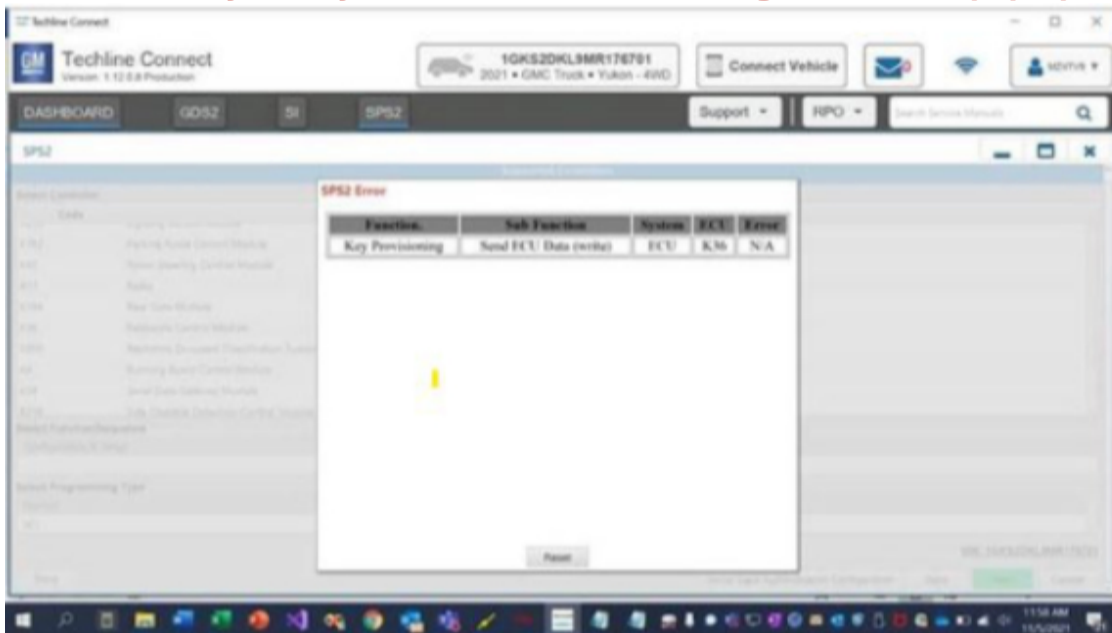
4. The SDAC will run up to 3 times before it fails. When it fails, there should be a pop box that shows up on the screen like the one below. Check and record the items listed under System and ECU. If the system box reads "Server" then the issue is related to the SPS system server or internet connection and not related to the vehicle. Attempt the SDAC again at a later time or the next day early in the morning. ( If the box doesn't read "Server" continue to step 5 ).

5. If the system box reads "ECU", then the Global ID of the module that is causing the concern should be able to be obtained. In the example above, the Global ID is listed as K36, which is for the SDM. The module's name can be found by looking at the global codes listed under "Control Module References" document in SI for the vehicle that is being working on

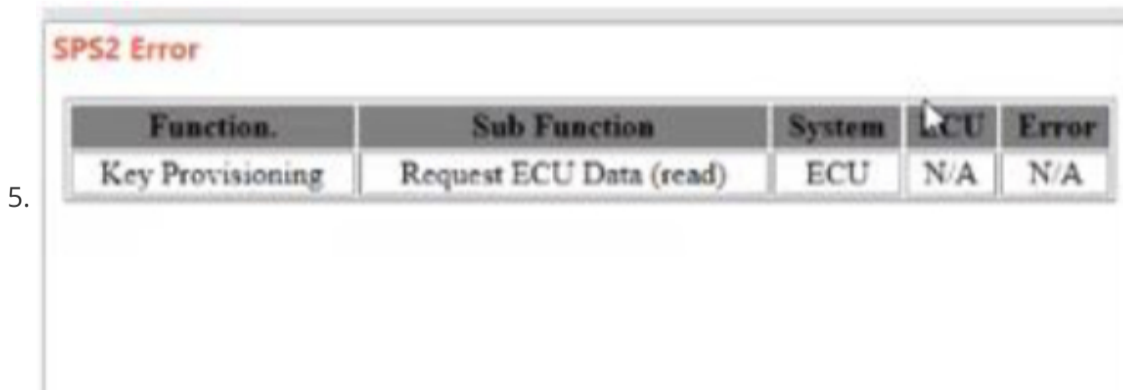
6. Sometimes the pop-up box will read "ECU" but it will not give you a Module ID in the ECU box. In this case, the servicing dealer will have to contact Techline support and they will have to assist by getting a SPS log file from the dealership's system. If this is the case, they must be contacted right after the SDAC failure. If any other programming is attempted before contacting Techline, then the SPS log will be erased.

7. Once the module that caused the concern has been identified, attempt to SPS program the module if a update is available and then attempt to run the SDAC again.
