Preliminary Information

PIT6175 Diagnostic Tip - Thump Chatter Vibration Rumble Rattle Type Noise From Rear Suspension Going Over Dips Or Bumps In The Road

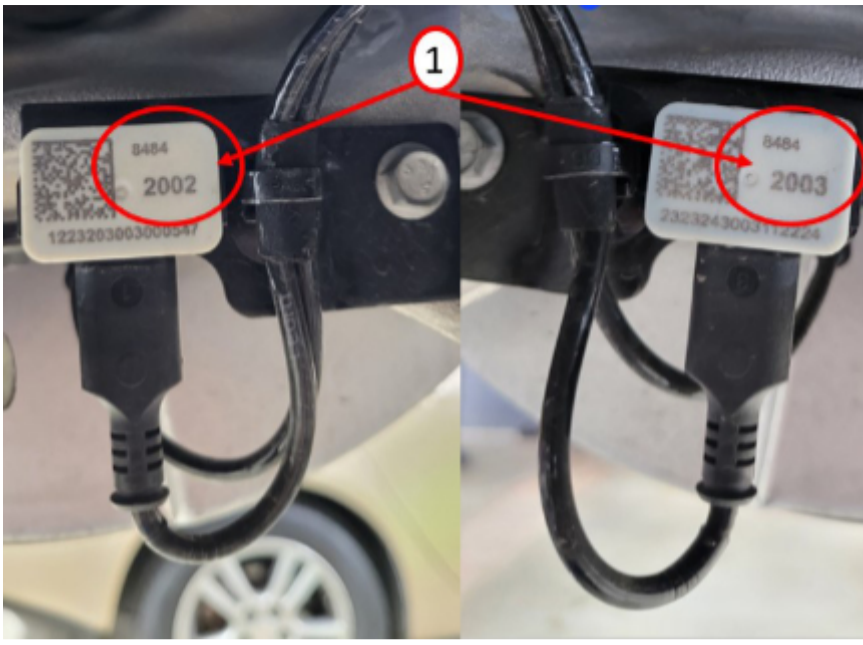
Involved Region or Country	North America
Additional Options (RPO)	Z95 MAGNETIC RIDE CONTROL
Condition	Some customers may comment on a Thump, Chatter, Vibration, Rumble, Rattle type noise from the rear suspension when going over a dip in the road as the suspension compresses and rebounds.
Cause	The cause of this condition could be the rear suspension accelerometer sensors installed on the vehicle.

- If the issue does not go away, then continue with normal SI diagnostics.
- If the issue goes away, then inspect the rear suspension accelerometer sensor part numbers that are installed on the vehicle, shown below (1). The parts catalog MUST BE USED to verify the rear suspension accelerometer sensor part numbers for the vehicle you are working on. If the part numbers listed in the parts catalog are different then what is installed on the vehicle, then replace the accelerometer sensors with the part number sensors listed in the parts catalog.
