### PIT5993B No Crank Due To Dead Battery / Battery Draw / Unwanted Alarm

#### Models

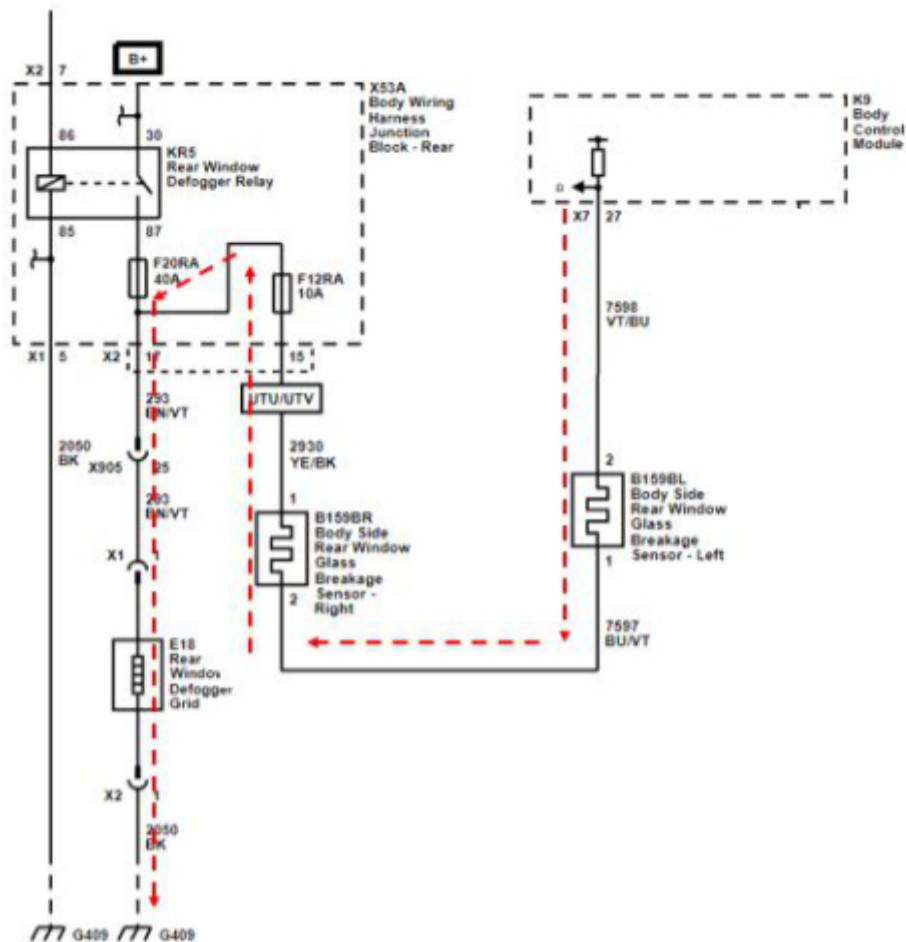
Involved Region or Country	North America
Additional Options (RPO)	Theft-deterrent alarm system RPO UTT Or UTR
Condition	Some customers may comment on a low or dead battery, no crank due to a dead battery or unwanted alarm.
Cause	<p>These concerns could be caused by high resistance in the glass breakage loop, which is shown below with a dotted red line. The glass breakage loop consists of the rear window defogger grid and each rear quarter glass, which are all connected in series. Normally, the complete glass breakage loop should have less than 20 ohms of resistance to ground. If there is high resistance or a break at any place in this series circuit, it could cause the condition.</p> <p><b>Note: In some cases, the battery draw can only be duplicated if the vehicle is completely closed up (all doors and hood latches tripped) and the vehicle is locked, but in other cases the vehicle does not need to be closed and locked up.</b></p>

If the resistance to ground is greater than 20 ohms, then inspect the glass breakage loop for poor connections, which could occur at any point in the series circuit, shown above. The most common areas seen are the connections at either of the rear quarter glass assemblies.

To test the glass breakage loop, disconnect the battery and the BCM X4 and X7 connectors. Using the correct test probe (EL-38125-58) check for proper terminal tension at the BCM X7 terminal 27. If terminal tension is good then use an ohmmeter to check the resistance of the glass breakage loop to the BCM ground. Do this by connecting one lead of the ohmmeter to the BCM ground at connector X4 terminal 24 or 25 and the other ohmmeter lead to terminal 27 of the BCM X7 connector. Measure the resistance.

If the resistance to ground is less than 20 ohms, then the loop resistance is within spec, but if you are dealing with an intermittent issue then inspect and manipulate the glass breakage loop connections/wiring to see if the resistance increases. Repair any points of high resistance.
