Preliminary Information

PIT6169A K45 Powertrain Control Module Fails Key Provisioning/Serial Data Authentication Configuration U1962

Brand:	Model:	Model Years:	VIN:		Engine:	Transmissions:
			from	to		
Chevrolet	Traverse	2024	All	All	LK0	All
GMC	Acadia	2024	All	All	LK0	All

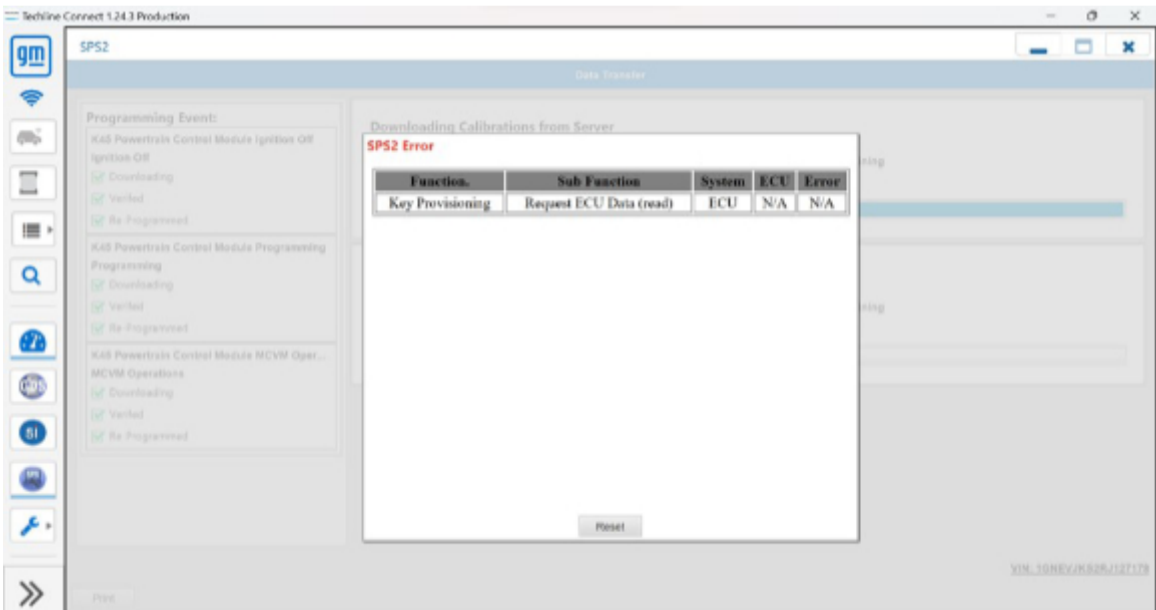
Involved Region or Country	North America
Condition	<p>During any module programming event that is followed by Key Provisioning (aka Serial Data Authentication Configuration/SDAC) the K45 PCM has the potential to fail key provisioning and U1962 will set.</p> <p>If this occurs it is not possible to recover the Powertrain Control Module (PCM) and it will need to be replaced.</p>
Cause	Software bug in the K45 PCM.

If you see the screen below at the end of programming you will need to access the SPS logs to determine if the PCM has locked up .

Take a photo or screenshot of the screen showing the ECU \$10 log and save it. The PCM is on parts restriction. Follow PIP5970 to obtain a replacement. The screenshot or photo of the log will be needed by PQC for authorization of a replacement PCM. If you are unable to locate the SPS failure logs and need assistance with this call TCSC at 800-828-6860. If ECU \$10 is not found in the log follow SI diagnostics for vehicle concern.

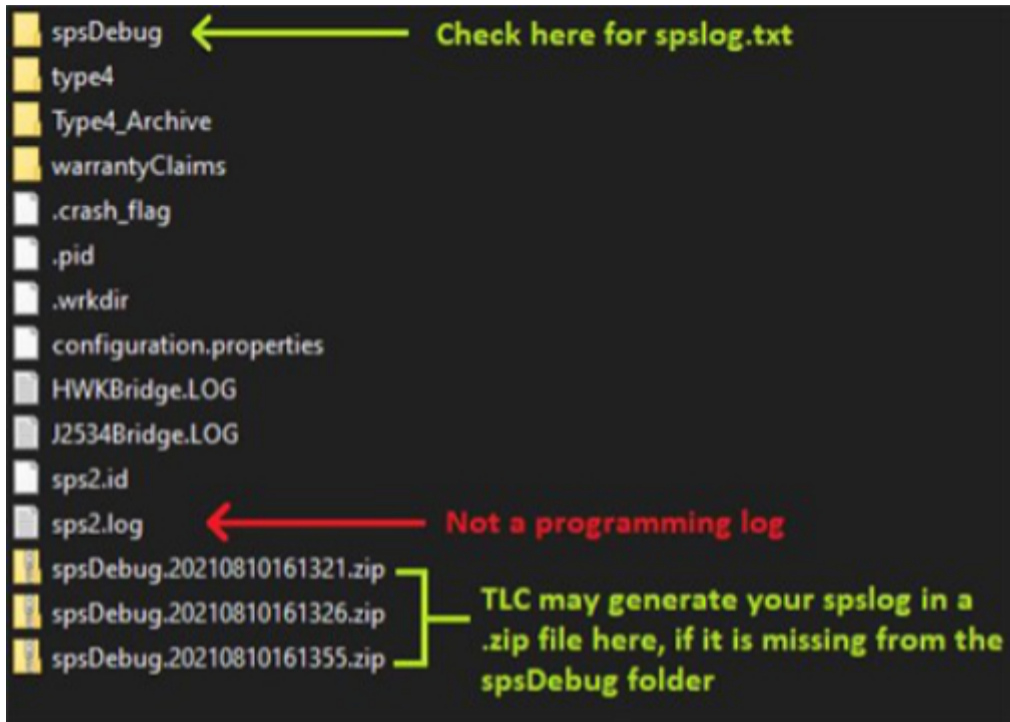
Locate your sps2.log

C:/ > Users > (user ID) > sps > spsDebug > spslog.txt

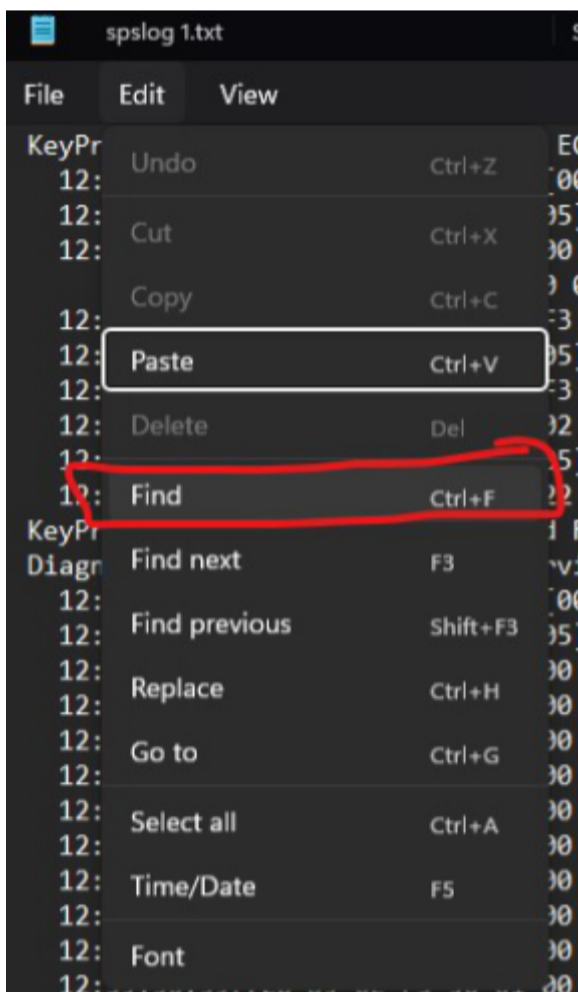
Open the spslog.txt with Microsoft Notepad as seen below or press Ctrl + F.

Type in: NegResponseCode \$22

If there are multiple "NegResponseCode \$22" lines, look through them all for one that says "ECU \$10".

If you find that log as shown below, that means the PCM failed Key Provisioning and will need to be replaced.
