PIP5927A Diagnostic Tip: Possible DTC P0237 P0101 P1101 or P0299 Reduced Power Potential Damage To Charge Air Inlet Hose At Turbocharger

Brand:	Model:	Model Years:	VIN:		Engine:	Transmissions:
			from	to		
Chevrolet	Equinox	2023 - 2024	All	All	1.5 LSD	All
GMC	Terrain	2023 - 2024	All	All	1.5 LSD	All

Involved Region or Country:	North America
Additional RPO/s:	None
Condition:	DTC P0237 P0101 P1101 or P0299 reduced power
Cause:	Potential damage to Charge Air Inlet Pipe at Turbocharger

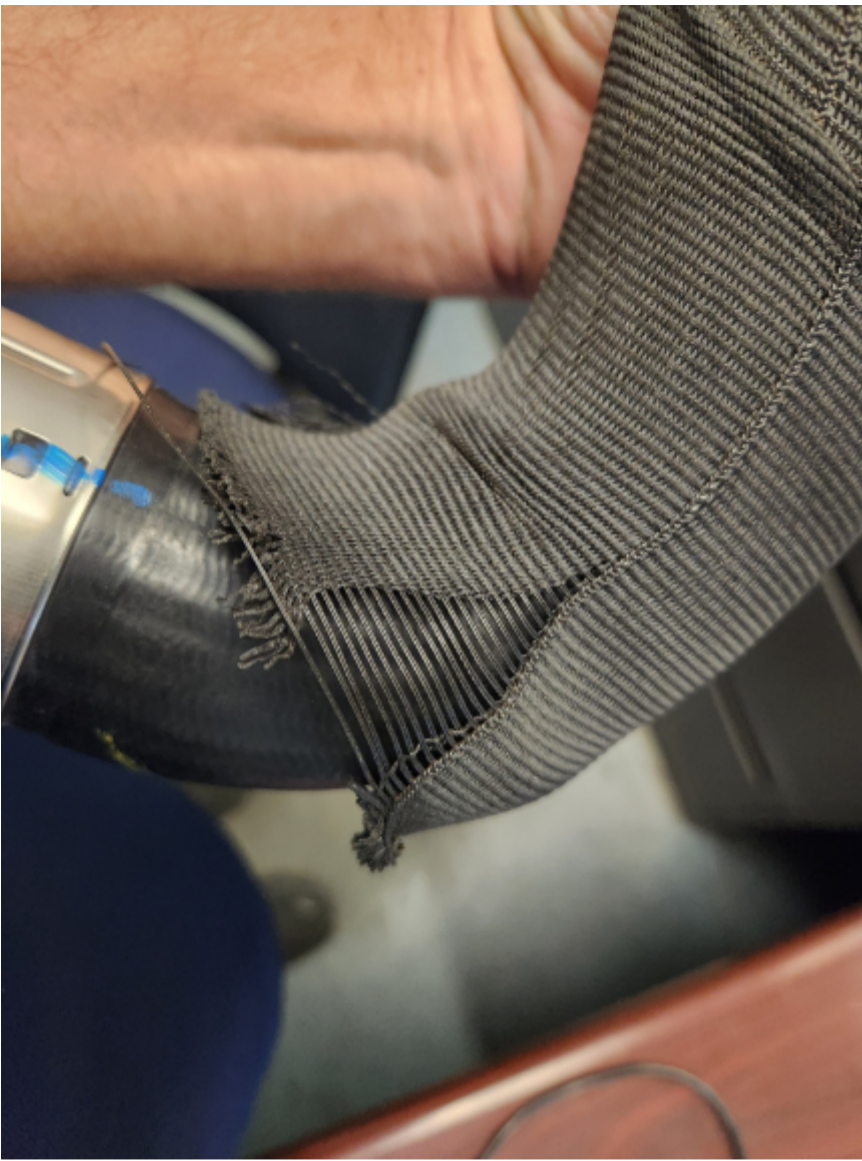
#1

This type of damage would allow the hose to swell under pressure damaging the abrasion sleeve and altering the readings within the boost control system or create a potential air leak.

Pictures below show damage to abrasion sleeve on Charge Air Inlet Hose.

Replace Charge Air Inlet Pipe assembly using latest parts listed in EPC.
