Preliminary Information

PIT6101E Intermittent No Audio

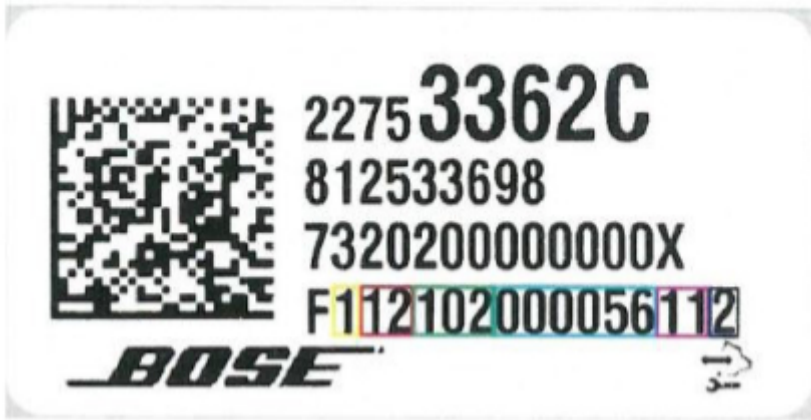
1. Verify that the amplifier has a Julian date of 23327 and later. To read the Julian date, see the image below. If the Julian date before 23327 and earlier, replace the amplifier.

Note: If there is a stock of amplifiers with the Julian date before 23327, please ship the parts back to CCA.
